ARCHITECT'S FIELD REPORT

038

| PROJECT | Eagle's Nest Townhouses 11 Morning Glory Way & 31 Marcellina Lane Mt. Crested Butte, CO 81225 | DATE | 3/15/11 |

| WORK OBSERVED | |
|---|--|
| Phase I – Construction, Interior Window Trim Inspection | |

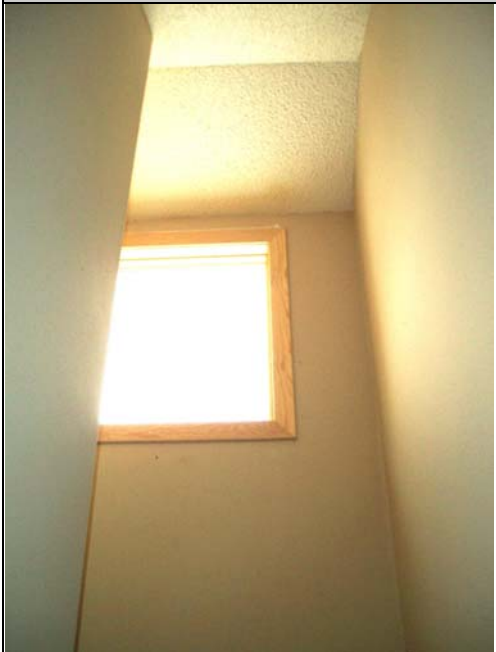
| PHOTO -WORK ITEM | DESCRIPTION | ACTION |
|---|---|---|
| | <p>3/10/11 – Photo 4 Unit 5</p> <p>Tan interior paint color. Exposed screws along top edge of trim.</p> | <p>BP</p> |

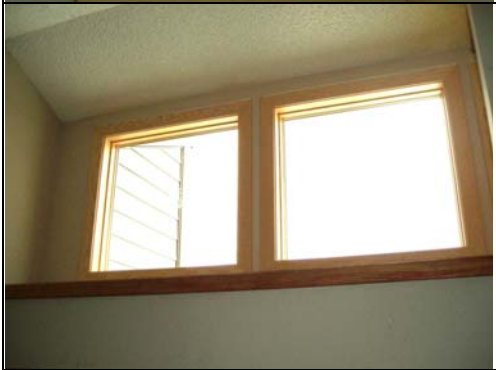
| PHOTO -WORK ITEM | DESCRIPTION | ACTION |
|---|---|---|
| | <p>3/10/11 – Photo 5 Unit 5</p> <p>Exposed area at top of windows will require a custom paint.</p> | <p>BP</p> |

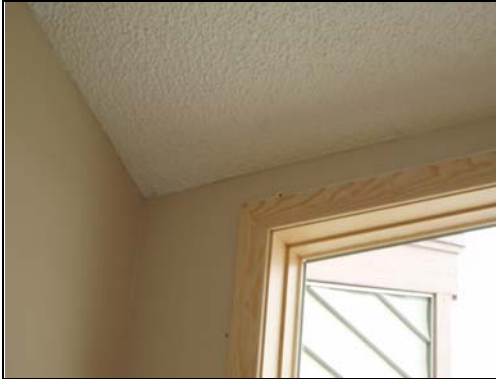
| PHOTO -WORK ITEM | DESCRIPTION | ACTION |
|---|---|---|
| | <p>3/10/11 – Photo 6 Unit 5</p> <p>Detail of exposed screw heads at top of window trim.</p> | <p>MHC BP</p> |

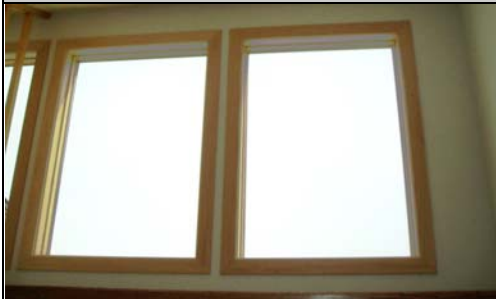
| PHOTO –WORK ITEM | DESCRIPTION | ACTION |
|---|---|---|
| | <p>3/10/11 – Photo 7 Unit 6</p> <p>Paint touch-up around windows required.</p> | <p>BP</p> |

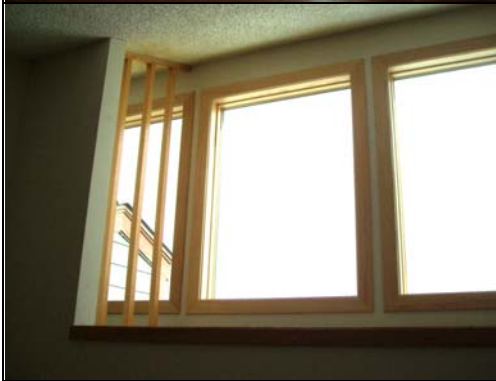
| PHOTO –WORK ITEM | DESCRIPTION | ACTION |
|---|---|---|
| | <p>3/10/11 – Photo 8 Unit 6</p> <p>Paint touch-up required.</p> | <p>BP</p> |

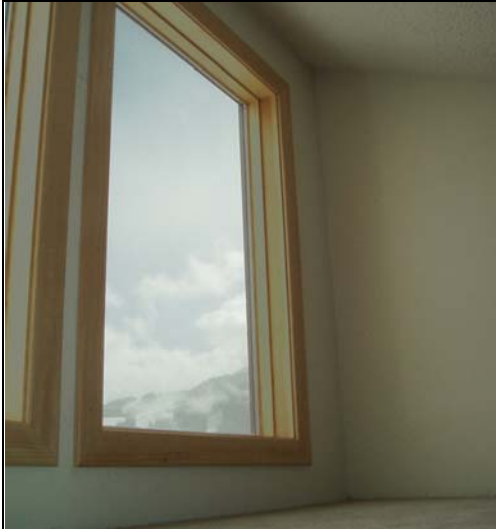
| PHOTO –WORK ITEM | DESCRIPTION | ACTION |
|---|---|---|
| | <p>3/10/11 – Photo 9 Unit 6</p> <p>Paint touch-up required.</p> | <p>BP</p> |

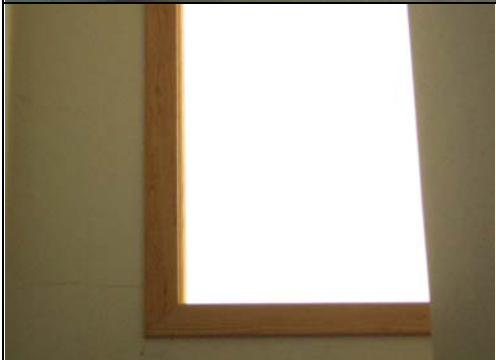
| PHOTO –WORK ITEM | DESCRIPTION | ACTION |
|---|---|---|
| | <p>3/10/11 – Photo 10 Unit 6</p> <p>Cracks visible along bottom edge of window will require repair.</p> | <p>MHC BP</p> |

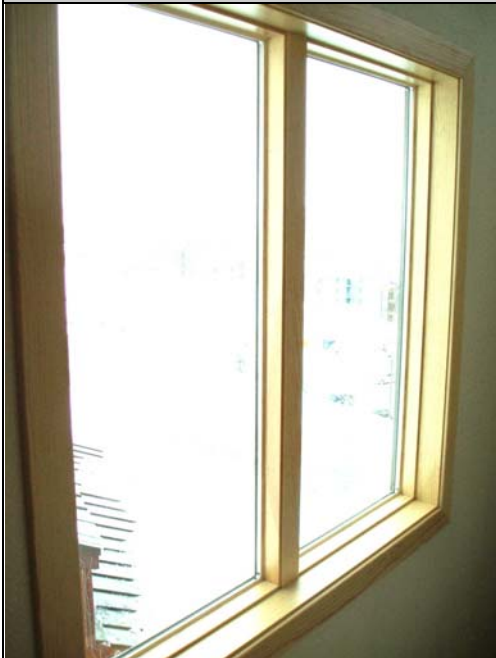
| PHOTO –WORK ITEM | DESCRIPTION | ACTION |
|---|---|---|
| | <p>3/10/11 – Photo 11 Unit 17</p> <p>End elevation window and trim.</p> <p>Wall will require cleaning and/or paint touchup.</p> | <p>BP</p> |

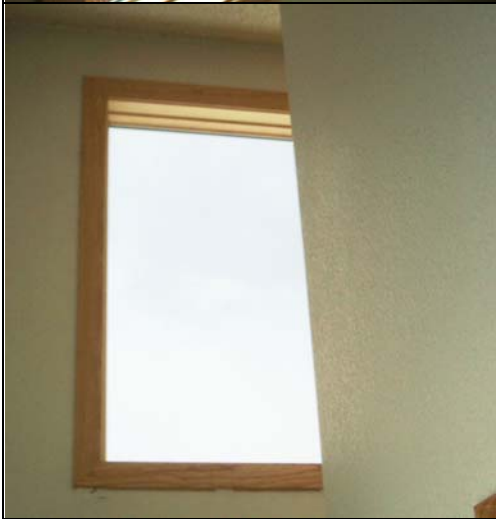
| PHOTO –WORK ITEM | DESCRIPTION | ACTION |
|---|---|---|
| | <p>3/10/11 – Photo 12 Unit 17</p> <p>Drywall cracks visible along lower edge of window trim will require repair.</p> | <p>MHC BP</p> |

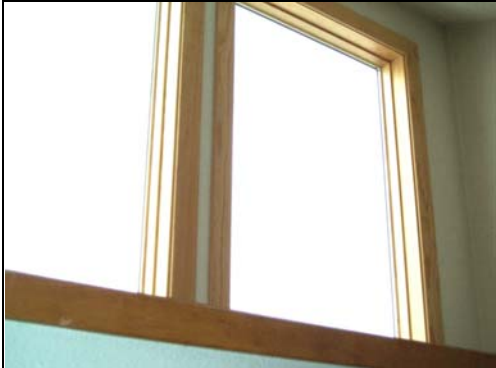
| PHOTO –WORK ITEM | DESCRIPTION | ACTION |
|---|---|---|
| | <p>3/10/11 – Photo 13 Unit 17</p> <p>Paint around windows will require paint.</p> | <p>BP</p> |

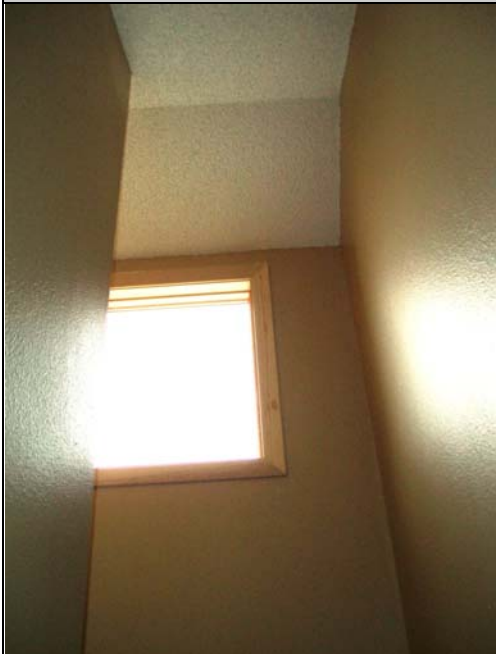
| PHOTO –WORK ITEM | DESCRIPTION | ACTION |
|---|--|---|
| | <p>3/10/11 – Photo 23 Unit 22</p> <p>Custom paint. Touch-up paint required at the top of window trim.</p> | <p>BP</p> |

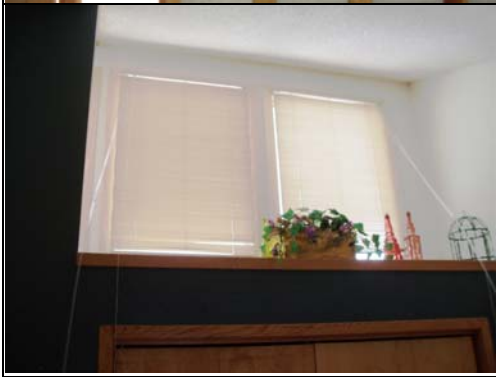
| PHOTO –WORK ITEM | DESCRIPTION | ACTION |
|---|--|---|
| | <p>3/10/11 – Photo 25 Unit 23</p> <p>Window trim is still bare. Wall will require touch-up paint.</p> <p>Blinds have adjustment extensions. Home Owner has requested extensions be reinstalled by Blind Faith.</p> | <p>BP CBL</p> |

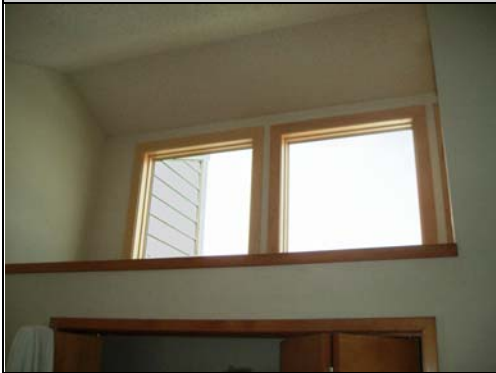
| PHOTO -WORK ITEM | DESCRIPTION | ACTION |
|---|---|---|
| | <p>3/10/11 – Photo 29 Unit 24</p> <p>Minor drywall repair required. Paint touch-up.</p> | <p>MHC BP</p> |

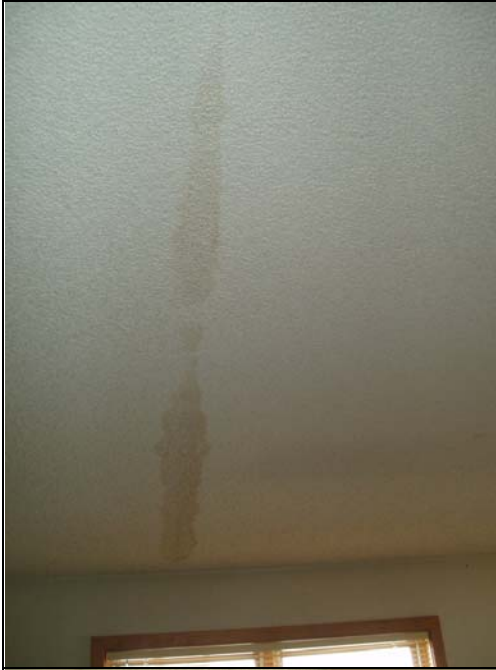
| PHOTO -WORK ITEM | DESCRIPTION | ACTION |
|---|---|---|
| | <p>3/10/11 – Photo 30 Unit 24</p> <p>Water damage to second floor bedroom ceiling.</p> <p>Roof inspection has been added to the Punch List.</p> <p>Ceiling will require repair.</p> | <p>MHC CBL</p> |

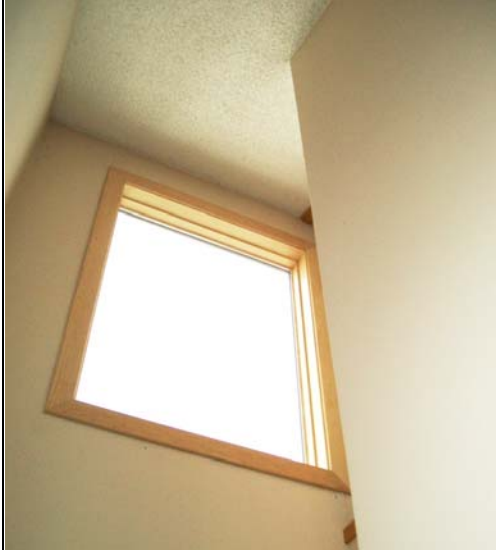
| PHOTO -WORK ITEM | DESCRIPTION | ACTION |
|---|---|---|
| | <p>3/10/11 – Photo 31 Unit 25</p> <p>Paint touch-up required.</p> | <p>BP</p> |
