ARCHITECT'S FIELD REPORT

046

PROJECT	Eagle's Nest Townhouses 11 Morning Glory Way & 31 Marcellina Lane Mt. Crested Butte, CO 81225	DATE	5/4/11
----------------	--	-------------	--------

WORK OBSERVED	
Phase II – Retaining Wall Repairs	
TRADES PRESENT	
None

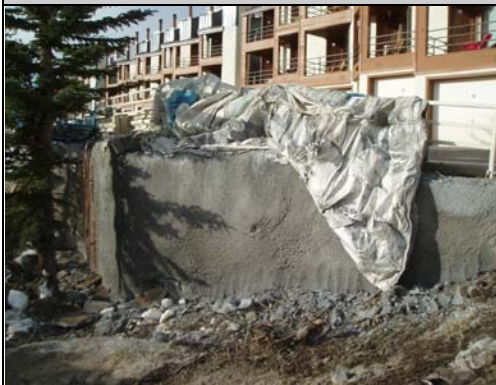
<p>5/4/11 – Photo 1 Lower Level Retaining Wall</p> <p>Initial north portion of the wall has the base layer of shotcrete covering anchor heads. The tarp above is an insulating blanket to help the concrete cure over night.</p>	<p>Note</p>

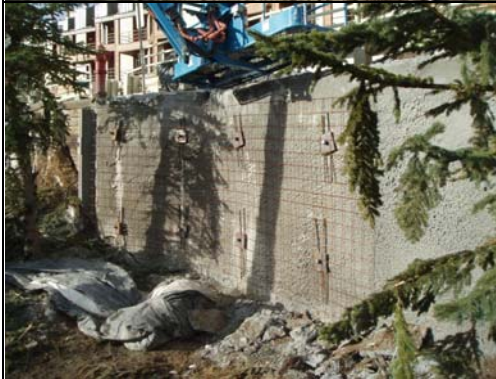
<p>5/4/11 – Photo 2 Lower Level Retaining Wall</p> <p>Middle portion of the wall with anchor heads and woven wire still exposed.</p> <p>Drainage mats have been installed behind the shotcrete.</p>	<p>Note</p>

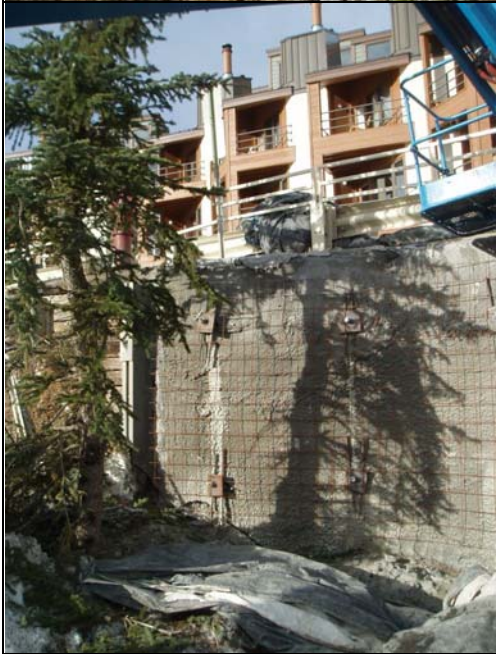
<p>5/4/11 – Photo 3 Lower Level Retaining Wall</p> <p>Southern portion of the wall with wire mesh and anchors still exposed. This portion of the wall will be covered with another layer of shotcrete.</p> <p>Note: The trees in this area have received a bit of damage – this is to be expected with retaining wall work being performed in close proximity.</p>	<p>Note</p>

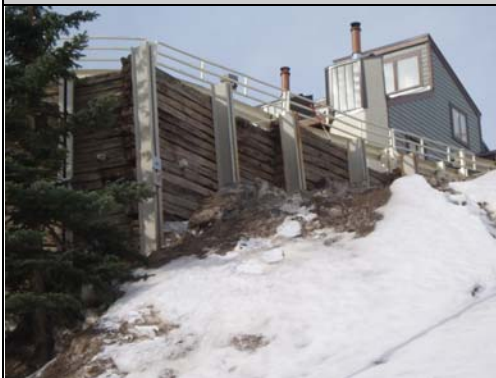
<p>5/4/11 – Photo 8 Mid-Level Retaining Wall</p> <p>Northern anchors are installed, bolted, and painted.</p>	<p>Note</p>

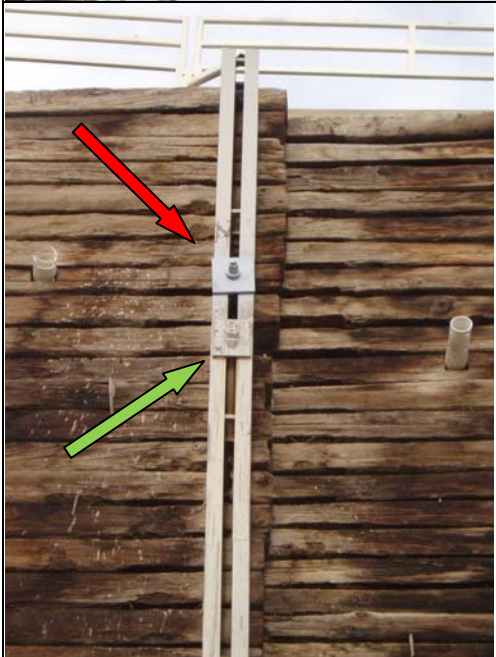
<p>5/4/11 – Photo 9 Example Finished Anchor Head</p> <p>Red Arrow – New Anchor Head Green Arrow – Abandoned Anchor Head</p>	<p>ENT</p>
