**ARCHITECT'S FIELD REPORT**

**066**

<b>PROJECT</b>	<b>Eagle's Nest Townhouses</b> 11 Morning Glory Way & 31 Marcellina Lane Mt. Crested Butte, CO 81225	<b>DATE</b>	11/30/11
----------------	--	-------------	----------

<b>WORK OBSERVED</b>	
Sloped Roof Design Units 19 & 20	
<b>TRADES PRESENT</b>	
None

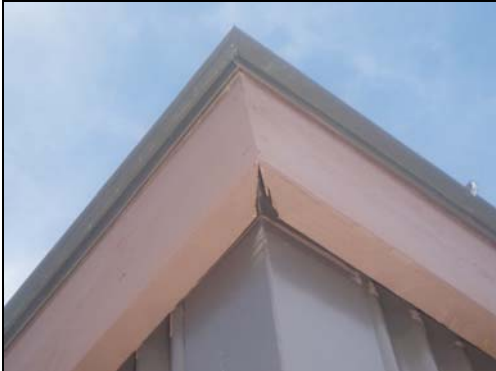
<p>11/11/30 – Photo 5 Unit 19</p> <p>Mitered corner detail. Large gap evident.</p>	<p>Note</p>

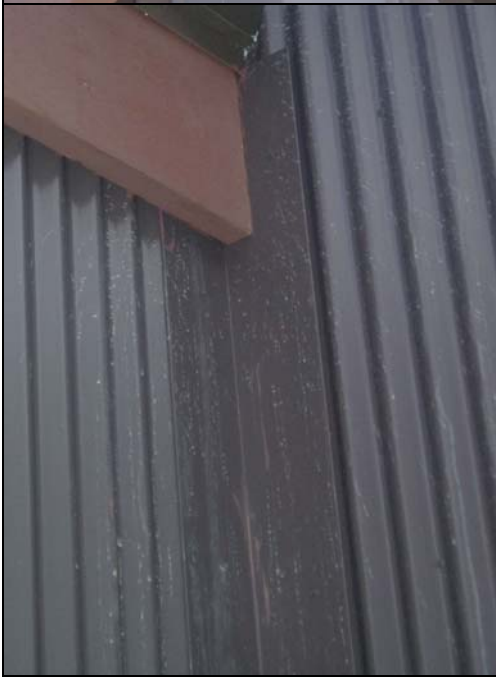
<p>11/11/30 – Photo 6 Unit 19</p> <p>Paint drips on existing siding and corner trim. Painting looks to have been completed in a short time frame with excessive drips and over-paint on existing siding.</p>	<p>TR</p>

<b>COMMENTS &amp; OBSERVATIONS</b>
<ol style="list-style-type: none"> <li>1. Observed completed work on sloped roofs of Units 19 &amp; 20.</li> <li>2. Work appears to be complete.</li> <li>3. Paint job appears to have been completed in a hurried manner. Drips and over-painting should be removed from the existing siding. Fascia boards may need an additional coat of paint. Due to the cold weather, painting might be better left for spring.</li> <li>4. Fascia boards are scarf jointed (not a single piece) and mitered corners are of low quality workmanship.</li> <li>5. Flashing appears to be installed per the drawings.</li> <li>6. Replaced siding is bent and dented. J-Channel finish trim is bent.</li> <li>7. Building "B" snow melt system appears operational. Recommend full functional test with +6" of snow.</li> </ol>

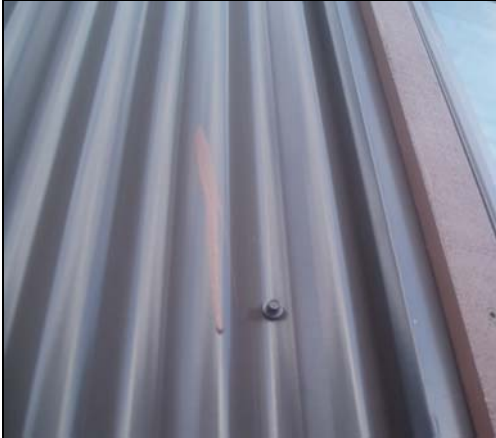
<p>11/11/30 – Photo 7 Unit 19</p> <p>Paint drips on existing siding.</p>	<p>TR</p>

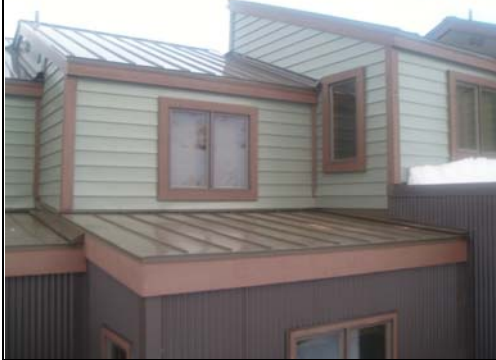
<p>11/11/30 – Photo 8 Unit 20</p> <p>View of completed roof.</p>	<p>Note</p>

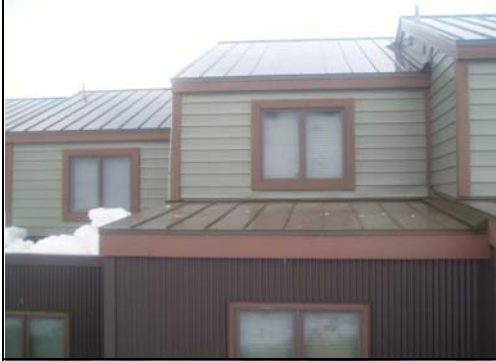
<p>11/11/30 – Photo 9 Unit 19</p> <p>View of completed roof.</p>	<p>Note</p>

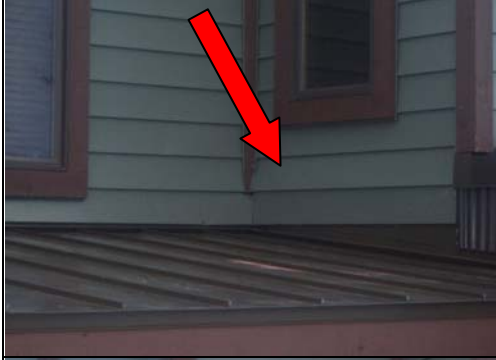
<p>11/11/30 – Photo 10 Unit 20</p> <p>Note buckled siding.</p>	<p>Note</p>

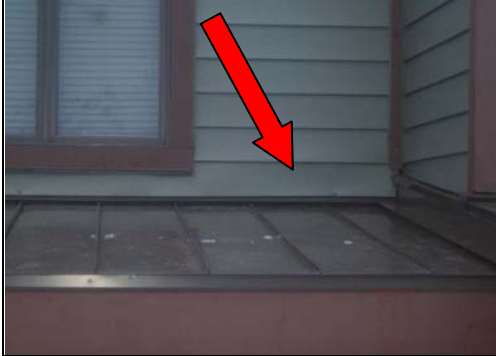
<p>11/11/30 – Photo 11 Unit 19</p> <p>Note buckled siding.</p>	<p>Note</p>
