# ARCHITECT'S FIELD REPORT

032

<b>PROJECT</b>	<b>Eagle's Nest Townhouses</b> 11 Morning Glory Way & 31 Marcellina Lane Mt. Crested Butte, CO 81225	<b>DATE</b>	1/26/11
----------------	--	-------------	---------

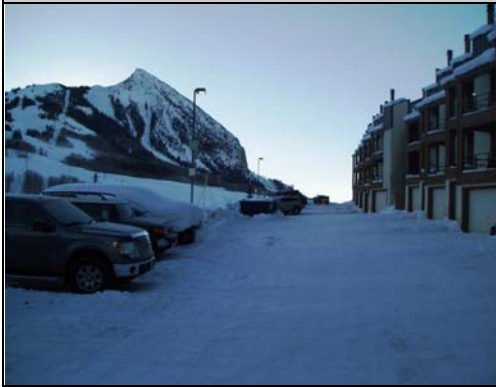
<p>1/26/11 – Photo 5 Lower Level Driveway &amp; Parking</p> <p>Site is in good order.</p>	<p>None</p>

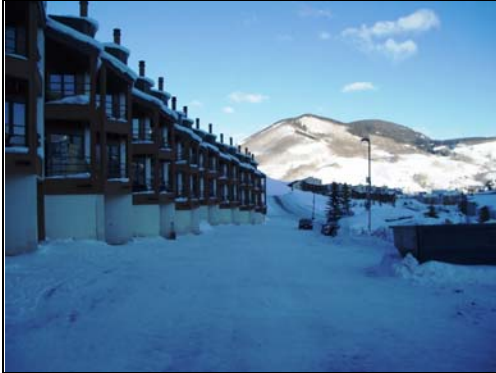
<p>1/26/11 – Photo 6 Lower Level Driveway &amp; Parking</p> <p>Site is in good order.</p>	<p>None</p>

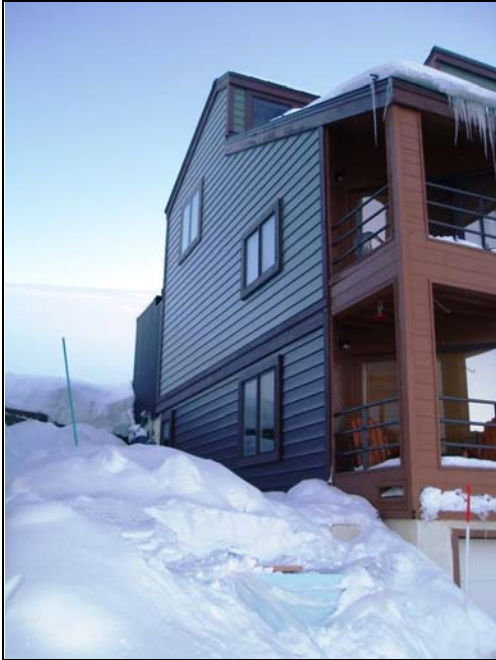
<p>1/26/11 – Photo 7 Unit 9 End Elevation</p> <p>Scaffolding has been moved to Unit 1. A small supply of rigid insulation remains between the buildings.</p>	<p>None</p>

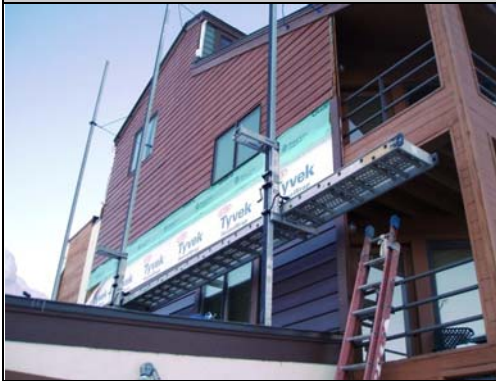
<p>1/26/11 – Photo 8 Unit 1 End Elevation</p> <p>Scaffolding is in place. Brown siding has been installed to the second belly band.</p>	<p>None</p>

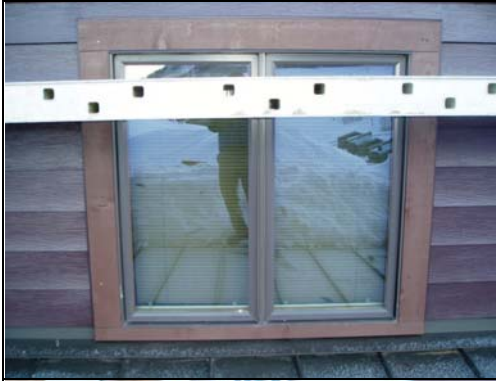
<p>1/26/11 – Photo 9 Unit 1 End Elevation</p> <p>Window trim is in place and installed per drawings.</p>	<p>None</p>

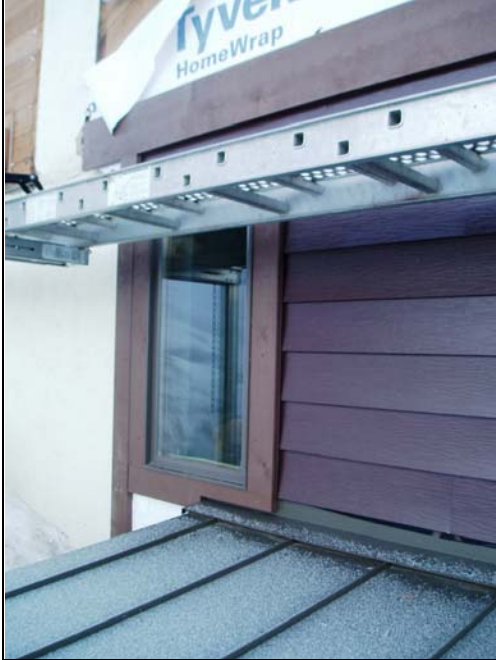
<p>1/26/11 – Photo 10 Unit 1 End Elevation</p> <p>Window trim is installed per drawings.</p>	<p>None</p>

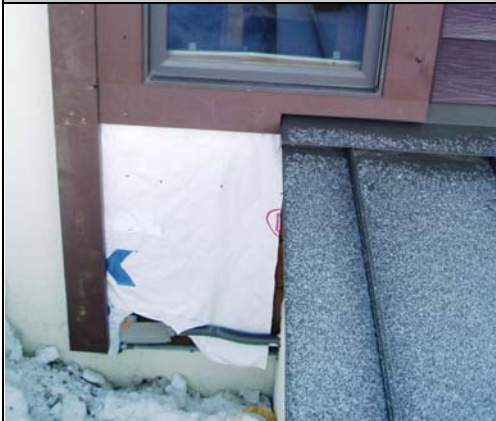
<p>1/26/11 – Photo 11 Unit 1 End Elevation</p> <p>Additional Brown siding will be installed at this location. Location was not indicated on the drawings.</p>	<p>None</p>

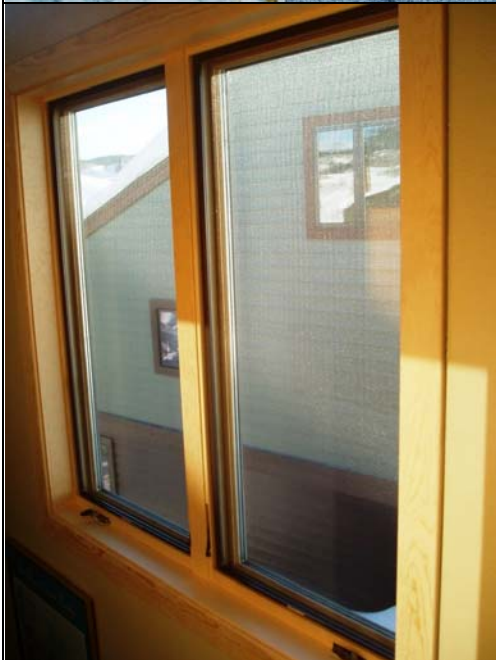
<p>1/26/11 – Photo 12 Unit 9</p> <p>New End Elevation operable window and trim.</p>	<p>None</p>

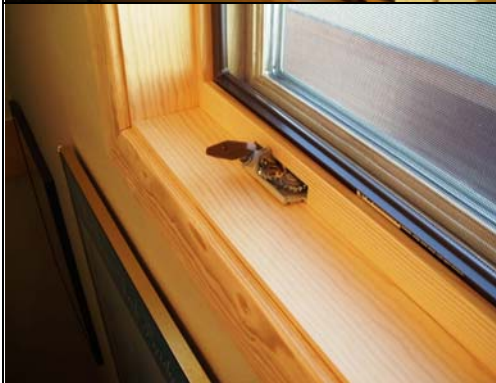
<p>1/26/11 – Photo 13 Unit 9</p> <p>Note: Missing covers on crank case.</p>	<p>MHC</p>

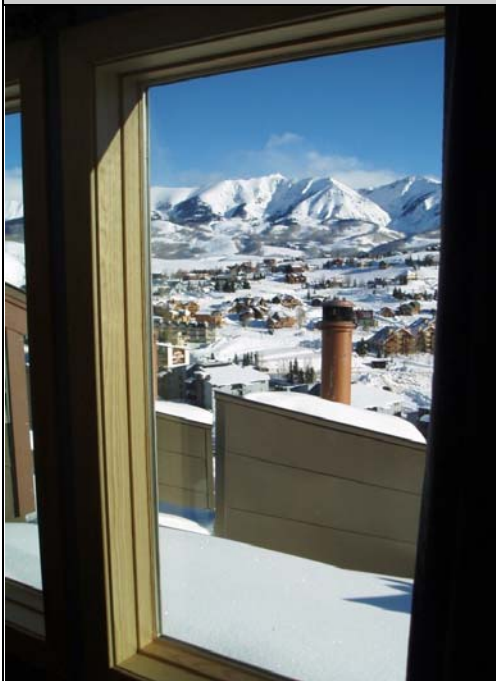
<p>1/26/11 – Photo 14 Unit 10</p> <p>Interior window trim has been installed.</p>	<p>None</p>

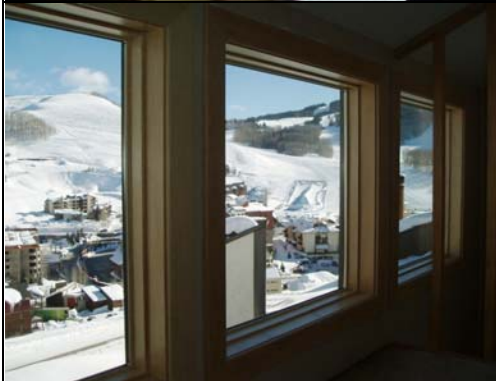
<p>1/26/11 – Photo 15 Unit 11</p> <p>Interior window trim has been installed.</p>	<p>None</p>

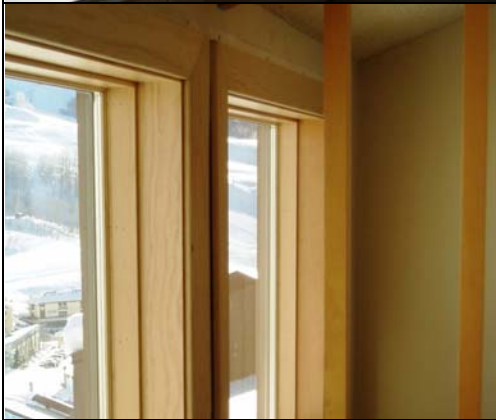
<p>1/26/11 – Photo 16 Unit 12</p> <p>Interior window trim has been installed.</p>	<p>None</p>

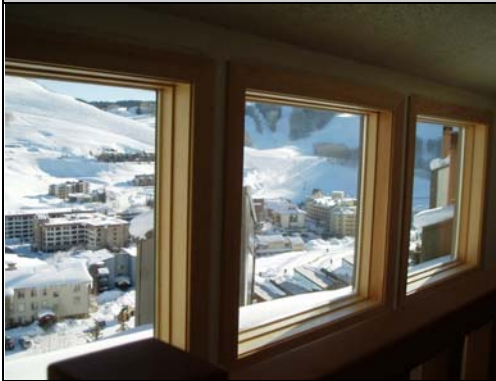
<p>1/26/11 – Photo 17 Unit 13</p> <p>Interior window trim has been installed.</p>	<p>None</p>

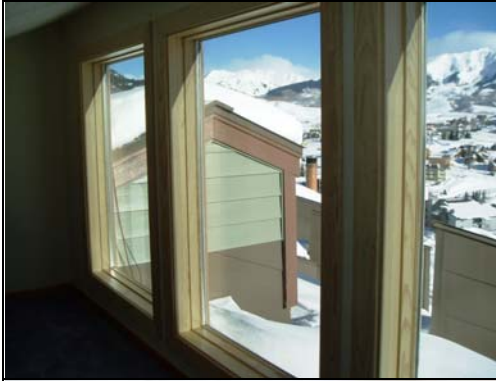
<p>1/26/11 – Photo 18 Unit 14</p> <p>Interior window trim has been installed.</p>	<p>None</p>

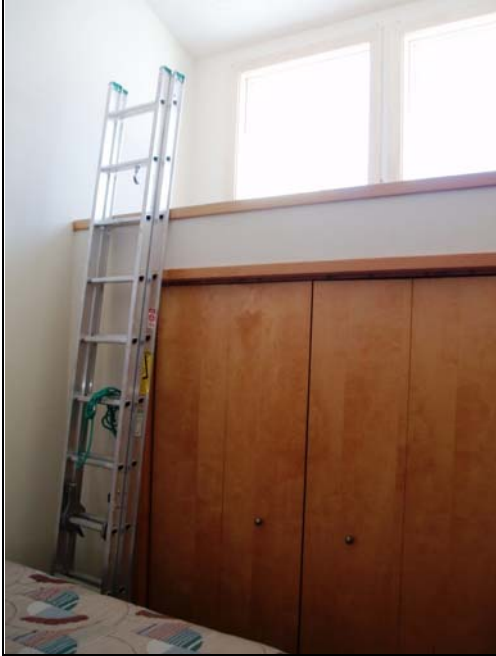
<p>1/26/11 – Photo 19 Unit 15</p> <p>Interior window trim has been installed.</p> <p>Does MHC own the ladder in this unit?</p>	<p>MHC?</p>

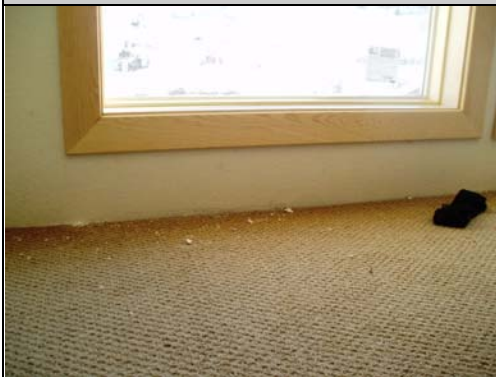
<p>1/26/11 – Photo 20 Unit 15</p> <p>A small amount of construction cleanup is needed.</p>	<p>None</p>
 	<p>1/26/11 – Photo 21 Unit 16</p> <p>End Elevation window has not been replaced.</p>	<p>None</p>
 	<p>1/26/11 – Photo 22 Unit 16</p> <p>Interior window trim has been installed.</p>	<p>None</p>

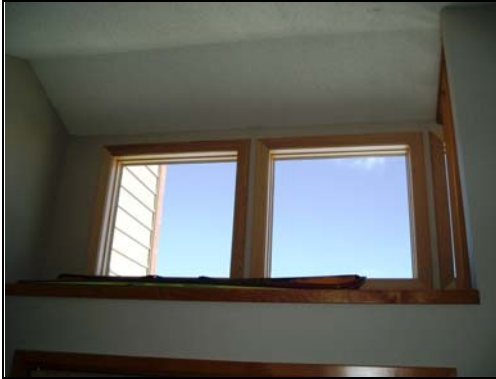
<p>1/26/11 – Photo 25 Unit 32</p> <p>Interior window trim has been installed.</p>	<p>None</p>

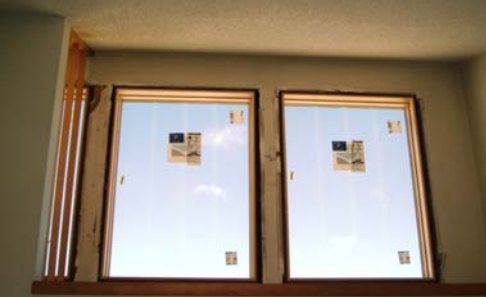
<p>1/26/11 – Photo 26 Unit 33</p> <p>Interior window trim has not yet been installed.</p>	None

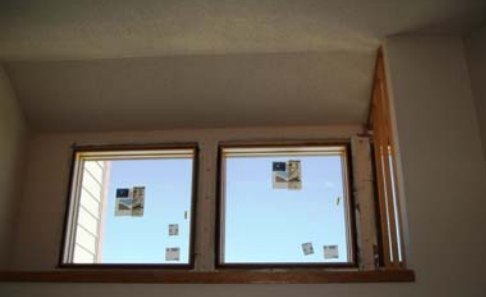
<p>1/26/11 – Photo 27 Unit 34</p> <p>Interior window trim has not yet been installed.</p>	None

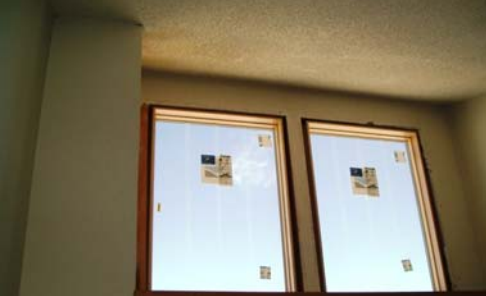
<p>1/26/11 – Photo 28 Unit 35</p> <p>Interior window trim has not yet been installed.</p>	None

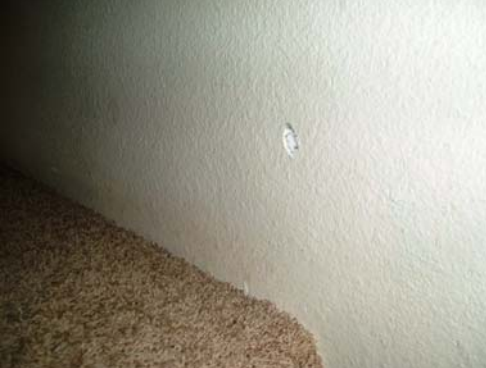
<p>1/26/11 – Photo 29 Unit 35</p> <p>Slight damage to the second floor stair. This was likely not caused by construction work but should receive a quick infill nonetheless.</p>	MHC

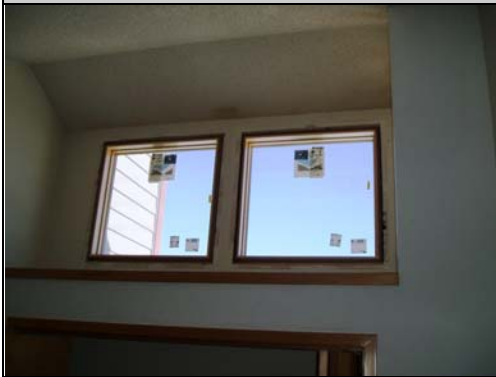
<p>1/26/11 – Photo 33 Unit 38</p> <p>Interior window trim has not been installed.</p>	<p>None</p>
 	<p>1/26/11 – Photo 34 Unit 39</p> <p>Interior window trim has been installed.</p>	<p>None</p>

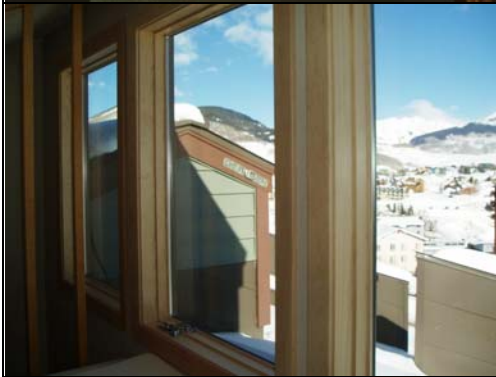
<p>1/26/11 – Photo 35 Unit 39</p> <p>Interior window trim has been installed.</p>	<p>None</p>
