ARCHITECT'S FIELD REPORT

PROJECT	Eagle's Nest Townhouses 11 Morning Glory Way & 31 Marcellina Lane Mt. Crested Butte, CO 81225	DATE	12/11/13
----------------	--	-------------	----------

WORK OBSERVED	
Phase IV Construction – Upper Level Renovations	
TRADES PRESENT	
None

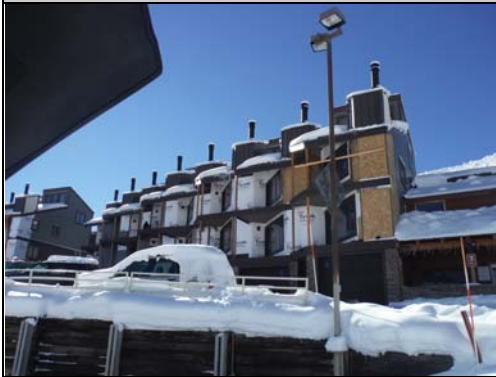
<p>12/11/13 – Photo 1 View of Building B</p> <p>Siding and trim installation is underway on Building B.</p>	<p>Note</p>

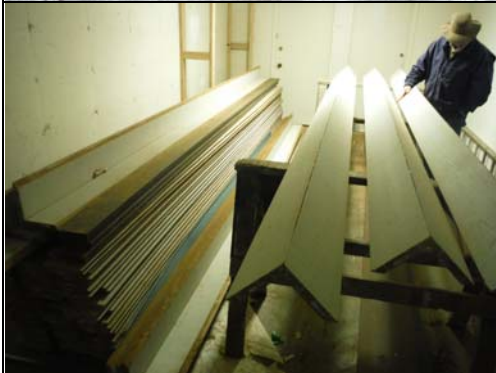
<p>12/11/13 – Photo 3 Column Wrap Components</p> <p>Posts wraps have been assembled. First coat of paint was started today.</p> <p>Note the stacked corners on the left.</p>	<p>Note</p>

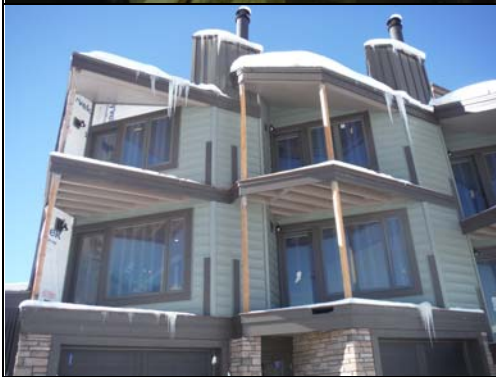
<p>12/11/13 – Photo 4 Units 1 & 2</p> <p>Light fixtures and door handles have been installed. Siding and trim on Unit 1 is awaiting brown corner trim.</p>	<p>Note</p>
