**ARCHITECT'S FIELD REPORT**

**152**

<b>PROJECT</b>	<b>Eagle's Nest Townhouses</b> 11 Morning Glory Way & 31 Marcellina Lane Mt. Crested Butte, CO 81225	<b>DATE</b>	6/12/2015
		<b>REV</b>

<b>WORK OBSERVED</b>	
Phase V – Manager's Units Renovations	
<b>TRADES PRESENT</b>	
Holgate Construction

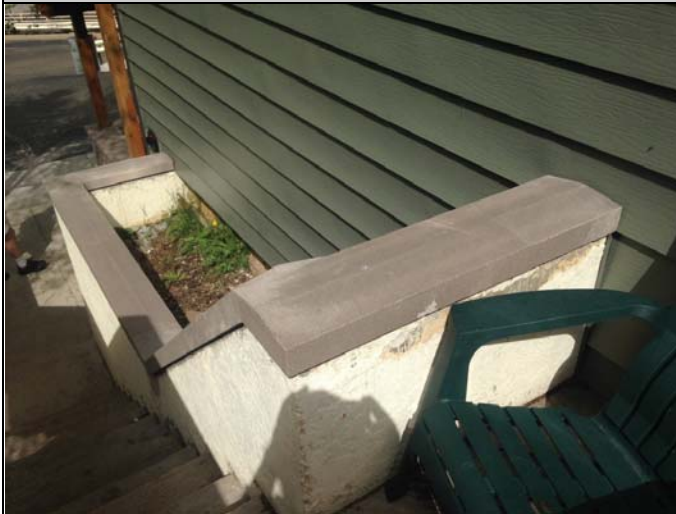
<p>6/12/15 – Photo 4 Upper Level Manager’s Unit</p> <p>Detail of the precast cap at the planter wall.</p>	<p>Note</p>

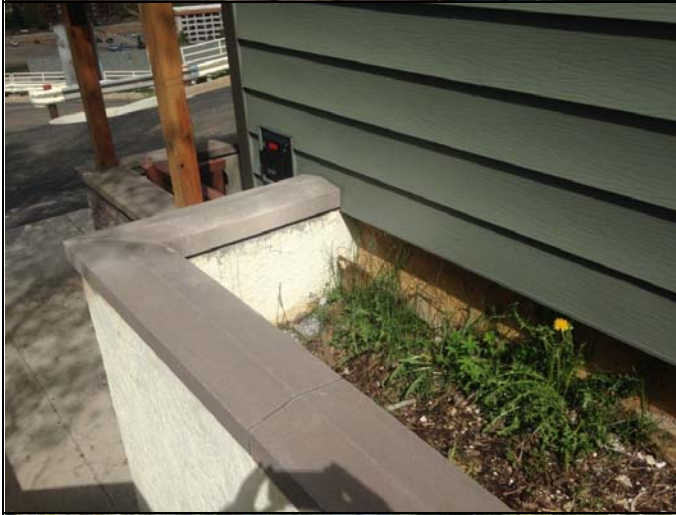
<p>6/12/15 – Photo 5 Upper Level Manager’s Unit</p> <p>Detail of precise cap at the south planter.</p>	<p>Note</p>

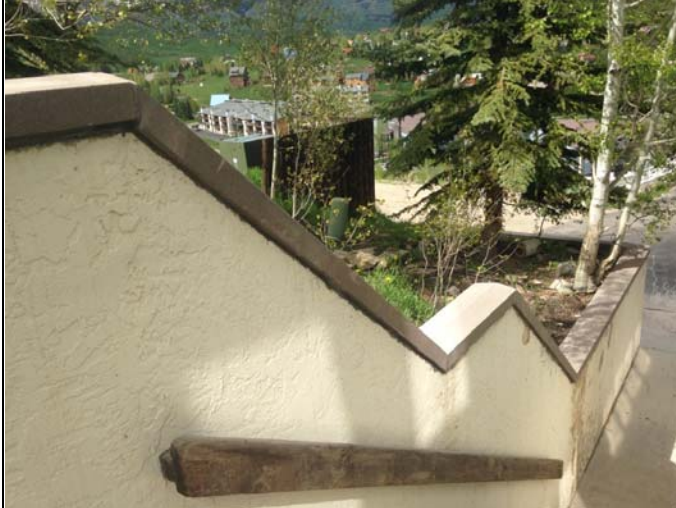
<p>6/12/15 – Photo 6 Upper Level Manager’s Unit</p> <p>Detail of the precast cap running the length of the stair retaining wall.</p>	<p>Note</p>

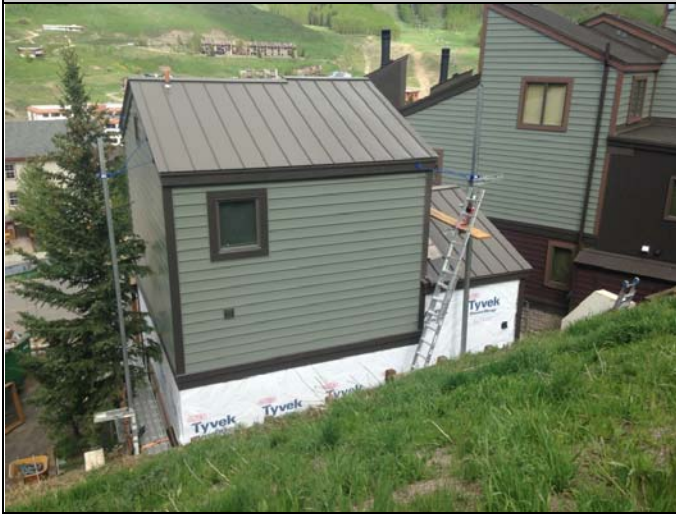
<p>6/12/15 – Photo 10 Lower Level Manager’s Unit</p> <p>View of the West Elevation</p> <p>Siding and trim work is complete. Fascia has been painted.</p> <p>Awaiting corrugated metal siding at the base level.</p>	<p>Note</p>

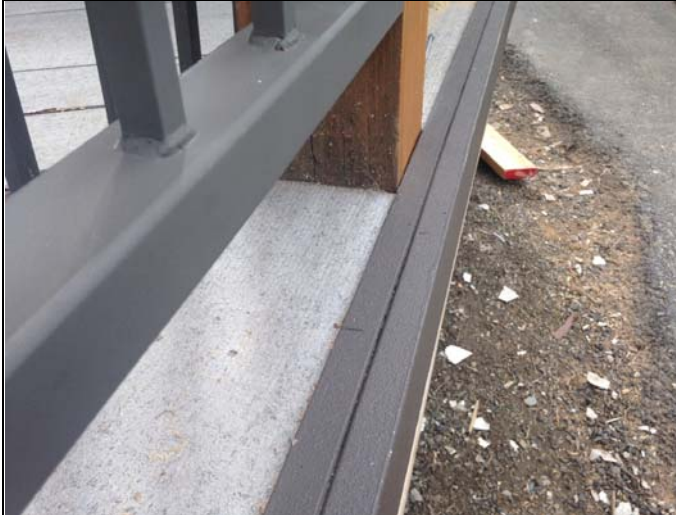
<p>6/12/15 – Photo 11 Lower Level Manager’s Unit</p> <p>Detail of trim at Deck Edge</p> <p>Two layers of Miratec have been installed on the deck edge.</p> <p>A length of flashing can be added to cover the gap and protect the surface, especially during snow removal.</p>	<p>ENT</p>

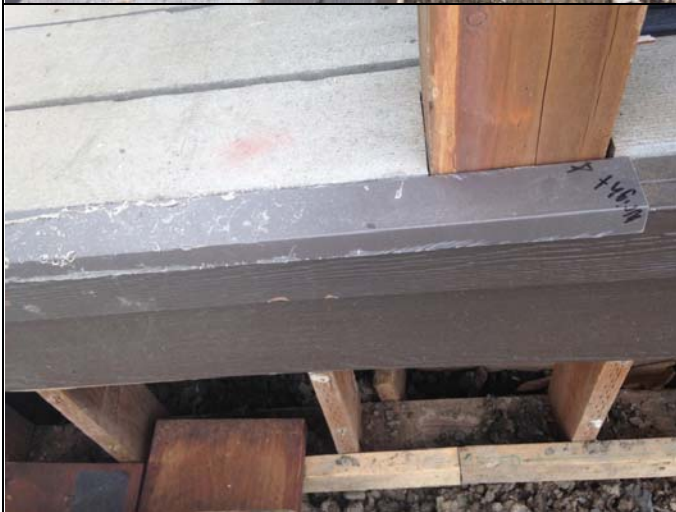
<p>6/12/15 – Photo 12 Lower Level Manager’s Unit</p> <p>Deck Edge Trim at Steps</p> <p>A length of metal edging has been installed at the deck edge.</p>	<p>Note</p>

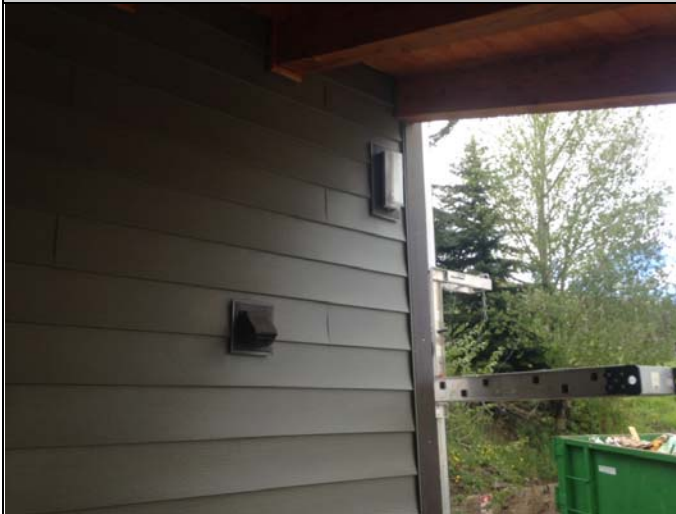
<p>6/12/15 – Photo 19 Lower Level Manager’s Unit</p> <p>Hot tub deck looking northwest, high. Trim work and siding installation is complete.</p>	<p>Note</p>

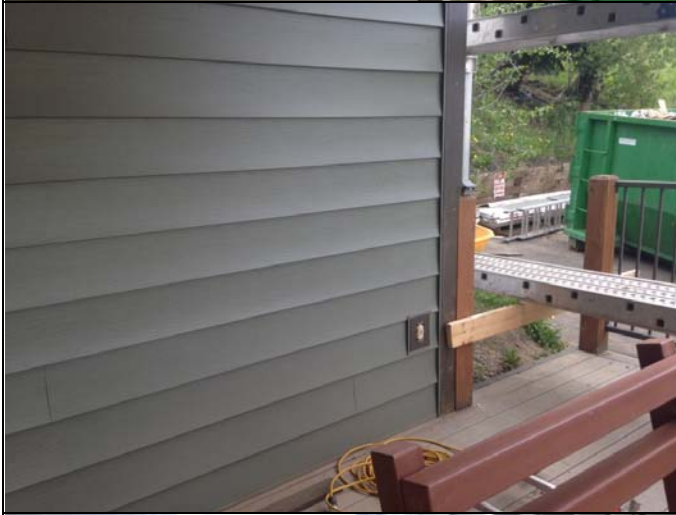
<p>6/12/15 – Photo 20 Lower Level Manager’s Unit</p> <p>Hot tub deck looking northwest. Trim and siding work is complete.</p> <p>Verify exterior outlet cover.</p>	<p>Note</p>
 	<p>6/12/15 – Photo 21 Lower Level Manager’s Unit</p> <p>Looking west at the upper deck. Interior demolition debris is in the background.</p>	<p>Note</p>
