ARCHITECT'S FIELD REPORT

PROJECT	Eagle's Nest Townhouses 11 Morning Glory Way & 31 Marcellina Lane Mt. Crested Butte, CO 81225	DATE	11/01/14
----------------	--	-------------	----------

WORK OBSERVED	
Sloped Roof – Final Inspection	
TRADES PRESENT	
None

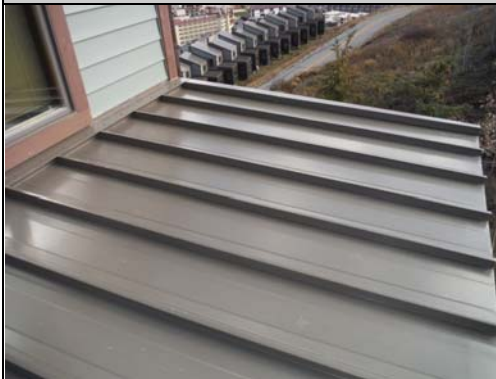
<p>11/01/14 – Photo 1 Unit 1</p> <p>Roof panel installation. No comments.</p>	<p>Note</p>

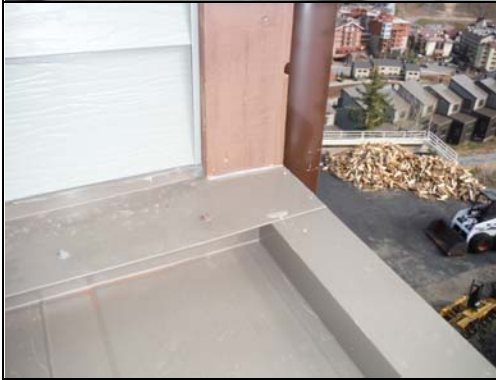
<p>11/01/14 – Photo 2 Unit 1</p> <p>Corner trim detail.</p>	<p>Note</p>

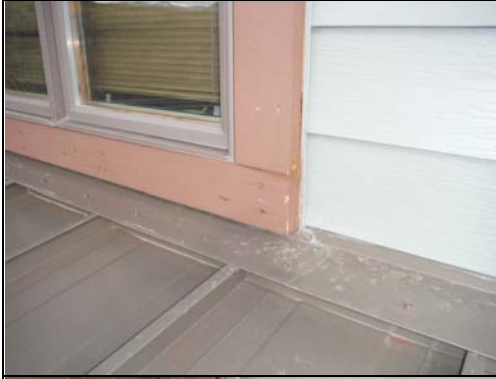
<p>11/01/14 – Photo 3 Unit 1</p> <p>Window Sill detail.</p>	<p>Note</p>

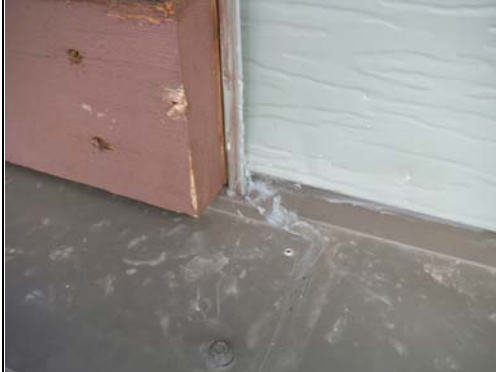
<p>11/01/14 – Photo 4 Unit 1</p> <p>Window sill detail.</p>	<p>Note</p>

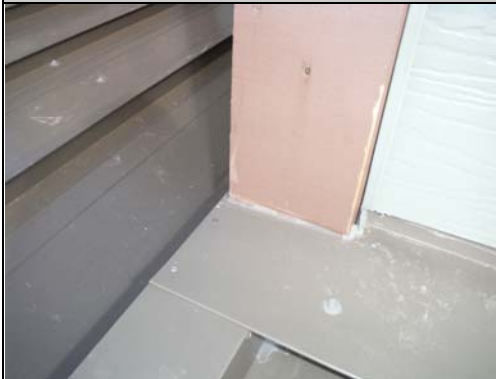
<p>11/01/14 – Photo 5 Unit 1</p> <p>Corner trim detail.</p>	<p>Note</p>

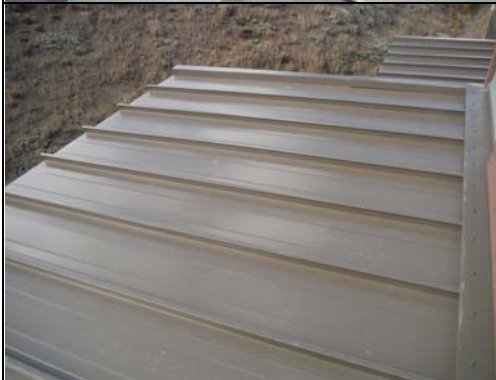
<p>11/01/14 – Photo 6 Unit 2</p> <p>Roof panel installation. See notes on Photo 22.</p>	<p>RM</p>

<p>11/01/14 – Photo 22 Unit 2 (Note Break in Sequence)</p> <p>Screws to infill holes have been placed in the second panel. The screws are loose and will likely be damaged or pulled out with sliding snow.</p>	<p>RM</p>

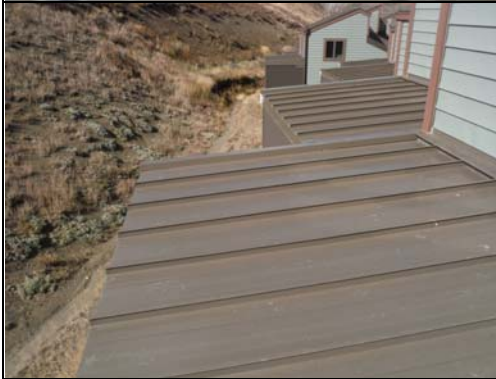
<p>11/01/14 – Photo 7 Unit 3</p> <p>Roof panel installation. No comments.</p>	<p>Note</p>

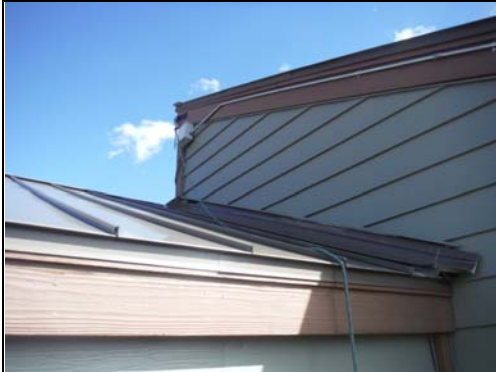
<p>11/01/14 – Photo 8 Unit 3</p> <p>Note rope to upper roof.</p>	<p>Note</p>

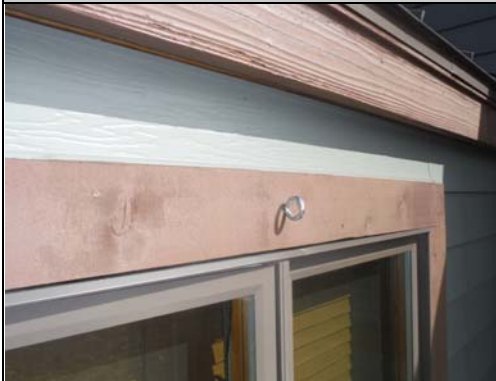
<p>11/01/14 – Photo 9 Unit 3</p> <p>Note eyebolt installation at window head. (Item not relevant to this scope of work.)</p>	<p>Note</p>

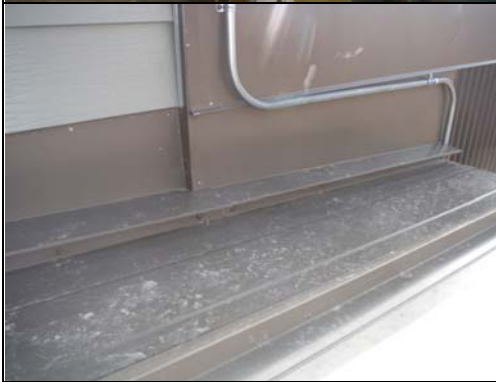
<p>11/01/14 – Photo 10 Unit 3</p> <p>Inside panel to wall detail.</p>	<p>Note</p>

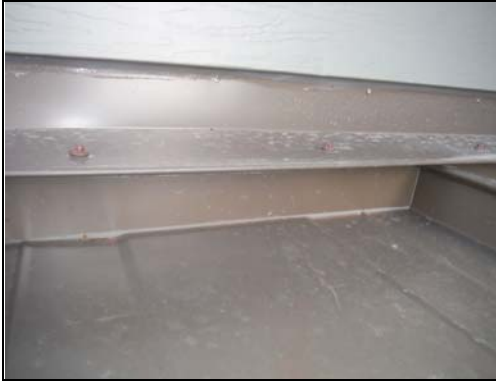
<p>11/01/14 – Photo 11 Unit 3</p> <p>Closure strip detail.</p>	<p>Note</p>

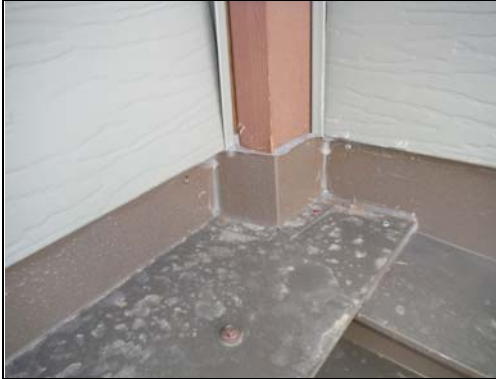
<p>11/01/14 – Photo 12 Unit 3</p> <p>Inside corner detail.</p>	<p>Note</p>

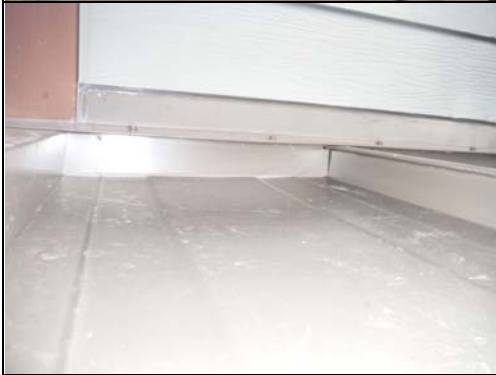
<p>11/01/14 – Photo 14 Unit 4</p> <p>Closure strip detail.</p>	<p>Note</p>

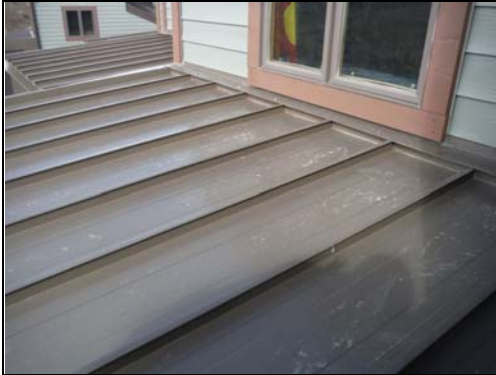
<p>11/01/14 – Photo 15 Unit 5</p> <p>Roof panel installation. No comments.</p>	<p>Note</p>

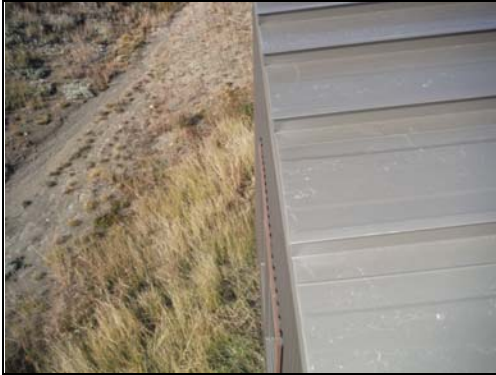
<p>11/01/14 – Photo 16 Unit 5</p> <p>Note drip edge alignment with window head below.</p>	<p>Note</p>

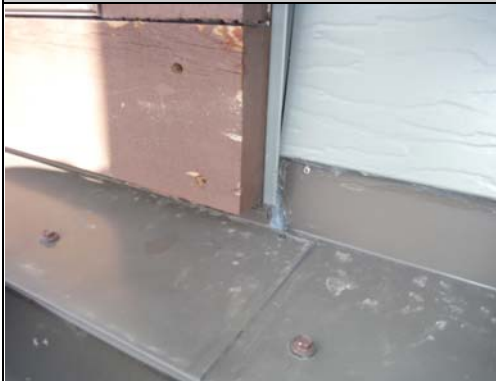
<p>11/01/14 – Photo 21 Unit 8</p> <p>Window trim detail.</p>	<p>Note</p>

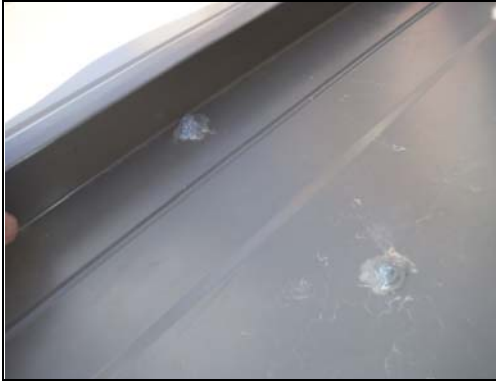
<p>11/01/14 – Photo 23 Unit 2 (Note Break in Sequence)</p> <p>Screws covered with sealant.</p>	<p>RM</p>

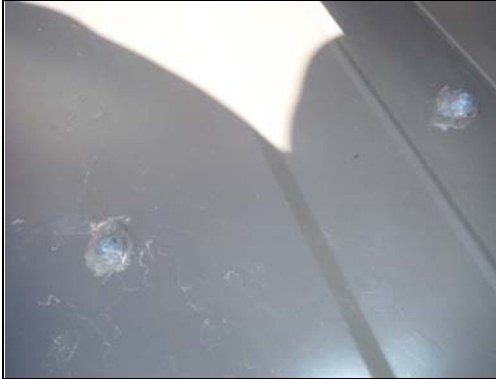
<p>11/01/14 – Photo 24 Unit 2 (Note Break in Sequence)</p> <p>Screws covered with sealant.</p>	<p>RM</p>

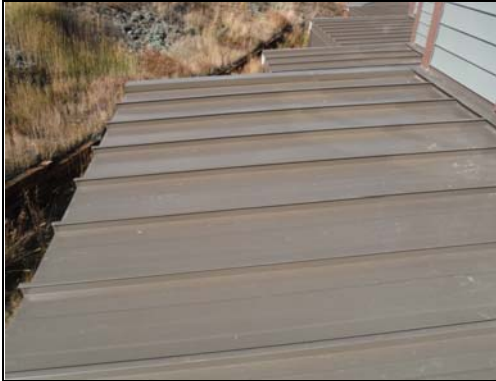
<p>11/01/14 – Photo 29 Unit 11</p> <p>Roof panel installation. No comments.</p>	<p>Note</p>
 	<p>11/01/14 – Photo 30 Unit 12</p> <p>Roof panel installation. No comments.</p>	<p>Note</p>
 	<p>11/01/14 – Photo 31 Unit 12</p> <p>Inside corner detail.</p>	<p>Note</p>
 	<p>11/01/14 – Photo 32 Unit 13</p> <p>Roof panel installation. No comments.</p>	<p>Note</p>

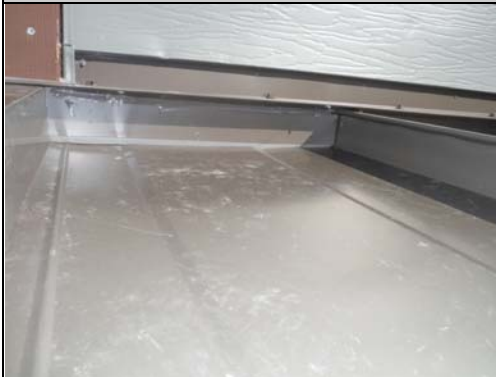
<p>11/01/14 – Photo 33 Unit 13</p> <p>Closure strip detail.</p>	<p>Note</p>
 	<p>11/01/14 – Photo 34 Unit 14</p> <p>Roof panel installation. No comments.</p>	<p>Note</p>
 	<p>11/01/14 – Photo 35 Unit 14</p> <p>Inside panel to wall detail.</p>	<p>Note</p>
 	<p>11/01/14 – Photo 36 Unit 14</p> <p>Inside panel to wall detail.</p>	<p>Note</p>

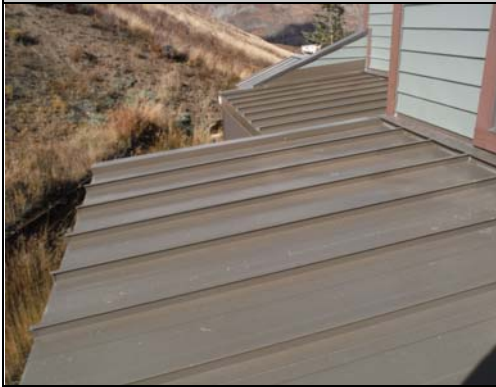
<p>11/01/14 – Photo 37 Unit 15</p> <p>Roof panel installation. No comments.</p>	<p>Note</p>

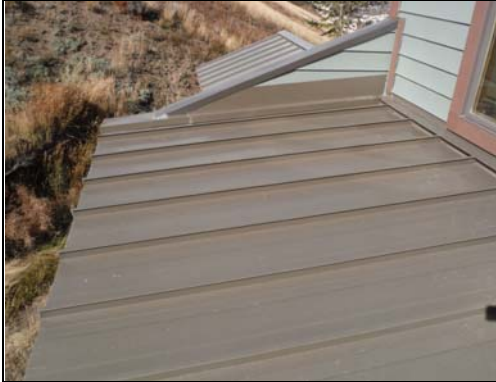
<p>11/01/14 – Photo 38 Unit 16</p> <p>Roof panel installation. No comments.</p>	<p>Note</p>

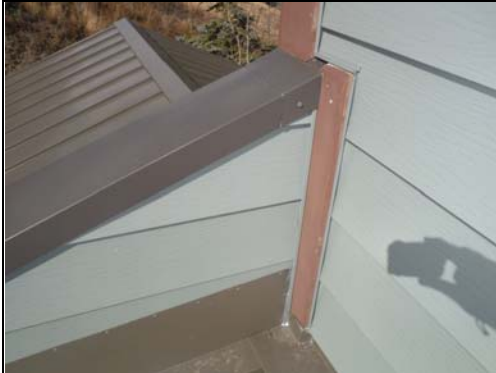
<p>11/01/14 – Photo 39 Unit 16</p> <p>Sloped parapet wall detail.</p>	<p>Note</p>

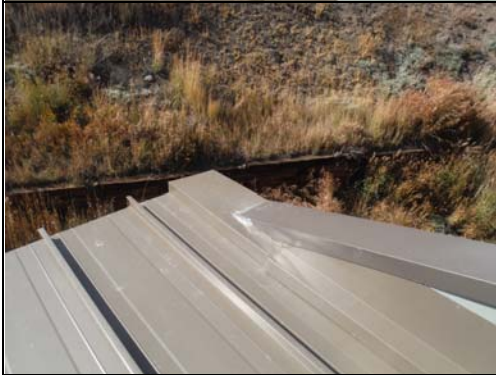
<p>11/01/14 – Photo 40 Unit 16</p> <p>Sloped parapet wall detail.</p>	<p>Note</p>
