ARCHITECT'S FIELD REPORT

PROJECT	Eagle's Nest Townhouses 11 Morning Glory Way & 31 Marcellina Lane Mt. Crested Butte, CO 81225	DATE	9/24/14
----------------	--	-------------	---------

WORK OBSERVED	
Sloped Roof	
TRADES PRESENT	
None

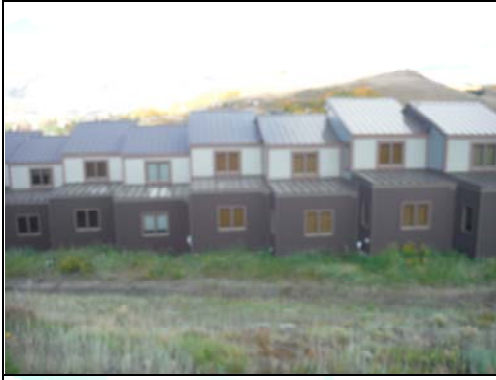
PHOTO –WORK ITEM	DESCRIPTION	ACTION
 	<p>9/24/14 – Photo 1 Building A, Units 1 to 4</p> <p>Roofing appears complete.</p>	<p>Note</p>
