**ARCHITECT'S FIELD REPORT**

**141**

<b>PROJECT</b>	<b>Eagle's Nest Townhouses</b> 11 Morning Glory Way & 31 Marcellina Lane Mt. Crested Butte, CO 81225	<b>DATE</b>	6/7/14
----------------	--	-------------	--------

<b>WORK OBSERVED</b>	
Completed Phase II Repairs	
<b>TRADES PRESENT</b>	
None

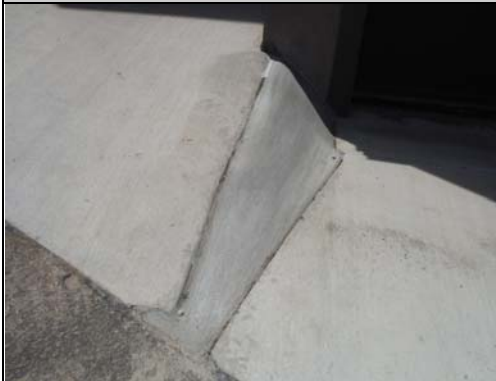
<p>6/4/14 – Photo 9 Unit 28</p> <p>Sloped transition has been replaced</p>	<p>Note</p>

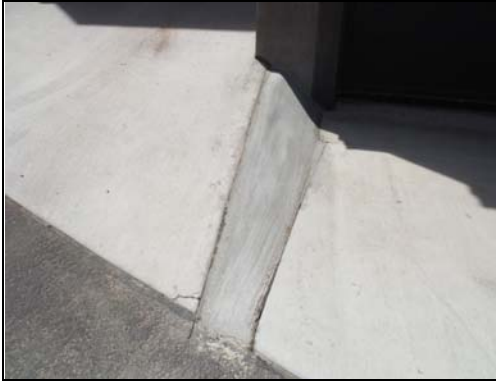
<p>6/4/14 – Photo 11 Unit 30</p> <p>Sloped transition has been replaced</p>	<p>Note</p>

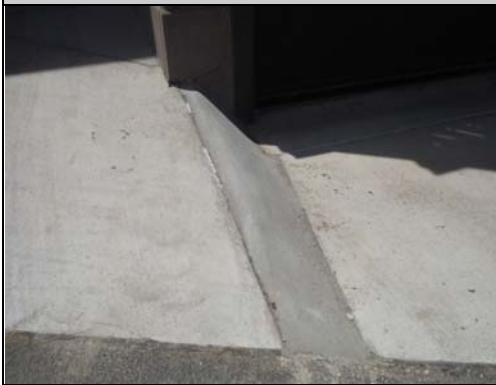
<p>6/4/14 – Photo 13 Unit 34</p> <p>Sloped transition has been replaced.</p>	<p>Note</p>

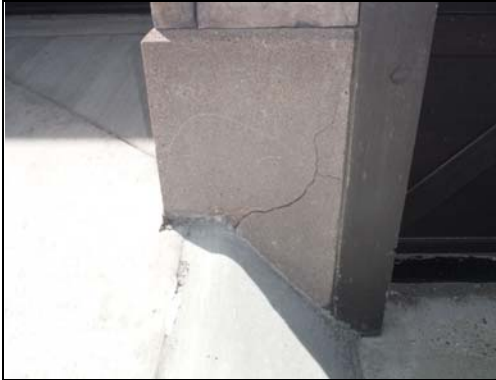
<p>6/4/14 – Photo 14 Unit 34</p> <p>Precast damage due to frost heave on the south side of the garage door. This damage was noted in 2013.</p>	<p>Note</p>
 	<p>6/4/14 – Photo 15 Unit 34</p> <p>Sealant has been installed in the joint between the valley pan and apron.</p>	<p>Note</p>

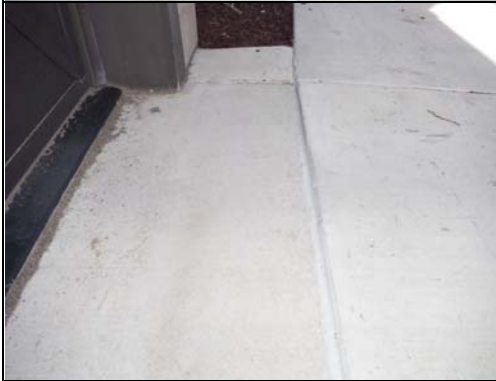
<p>6/4/14 – Photo 16 Unit 34 Detail</p> <p>Sealant has been installed in the joint between the valley pan and apron.</p>	<p>Note</p>

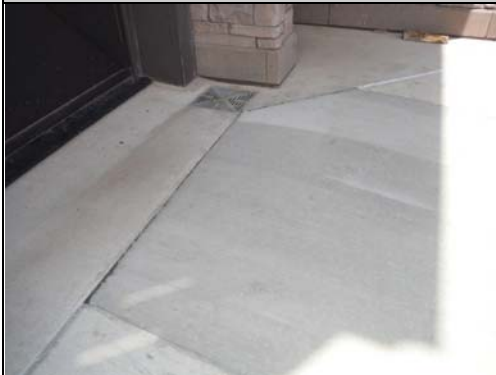
<p>6/4/14 – Photo 25 Unit 40 Detail</p> <p>Detail view of the replaced concrete.</p>	<p>Note</p>

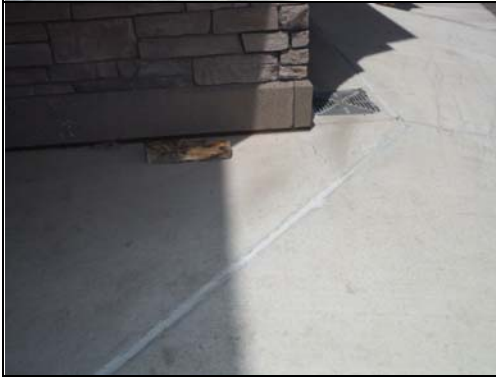
<p>6/4/14 – Photo 26 Unit 40</p> <p>Detail of joint sealant at the entry of Units 39 &amp; 40.</p>	<p>Note</p>
