ARCHITECT'S FIELD REPORT

033

PROJECT	Eagle's Nest Townhouses 11 Morning Glory Way & 31 Marcellina Lane Mt. Crested Butte, CO 81225	DATE	2/2/11
----------------	--	-------------	--------

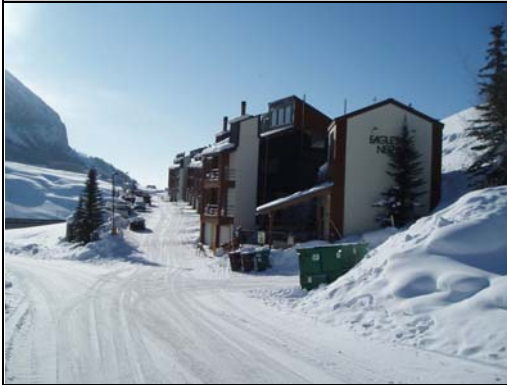
<p>2/2/11 – Photo 1 Lower Level Units</p> <p>Loft window replacement is 100% complete for the project. Scaffolding has been removed from the roof.</p>	<p>None</p>

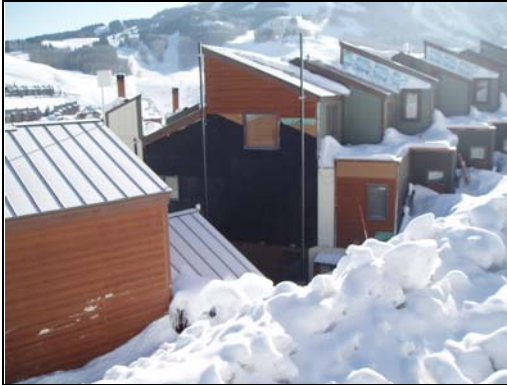
<p>2/2/11 – Photo 2 Unit 17</p> <p>Scaffolding is in place and demolition has begun on the end elevation.</p>	<p>None</p>

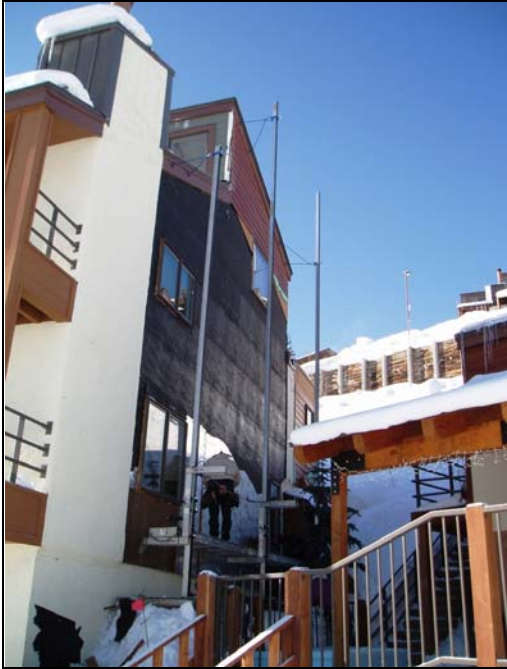
<p>2/2/11 – Photo 3 Unit 17</p> <p>Workers have removed the Hardie Board siding and original wood siding. Felt paper (black) and original insulation board (silver) are visible.</p>	<p>None</p>

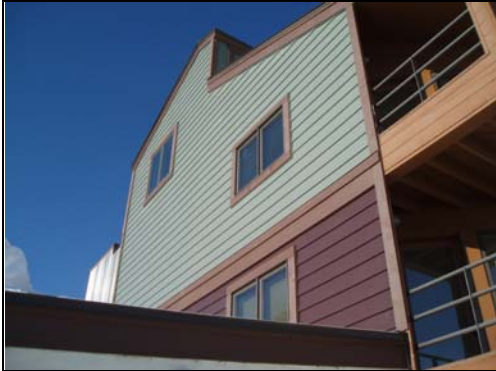
<p>2/2/11 – Photo 4 Unit #1</p> <p>End Elevation siding and window installation is complete.</p>	<p>None</p>

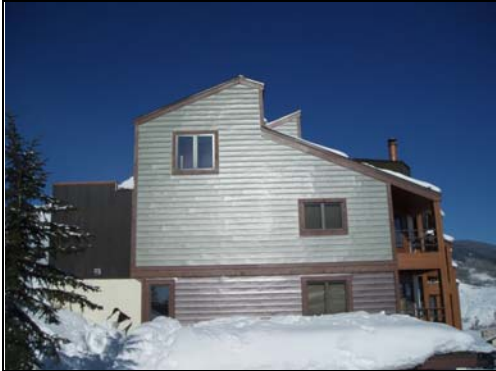
<p>2/2/11 – Photo 5 Unit #1</p> <p>End Elevation Siding.</p>	<p>None</p>

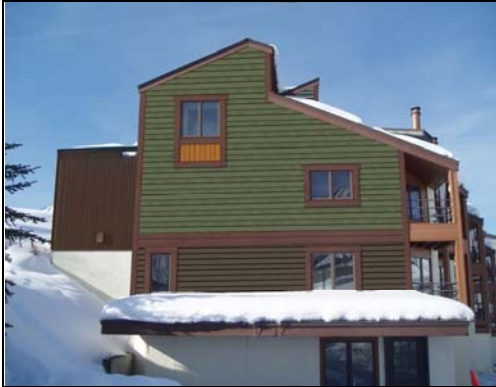
<p>2/2/11 – Photo 6 Comparison Work</p> <p>This is the computer rendering of the original design for comparison.</p>	<p>None</p>

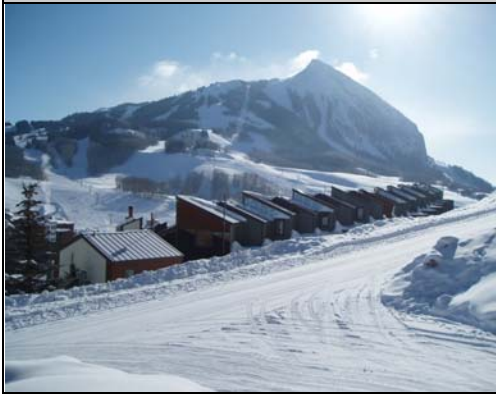
<p>2/2/11 – Photo 7 Lower Level Units</p> <p>Gable ends have yet to be completed. 2 days will be required for this work. Roof snow does not appear to be affecting this area.</p>	<p>None</p>

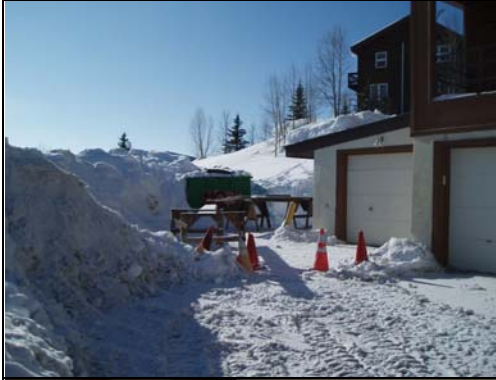
<p>2/2/11 – Photo 8 Upper Level Work Area</p> <p>Area is clean and in good order. Dumpster is 100% full.</p>	<p>None</p>

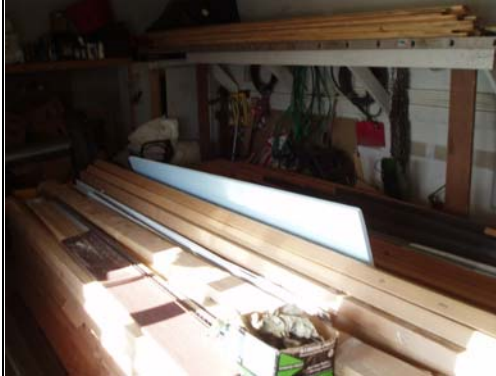
<p>2/2/11 – Photo 9 Upper Level Maintenance Shed</p> <p>Materials are stored in the work shed. Cedar 2X12, milled corner pieces, and parapet cap metal are in good order.</p>	<p>None</p>

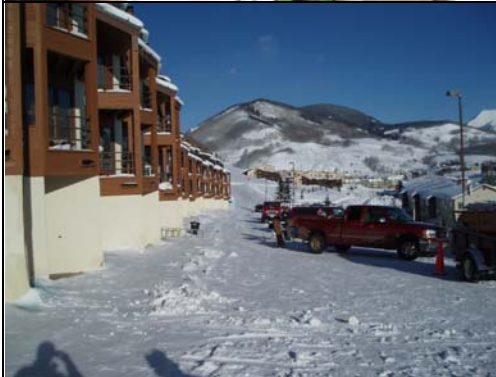
<p>2/2/11 – Photo 10 Lower Level Parking Area</p> <p>Work is staged outside of Unit 34. Site is in good order.</p>	<p>None</p>
