ARCHITECT'S FIELD REPORT

003

PROJECT **Eagle's Nest Townhouses** **DATE** 11/16/09
 11 Morning Glory Way & 31 Marcellina Lane
 Mt. Crested Butte, CO 81225

WORK OBSERVED	
Investing completed roofing work by Telluride Roofing.	
TRADES PRESENT	
None.

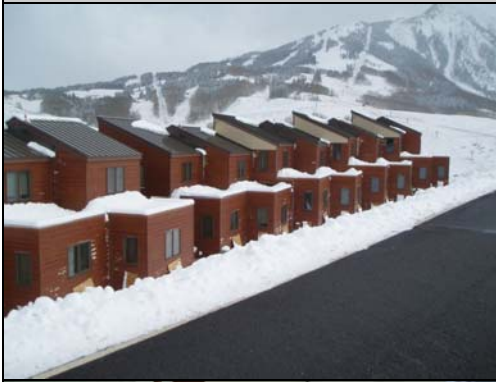
<p>11/15/09 – Photo 12 Lower Level Units – Rear View. Condition of flat roofs is hidden. Side wall flashing appears to be in good order.</p>	<p>None</p>

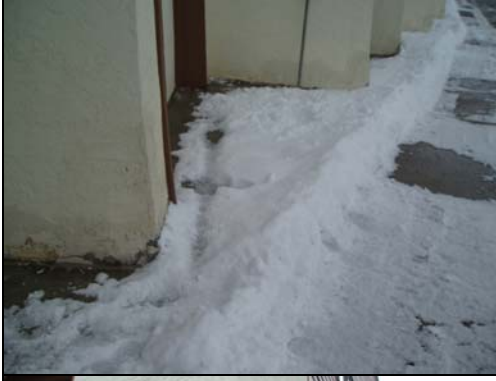
<p>11/15/09 – Photo 13 Garage Door Threshold, common condition. Note ice accumulation at garage entrance from working snow melt system above.</p>	<p>None</p>

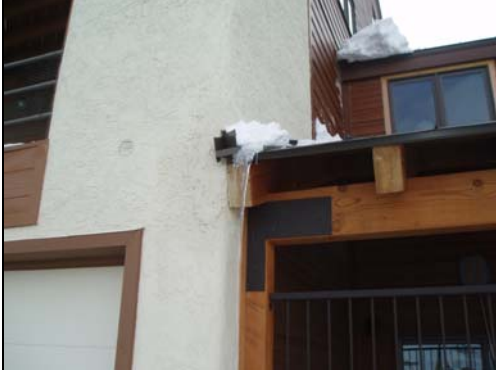
<p>11/15/09 – Photo 14 Upper Unit Common Area – note metal roof diverter. The diverter is successfully deflecting ice from the side wall.</p>	<p>None</p>
