# ARCHITECT'S FIELD REPORT

050

<b>PROJECT</b>	<b>Eagle's Nest Townhouses</b> 11 Morning Glory Way & 31 Marcellina Lane Mt. Crested Butte, CO 81225	<b>DATE</b>	5/18/11
----------------	--	-------------	---------

WORK OBSERVED	
Phase II – Retaining Wall Repairs & Existing Conditions	
TRADES PRESENT	
None

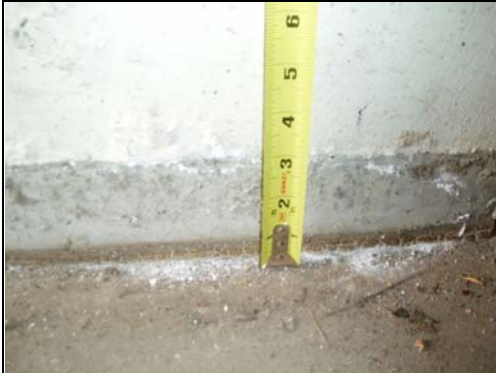
<p>5/18/11 – Photo 7 Unit 36 Garage Slab</p> <p>Detail of Photo 6 showing approximately 3” of settlement at mid-span.</p>	<p>ENT BWA</p>

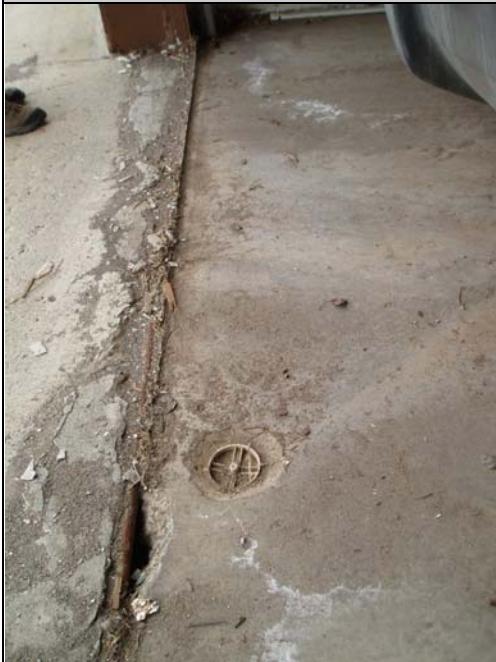
<p>5/18/11 – Photo 8 Unit 36 Garage Slab</p> <p>Threshold of garage door. Note damage in the lower portion of the photo.</p>	<p>ENT BWA</p>

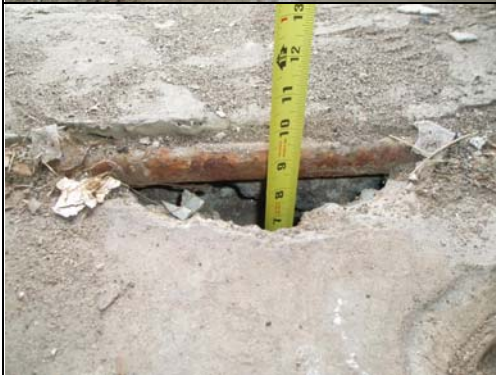
<p>5/18/11 – Photo 9 Unit 36 Garage Slab</p> <p>Damaged area revealed a void approximately 8” deep.</p>	<p>ENT BWA</p>

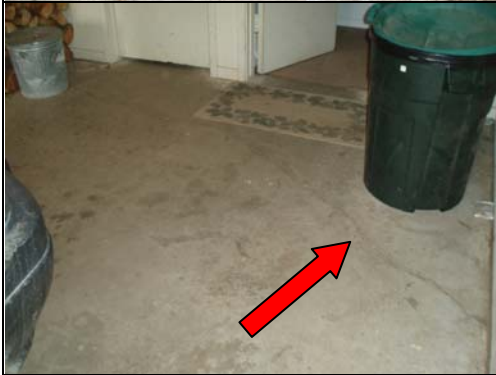
<p>5/18/11 – Photo 10 Unit 36 Garage Slab</p> <p>Crack is visible along western end of the garage slab leading from the entry door to the Owner’s Storage Closet.</p>	<p>ENT BWA</p>
