## ARCHITECT'S FIELD REPORT

106

PROJECT	<b>Eagle's Nest Townhouses</b> 11 Morning Glory Way & 31 Marcellina Lane Mt. Crested Butte, CO 81225	DATE	5/15/13
---------	--	------	---------

WORK OBSERVED	
Phase IV Construction	
TRADES PRESENT	
Holgate Construction Co.

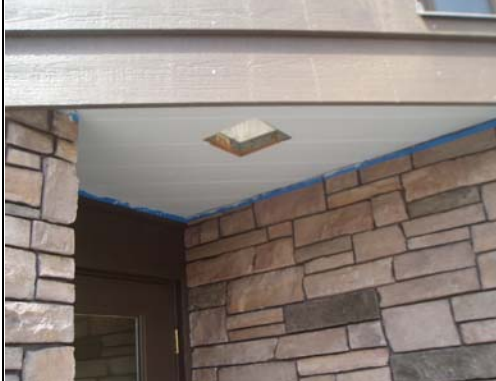
<p>5/15/13 – Photo 9 Unit 19 &amp; 20</p> <p>Entry ceiling has been primed.</p>	Note

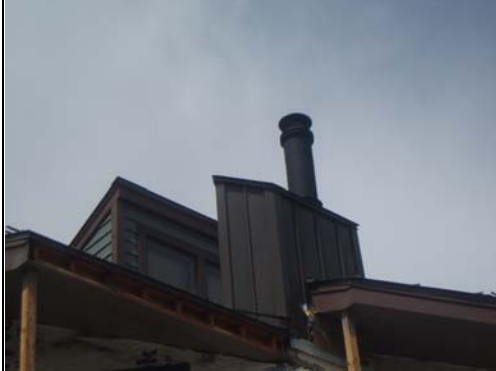
<p>5/15/13 – Photo 10 Unit 23 Chimney Flue</p> <p>Test chimney flue has been painted.</p>	Note

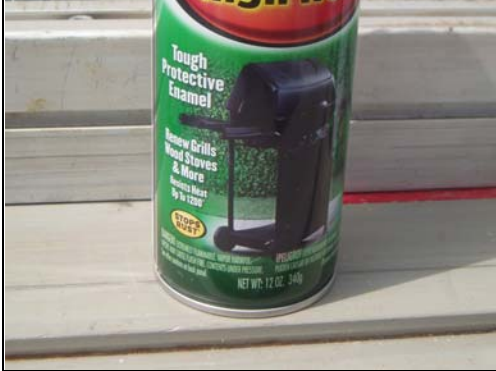
<p>5/15/13 – Photo 11</p> <p>1200 degree rated Rustoleum enamel paint to be used on the chimney flues.</p>	Note

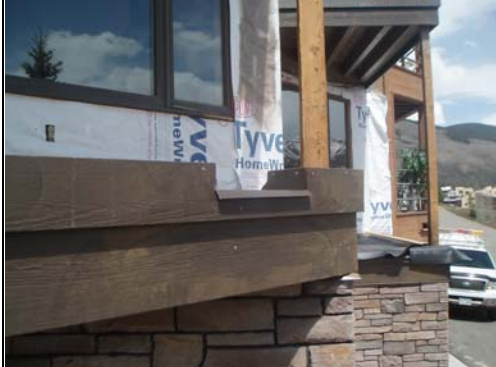
<p>5/15/13 – Photo 12 Unit 23 Scupper Drain</p> <p>Metal scupper drains have been installed on Buildings C &amp; D. Note: EPDM deck membrane is underway on Unit 22.</p>	Note

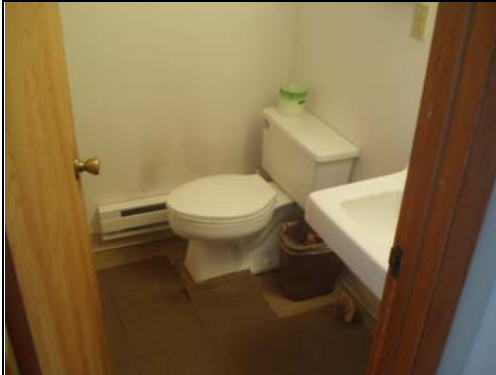
<p>5/15/13 – Photo 17 Lower Level Hot Tub Restroom</p> <p>Restroom is clean and in good order.</p>	Note
