ARCHITECT'S FIELD REPORT

039

PROJECT	Eagle's Nest Townhouses 11 Morning Glory Way & 31 Marcellina Lane Mt. Crested Butte, CO 81225	DATE	3/16/11
----------------	------------------------------------------------------------------------------------------------------------	-------------	---------

WORK OBSERVED	
Phase I – Construction, Interior Window Trim Inspection	
TRADES PRESENT	
None

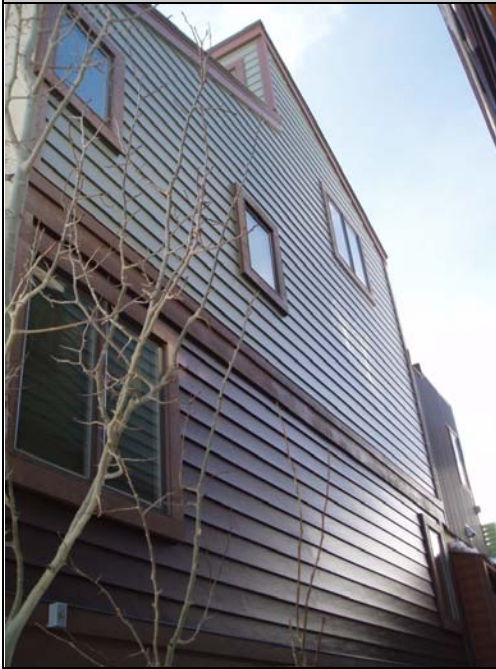
<p>3/16/11 – Photo 4 Unit 33</p> <p>End elevation is complete.</p>	<p>None</p>

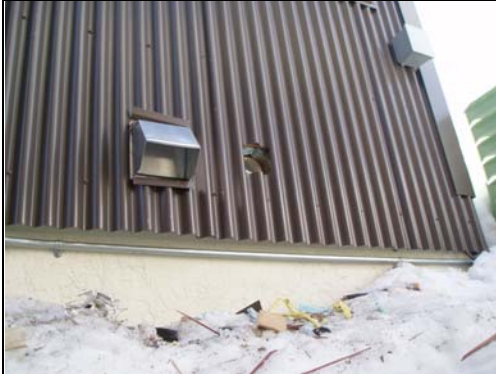
<p>3/16/11 – Photo 5 Unit 33</p> <p>Bath vent is on order. An extra vent was needed to accommodate an unforeseen dryer vent.</p>	<p>MHC</p>

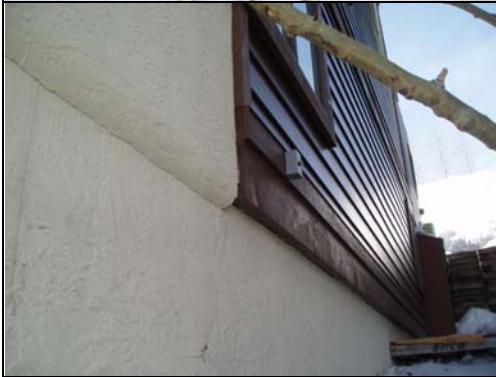
<p>3/16/11 – Photo 6 Unit 33</p> <p>Photo sensor unit has been installed.</p>	<p>None</p>

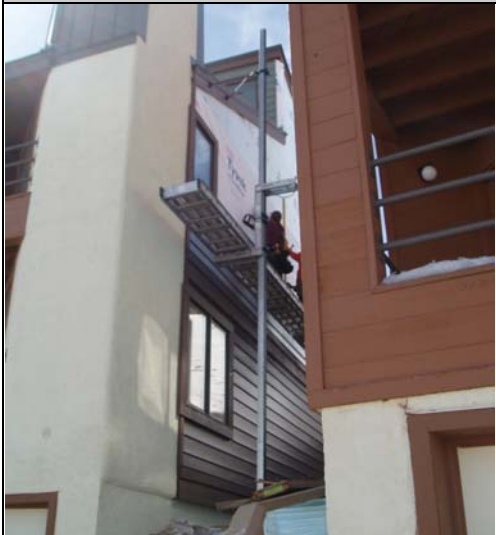
<p>3/16/11 – Photo 7 Unit 25</p> <p>Siding is currently underway. Construction is approximately 75% complete.</p>	<p>None</p>

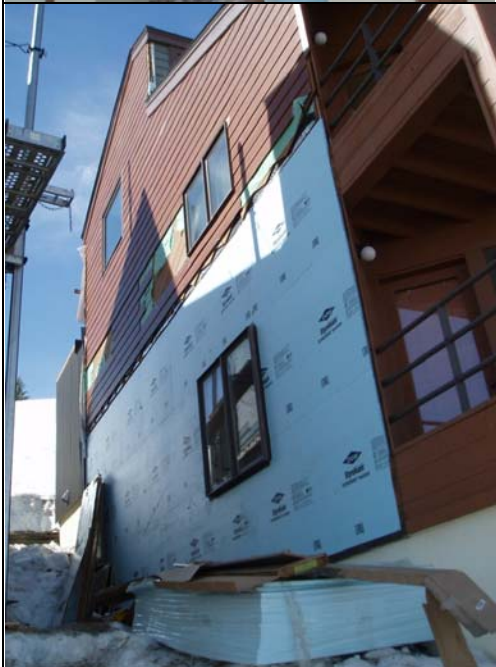
<p>3/16/11 – Photo 8 Unit 24</p> <p>2nd Floor has new rigid insulation and new window flashing.</p>	<p>None</p>

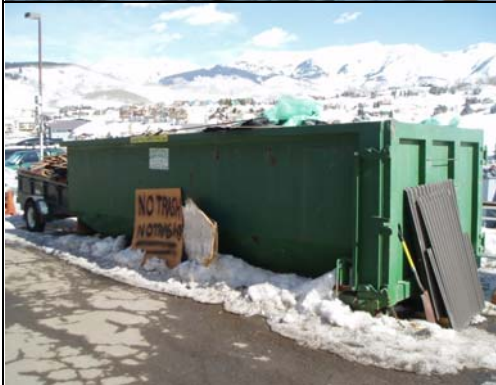
<p>3/16/11 – Photo 9 Lower Level Dumpster</p> <p>Dumpster is 100% full and scheduled to be replaced 3/17/11.</p>	<p>None</p>

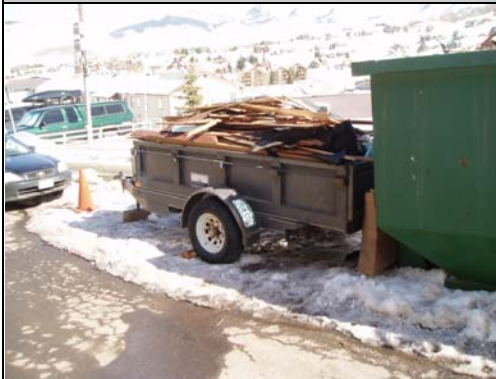
<p>3/16/11 – Photo 10 Lower Level Work Area</p> <p>Auxiliary trailer is 100% full as well.</p>	<p>None</p>

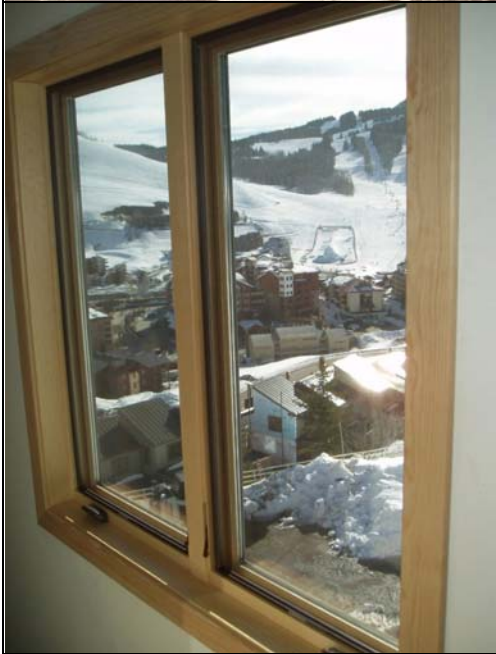
<p>3/16/11 – Photo 11 Unit 1</p> <p>Operable window is installed. Cranks and covers are in place.</p>	<p>None</p>

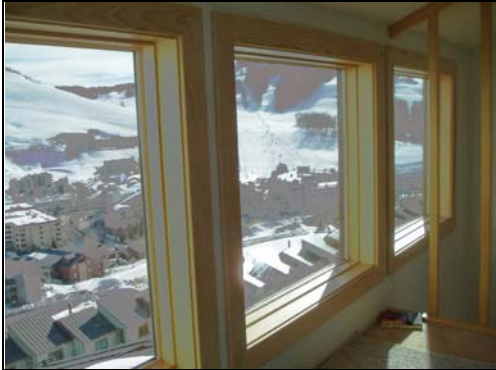
<p>3/16/11 – Photo 12</p> <p>Paint touch-up required.</p>	<p>BP</p>

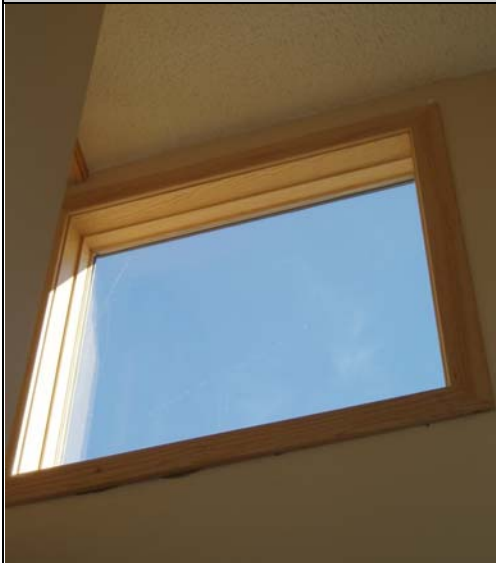
<p>3/16/11 – Photo 13 Unit 7</p> <p>Minor drywall repair. Paint touch-up required.</p>	<p>MHC BP</p>

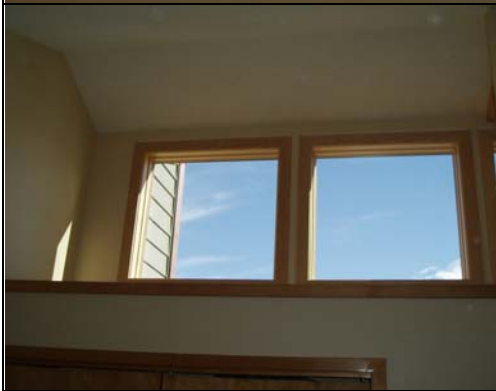
<p>3/16/11 – Photo 14 Unit 7</p> <p>Paint touch-up required.</p>	<p>BP</p>

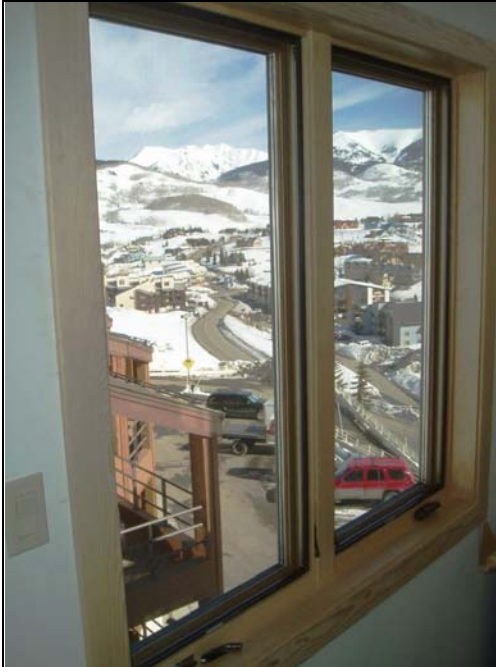
<p>3/16/11 – Photo 15 Unit 8</p> <p>End window cranks still to be installed. Minor wall cleaning.</p>	<p>MHC</p>

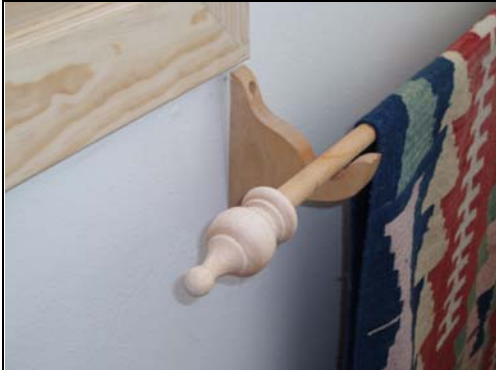
<p>3/16/11 – Photo 16 Unit 8</p> <p>Decorative hanging rod to be lowered or trimmed to fit under window.</p>	<p>MHC</p>

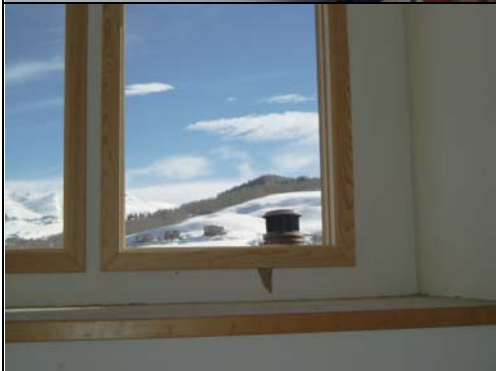
<p>3/16/11 – Photo 17 Unit 8</p> <p>Minor drywall repair. Paint touch-up required.</p>	<p>MHC BP</p>

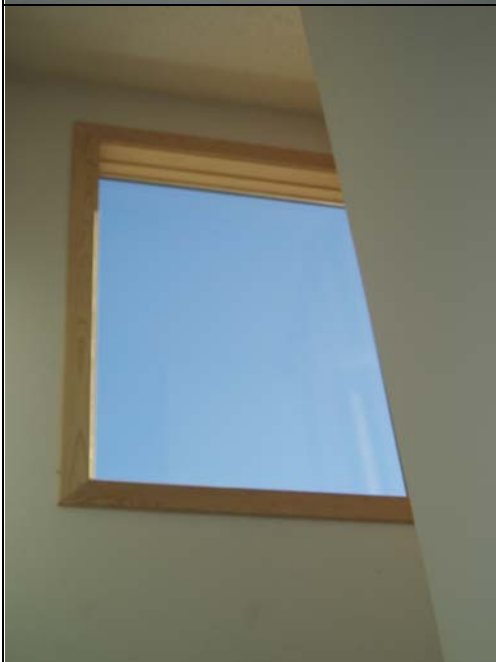
<p>3/16/11 – Photo 18 Unit 8</p> <p>Paint touch-up.</p>	<p>BP</p>

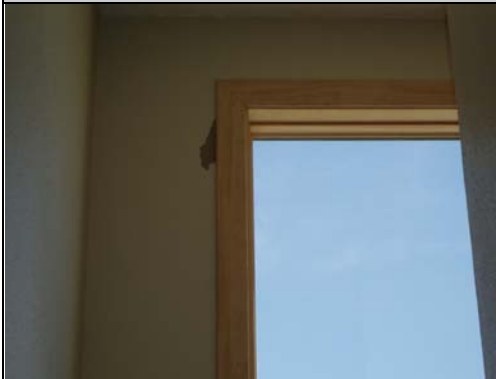
<p>3/16/11 – Photo 22 Unit 27</p> <p>Minor drywall repair.</p>	<p>MHC BP</p>

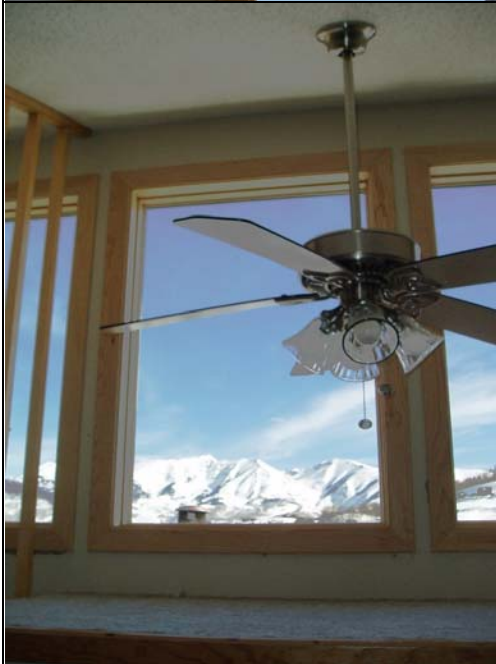
<p>3/16/11 – Photo 23 Unit 27</p> <p>Paint touch-up required.</p>	<p>BP</p>

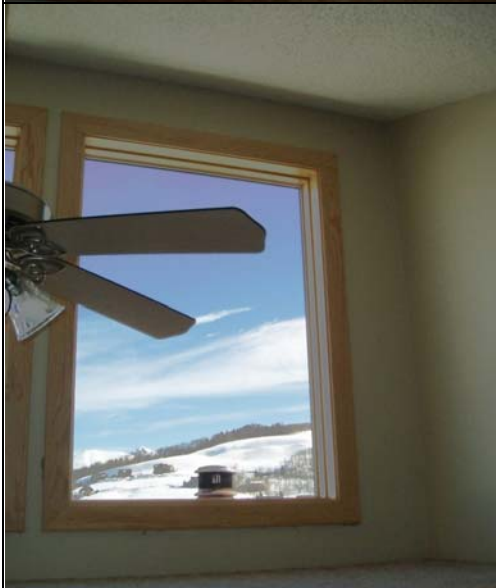
<p>3/16/11 – Photo 24 Unit 27</p> <p>Paint touch-up required.</p>	<p>BP</p>

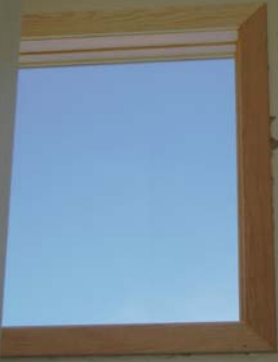
<p>3/16/11 – Photo 31 Unit 30</p> <p>Minor drywall repair and paint touch-up.</p>	<p>MHC BP</p>

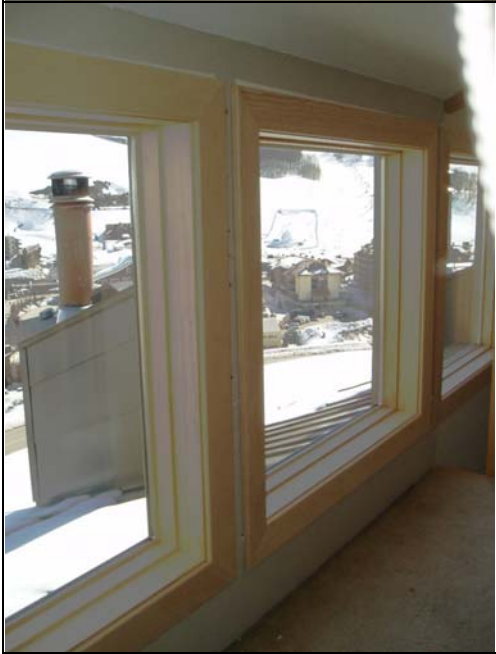
<p>3/16/11 – Photo 32 Unit 30</p> <p>Minor hole patching. Paint touch-up. Note custom paint color.</p>	<p>MHC BP</p>

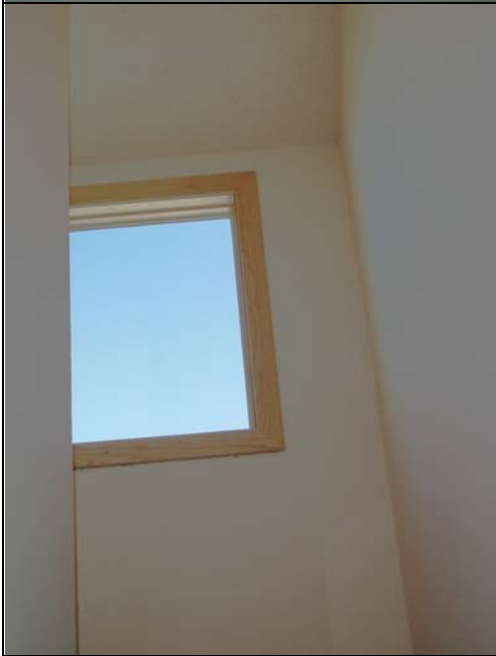
<p>3/16/11 – Photo 37 Unit 34</p> <p>Minor drywall repair. Paint touch-up required.</p>	<p>MHC BP</p>
 	<p>3/16/11 – Photo 38 Unit 34</p> <p>Minor drywall repair. Paint touch-up required.</p>	<p>MHC BP</p>

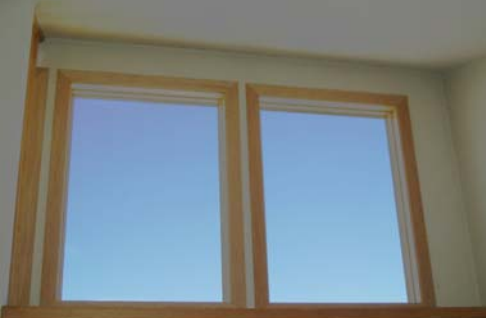
<p>3/16/11 – Photo 42 Unit 35</p> <p>Paint touch-up only.</p>	<p>BP</p>

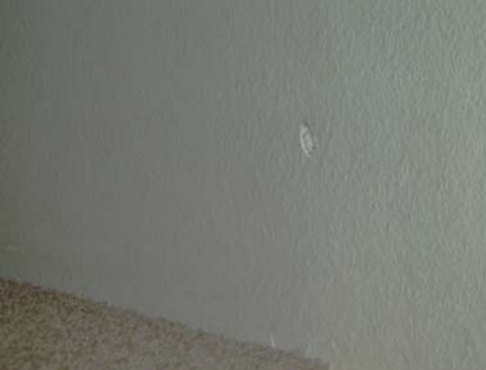
<p>3/16/11 – Photo 43 Unit 35</p> <p>Second floor stair has minor drywall damage. It is not known if this was done during construction.</p>	<p>MHC</p>

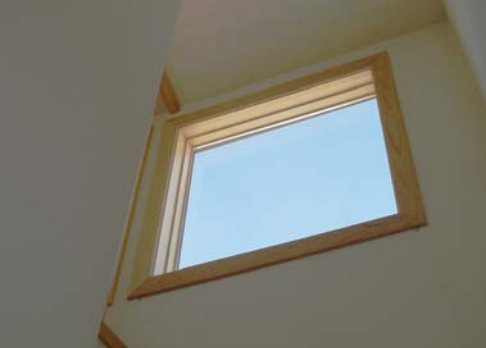
<p>3/16/11 – Photo 44 Unit 38</p> <p>Paint touch-up only.</p>	<p>BP</p>

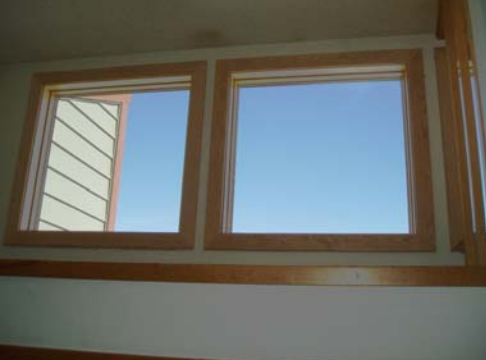
<p>3/16/11 – Photo 45 Unit 38</p> <p>Paint touch-up only.</p>	<p>BP</p>
