# ARCHITECT'S FIELD REPORT

104

| <b>PROJECT</b> | <b>Eagle's Nest Townhouses</b><br>11 Morning Glory Way & 31 Marcellina Lane<br>Mt. Crested Butte, CO 81225 | <b>DATE</b> | 5/1/13 |

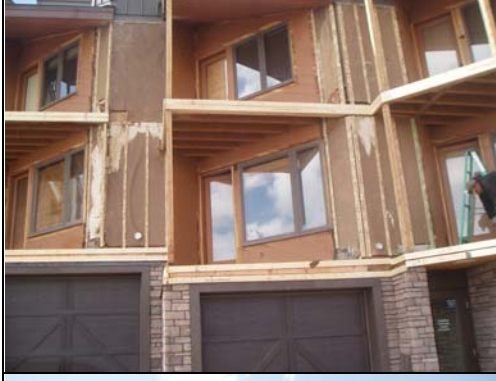
| PHOTO –WORK ITEM | DESCRIPTION | ACTION |
|---|--|---|
| | <p>5/1/13 – Photo 11<br/>Unit 30 – 2<sup>nd</sup> Floor</p> <p>Demolition is complete. Deck repairs are complete. Awaiting wall treatment.</p> | <p>Note</p> |

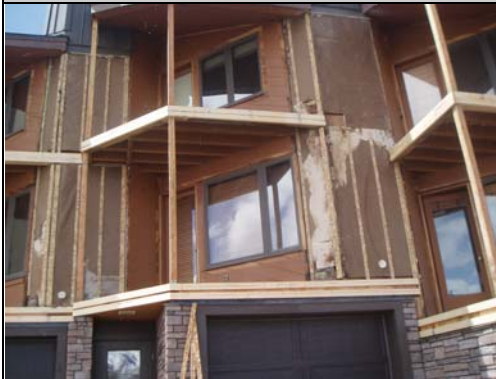
| PHOTO –WORK ITEM | DESCRIPTION | ACTION |
|---|---|---|
| | <p>5/1/13 – Photo 13<br/>Unit 31 – 2<sup>nd</sup> Floor</p> <p>Note a few areas of damaged drywall sheathing at the chimney. This area is being covered by new sheathing.</p> | <p>Note</p> |

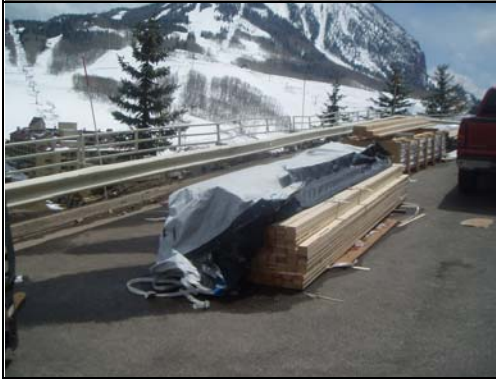
| PHOTO –WORK ITEM | DESCRIPTION | ACTION |
|---|--|---|
| | <p>5/1/13 – Photo 18<br/>Lower Level, South Parking Lot</p> <p>Materials are staged on the north end of the lot.</p> | <p>Note</p> |

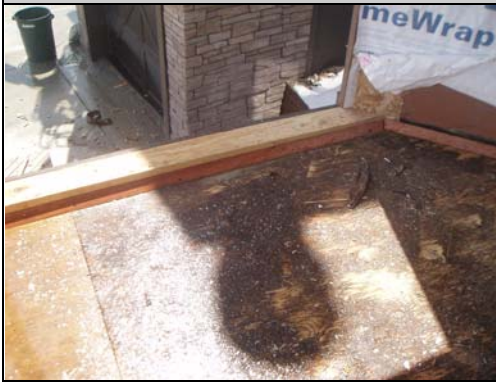
| PHOTO –WORK ITEM | DESCRIPTION | ACTION |
|---|---|---|
| | <p>5/1/13 – Photo 21<br/>Unit 24, 2<sup>nd</sup> Floor Deck</p> <p>Mock-Up Example Unit</p> <p>Belly Bands are in place and deck rim treatment has been installed. The cant strip (beveled wood) is being laid out for the new membrane roof.</p> | <p>Note</p> |

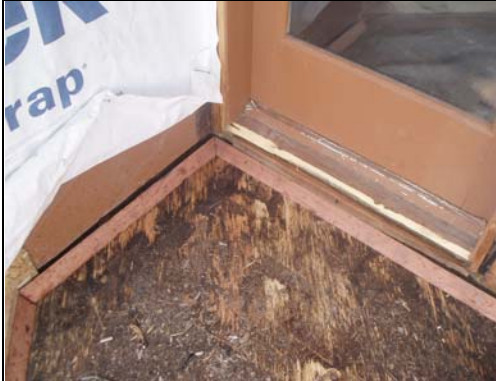
| PHOTO –WORK ITEM | DESCRIPTION | ACTION |
|---|---|---|
| | <p>5/1/13 – Photo 22<br/>Unit 24, 2<sup>nd</sup> Floor Deck</p> <p>Condition at threshold. The wood threshold underneath the door will be removed.</p> | <p>Note</p> |

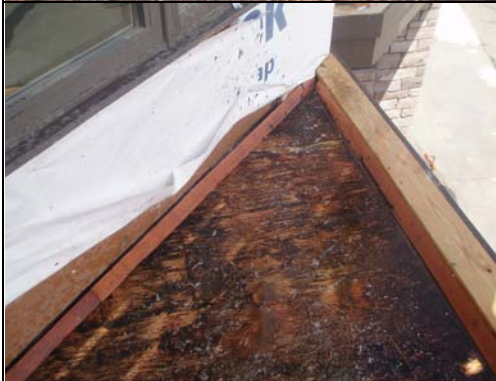
| PHOTO –WORK ITEM | DESCRIPTION | ACTION |
|---|---|---|
| | <p>5/1/13 – Photo 23<br/>Unit 24, 2<sup>nd</sup> Floor Deck</p> <p>Condition at far corner.</p> <p>(Deck is wet due to recent snowfall.)</p> | <p>Note</p> |

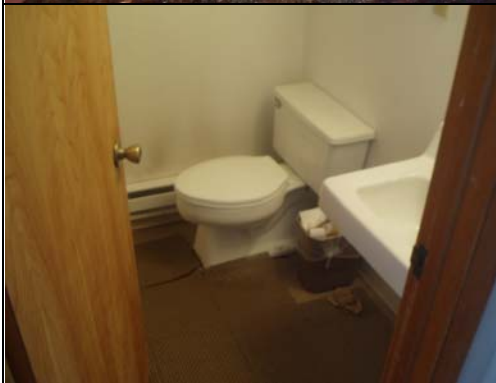
| PHOTO –WORK ITEM | DESCRIPTION | ACTION |
|---|---|---|
| | <p>5/1/13 – Photo 24<br/>Lower Level Hot Tub Restroom</p> <p>Restroom is in good order but should be cleaned.</p> | <p>Note</p> |
