ARCHITECT'S FIELD REPORT

070

PROJECT	Eagle's Nest Townhouses 11 Morning Glory Way & 31 Marcellina Lane Mt. Crested Butte, CO 81225	DATE	5/1/12
----------------	--	-------------	--------

WORK OBSERVED	
Phase III - Demolition	
TRADES PRESENT	
Holgate Construction

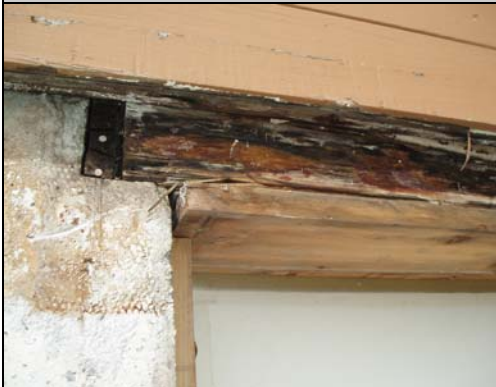
<p>5/01/12 – Photo 5 Unit 1 Detail</p> <p>Detail of degraded header at south bearing location.</p>	<p>Note</p>

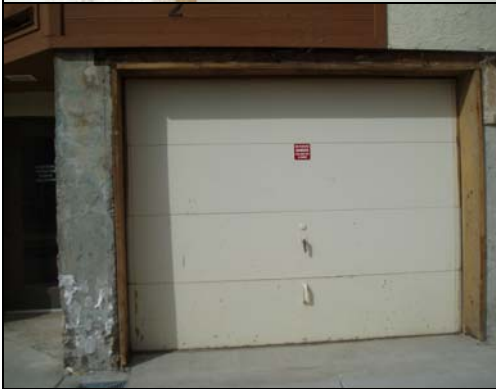
<p>5/01/12 – Photo 6 Unit 2</p> <p>Header and jamb trim appear to be in a usable condition.</p>	<p>Note</p>

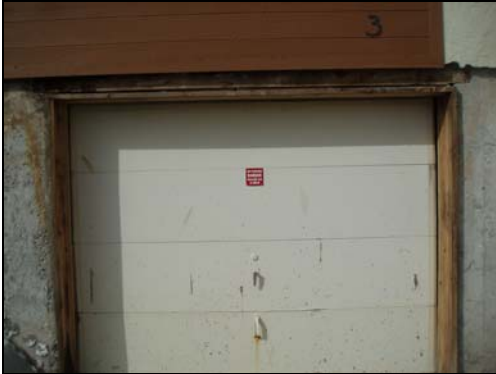
<p>5/01/12 – Photo 7 Unit 3</p> <p>Header appears to be in a usable condition. Lower 2' of south jamb trim should be replaced.</p>	<p>Note</p>

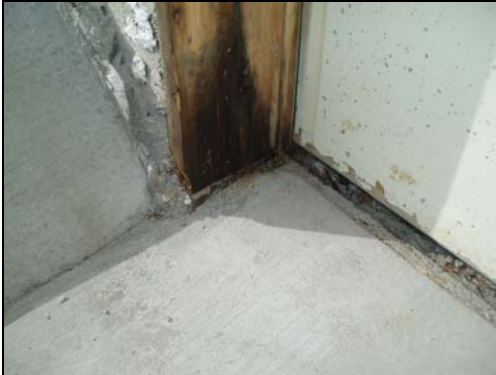
<p>5/01/12 – Photo 8 Unit 3 Detail</p> <p>Degraded south jamb trim.</p>	<p>Note</p>

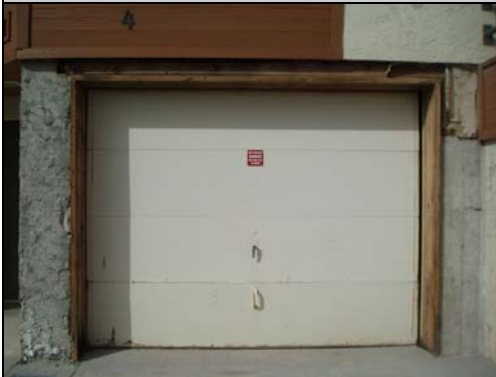
<p>5/01/12 – Photo 9 Unit 4</p> <p>Header and jamb trim appear to be in a usable condition.</p>	<p>Note</p>

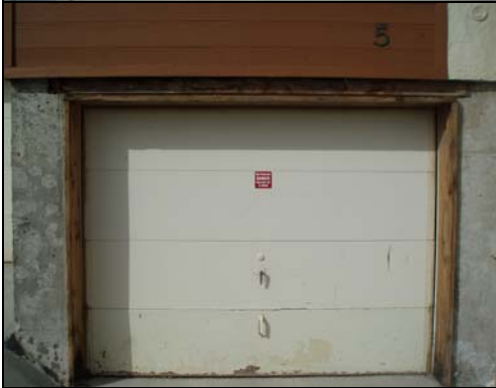
<p>5/01/12 – Photo 10 Unit 5</p> <p>Header appears to be in a usable condition. Lower 2' of jamb trim on each side should be replaced.</p>	<p>Note</p>

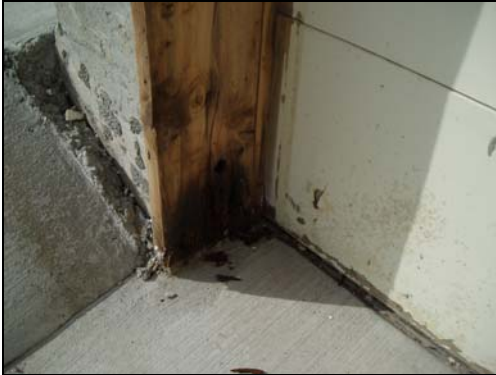
<p>5/01/12 – Photo 11 Unit 5 Detail</p> <p>Degraded south jamb trim.</p>	<p>Note</p>

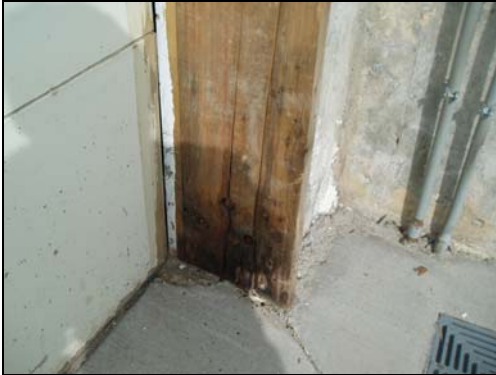
<p>5/01/12 – Photo 12 Unit 5 Detail</p> <p>Degraded north jamb trim.</p>	<p>Note</p>

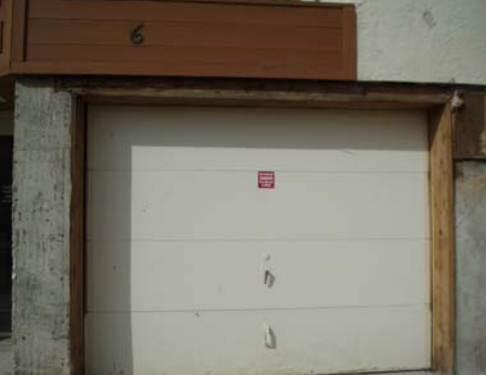
<p>5/01/12 – Photo 13 Unit 6</p> <p>Header and jamb trim appear to be in a usable condition.</p>	<p>Note</p>

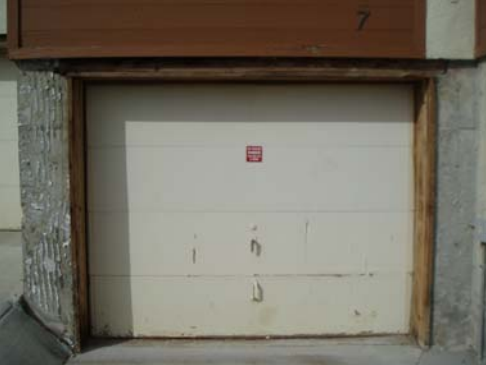
<p>5/01/12 – Photo 14 Unit 7</p> <p>Header and jamb trim appear to be in a usable condition.</p>	<p>Note</p>

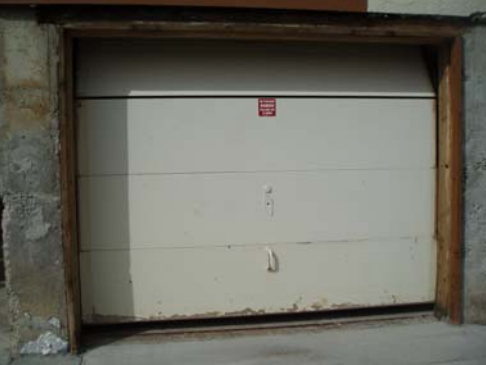
<p>5/01/12 – Photo 15 Unit 8</p> <p>Header appears to be in a usable condition.</p> <p>Jamb trim will need to be replaced.</p>	<p>Note</p>

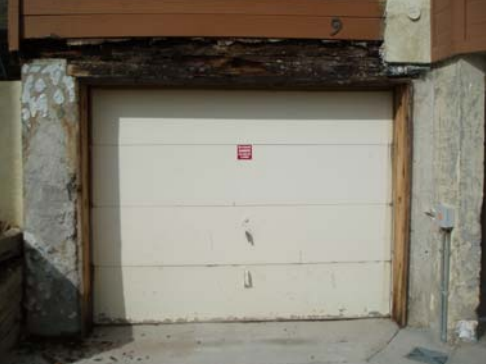
<p>5/01/12 – Photo 16 Unit 9</p> <p>Header, deck support and bearing for porch column are completely destroyed. Recommend immediate attention to this unit and complete rebuild of the lower wood framing.</p>	<p>ENT Urgent</p>

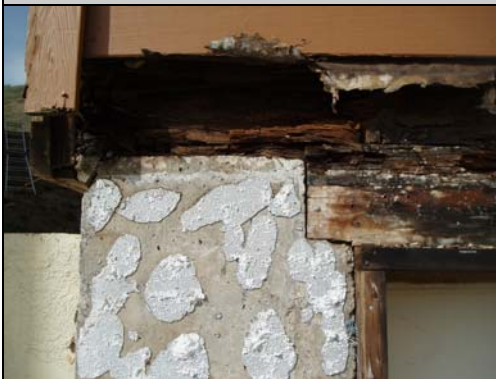
<p>5/01/12 – Photo 17 Unit 9 Detail</p> <p>Rotten and brittle condition of header and bearing for porch column. Sill plate is completely degraded; porch post supporting the decks and roof above are compromised.</p>	<p>ENT Urgent</p>

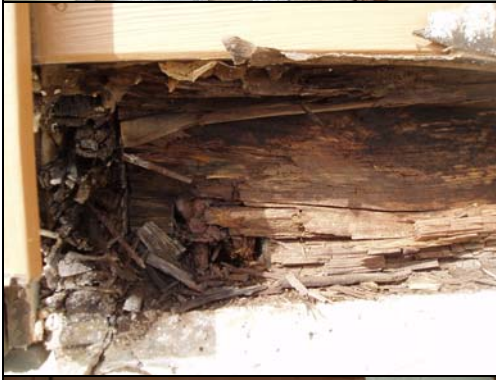
<p>5/01/12 – Photo 18 Unit 9 Detail</p> <p>Anchor bolt for sill plate is visible. Wood crumbles when touched. Recommend to replace failed construction as soon as possible.</p>	<p>ENT Urgent</p>

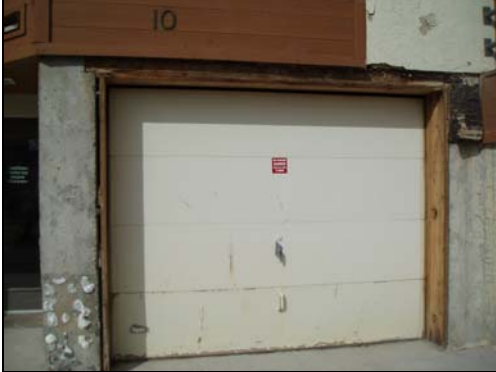
<p>5/01/12 – Photo 19 Unit 10</p> <p>Header and jamb trim appear to be in a usable condition.</p>	<p>Note</p>

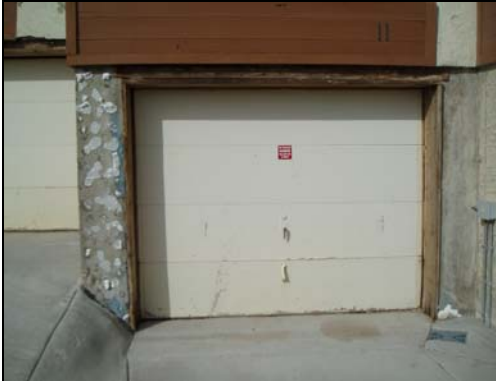
<p>5/01/12 – Photo 20 Unit 11</p> <p>Header and jamb trim appear to be in a usable condition.</p>	<p>Note</p>

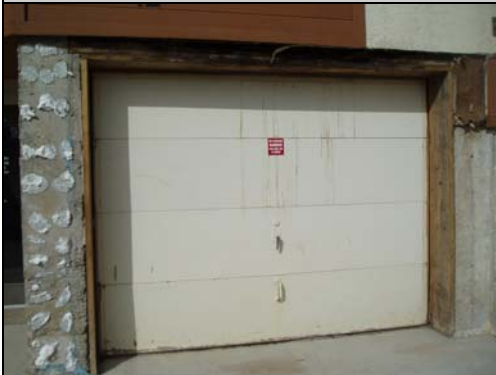
<p>5/01/12 – Photo 21 Unit 12</p> <p>Header is in a degraded condition. Recommend replacement.</p>	<p>Note</p>

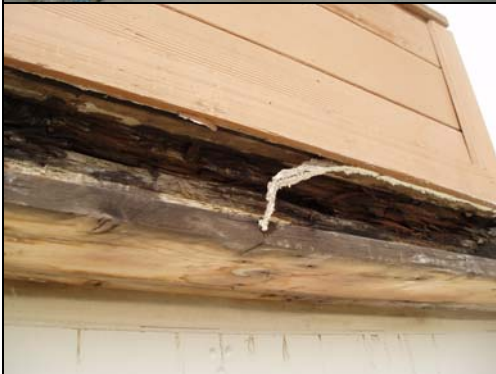
<p>5/01/12 – Photo 22 Unit 12 Detail</p> <p>Detail of dry rot header.</p>	<p>Note</p>

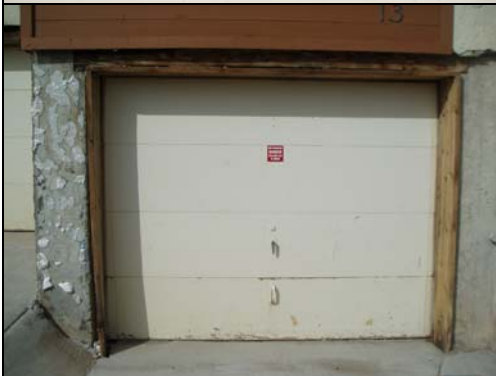
<p>5/01/12 – Photo 23 Unit 13</p> <p>Header is in a degraded condition. Recommend replacement.</p>	<p>Note</p>

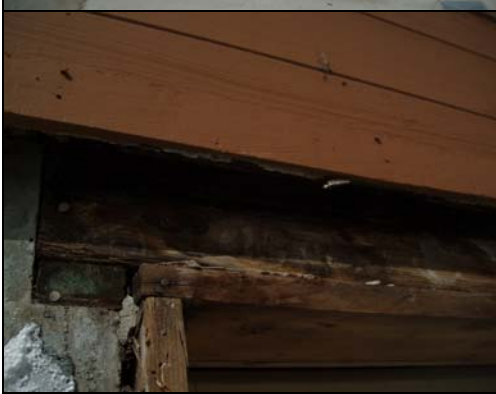
<p>5/01/12 – Photo 24 Unit 13 Detail</p> <p>Detail of dry rot header.</p>	<p>Note</p>

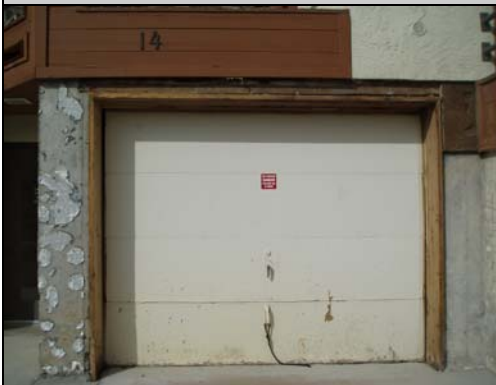
<p>5/01/12 – Photo 25 Unit 14</p> <p>Header and jamb trim appear to be in a usable condition.</p>	<p>Note</p>

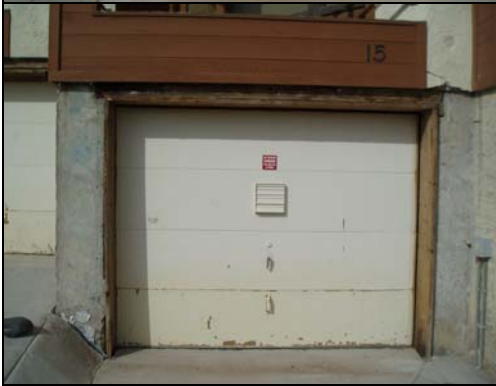
<p>5/01/12 – Photo 26 Unit 15</p> <p>Header is in a degraded condition. Recommend replacement.</p>	<p>Note</p>

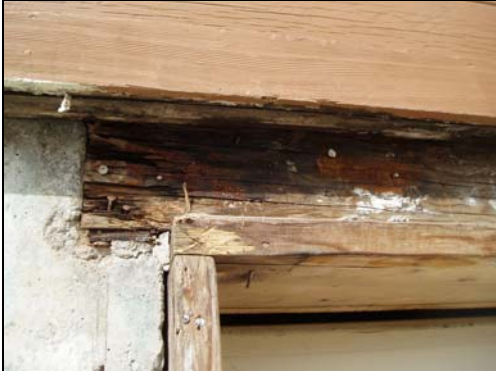
<p>5/01/12 – Photo 27 Unit 15 Detail</p> <p>Detail of dry rot header.</p>	<p>Note</p>

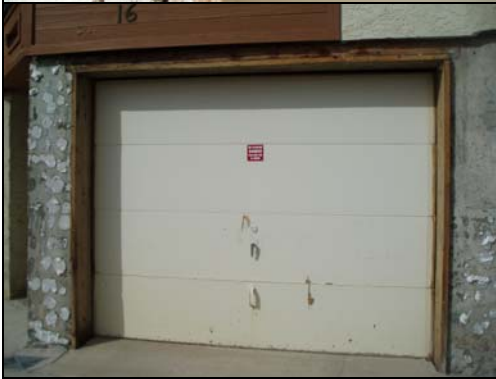
<p>5/01/12 – Photo 28 Unit 16</p> <p>Header and jamb trim appear to be in a usable condition.</p>	<p>Note</p>

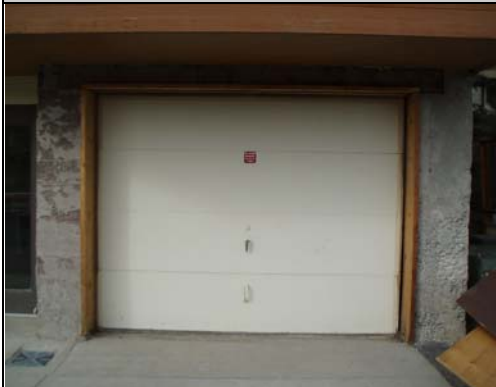
<p>5/01/12 – Photo 29 Unit 17</p> <p>Header and jamb trim appear to be in a usable condition.</p>	<p>Note</p>

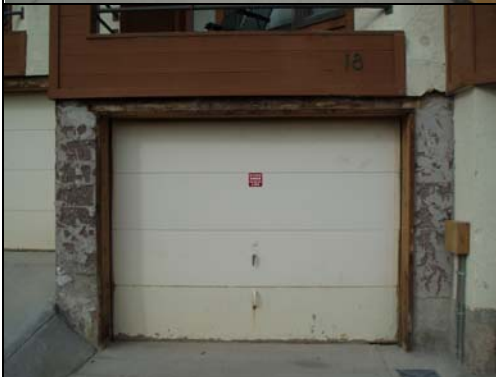
<p>5/01/12 – Photo 30 Unit 18</p> <p>Header and jamb trim appear to be in a usable condition.</p>	<p>Note</p>

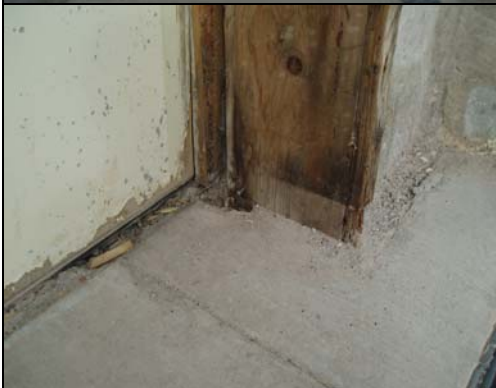
<p>5/01/12 – Photo 31 Unit 18 Detail (Typical Condition)</p> <p>Recommend removing bottom portion of jamb trim to hold the end grain off the face of concrete. This condition is common at all locations.</p>	<p>Note</p>

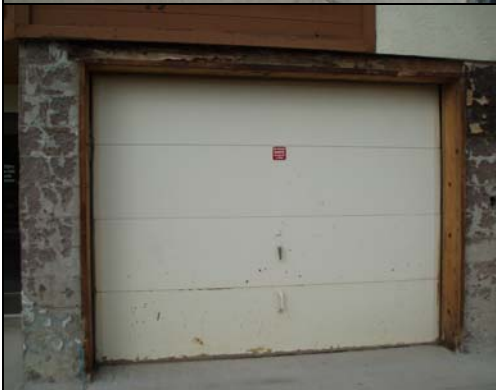
<p>5/01/12 – Photo 32 Unit 19</p> <p>Header is in a degraded condition. Recommend replacement.</p>	<p>Note</p>

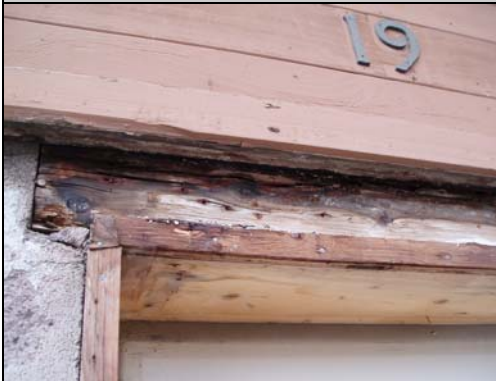
<p>5/01/12 – Photo 33 Unit 19 Detail</p> <p>Detail of degraded condition of header at the south bearing location.</p>	<p>Note</p>

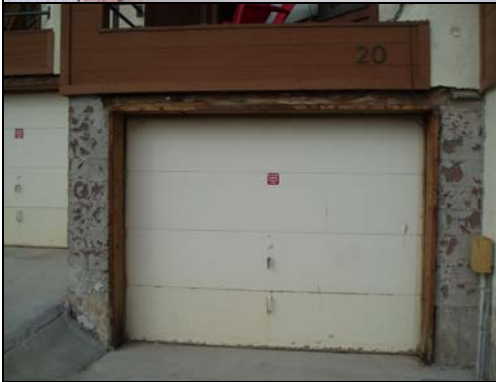
<p>5/01/12 – Photo 34 Unit 20</p> <p>Header and jamb trim appear to be in a usable condition.</p>	<p>Note</p>

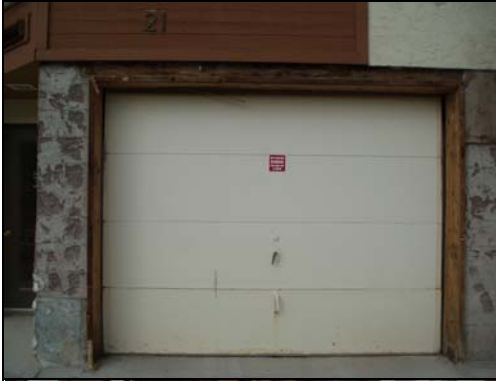
<p>5/01/12 – Photo 35 Unit 21</p> <p>Header and jamb trim appear to be in a usable condition.</p>	<p>Note</p>

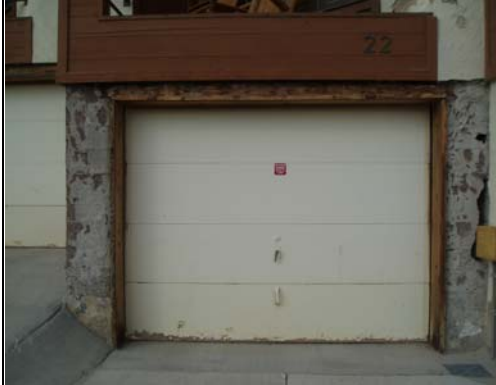
<p>5/01/12 – Photo 36 Unit 22</p> <p>Header and jamb trim appear to be in a usable condition.</p>	<p>Note</p>

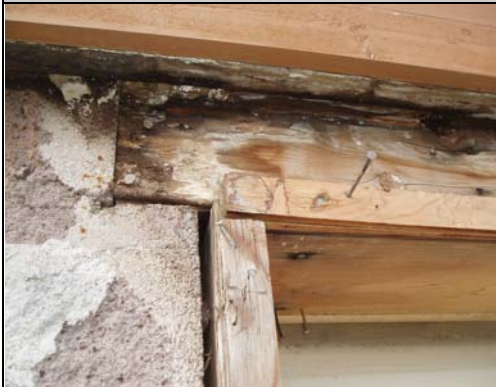
<p>5/01/12 – Photo 37 Unit 22 Detail</p> <p>Face board of header appears degraded. Possible replacement of the face-board recommended. Further inspection may be required to see if the remaining structural members are degraded.</p>	<p>Note</p>

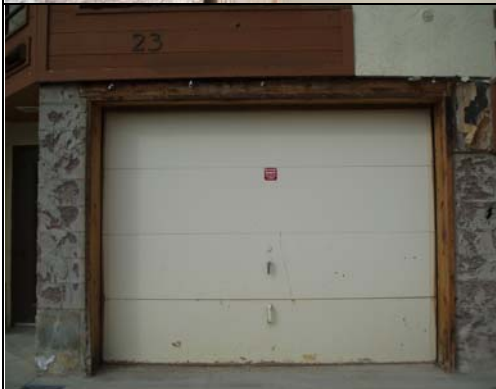
<p>5/01/12 – Photo 38 Unit 23</p> <p>Header and jamb trim appear to be in a usable condition.</p>	<p>Note</p>

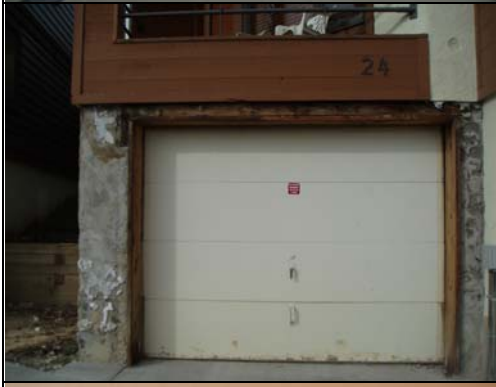
<p>5/01/12 – Photo 39 Unit 24</p> <p>Header is in a degraded condition. Recommend replacement.</p>	<p>Note</p>

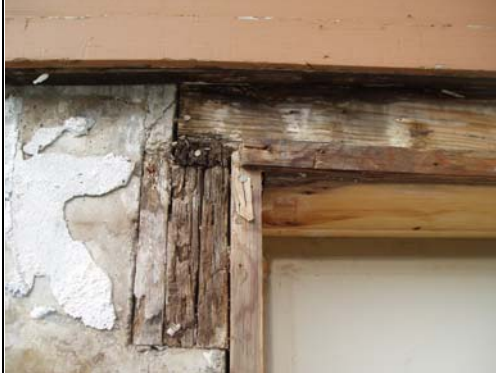
<p>5/01/12 – Photo 40 Unit 24 Detail</p> <p>Detail of degraded bearing end and stud pack. Members will need to be replaced and protected from contact with the concrete.</p>	<p>Note</p>

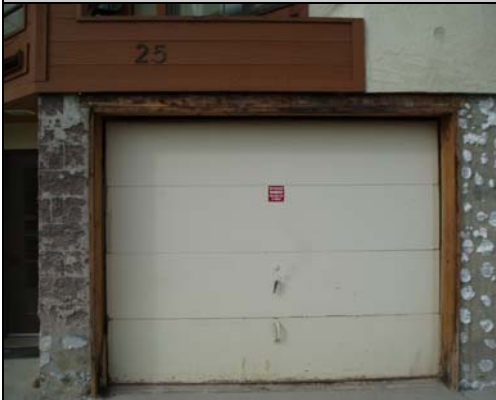
<p>5/01/12 – Photo 41 Unit 25</p> <p>Header appears to be in a usable condition. Lower 2' of jamb trim on each side should be replaced.</p>	<p>Note</p>

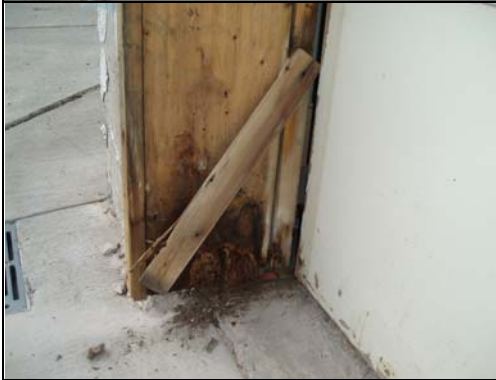
<p>5/01/12 – Photo 42 Unit 25 Detail</p> <p>Detail of degraded jamb trim.</p>	<p>Note</p>

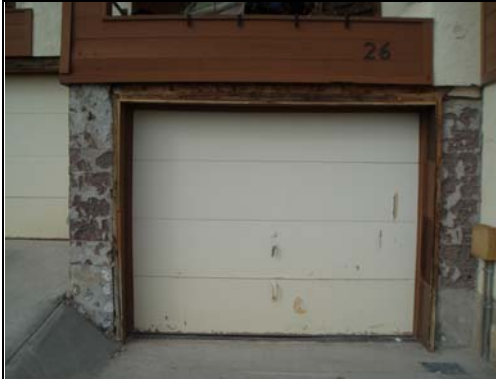
<p>5/01/12 – Photo 43 Unit 26</p> <p>Header and jamb trim appear to be in a usable condition.</p>	<p>Note</p>

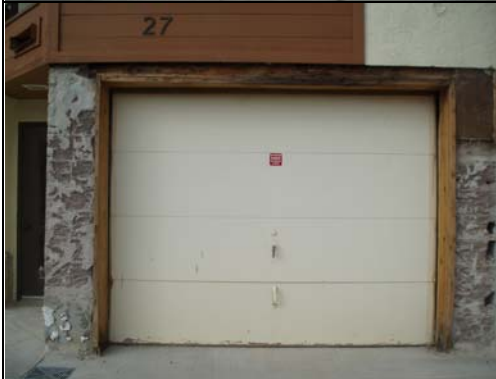
<p>5/01/12 – Photo 44 Unit 27</p> <p>Header and jamb trim appear to be in a usable condition.</p>	<p>Note</p>

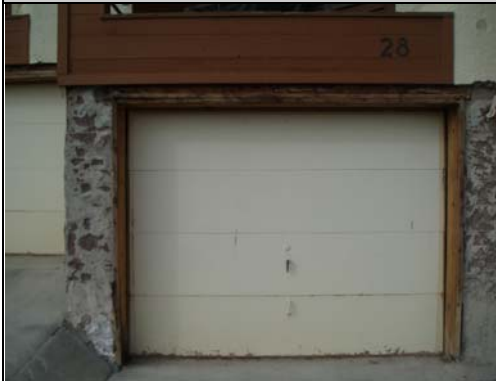
<p>5/01/12 – Photo 45 Unit 28</p> <p>Header and jamb trim appear to be in a usable condition.</p>	<p>Note</p>

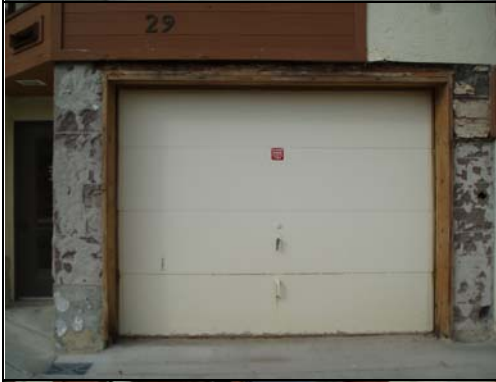
<p>5/01/12 – Photo 46 Unit 29</p> <p>Header and jamb trim appear to be in a usable condition.</p>	<p>Note</p>

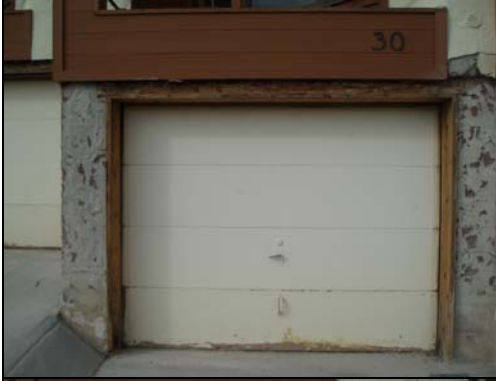
<p>5/01/12 – Photo 47 Unit 30</p> <p>Header and jamb trim appear to be in a usable condition.</p>	<p>Note</p>

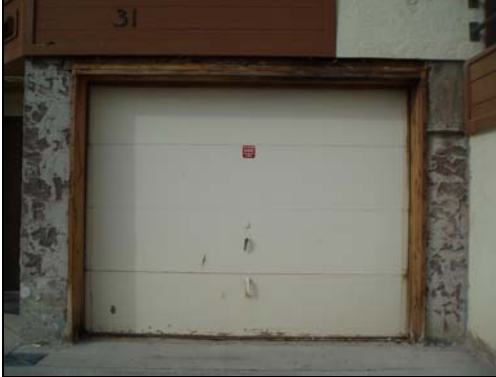
<p>5/01/12 – Photo 48 Unit 31</p> <p>Header and jamb trim appear to be in a usable condition.</p>	<p>Note</p>

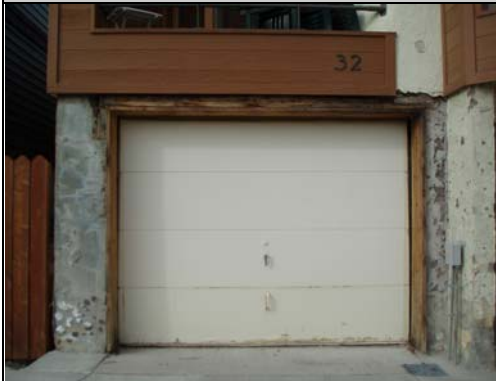
<p>5/01/12 – Photo 49 Unit 32</p> <p>Header and jamb trim appear to be in a usable condition.</p>	<p>Note</p>

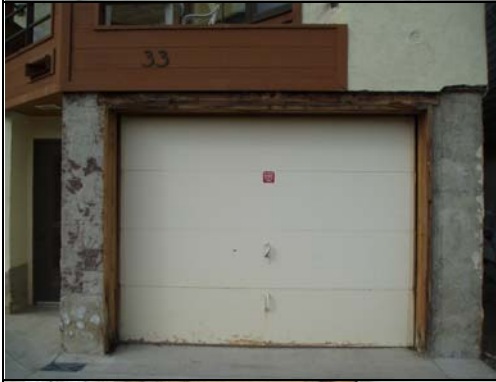
<p>5/01/12 – Photo 50 Unit 33</p> <p>Header appears to be in a usable condition. Lower 2' of jamb trim on each side should be replaced.</p>	<p>Note</p>

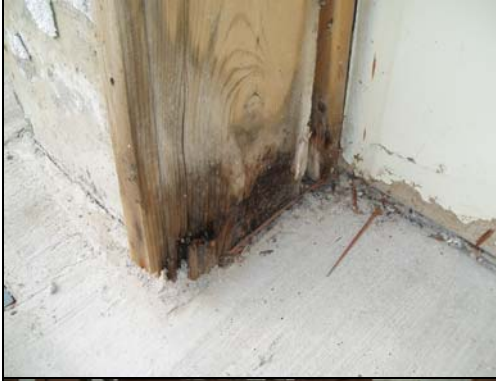
<p>5/01/12 – Photo 51 Unit 33 Detail</p> <p>Detail of degraded jamb trim.</p>	<p>Note</p>
 	<p>5/01/12 – Photo 52 Unit 34</p> <p>Header and jamb trim appear to be in a usable condition.</p>	<p>Note</p>

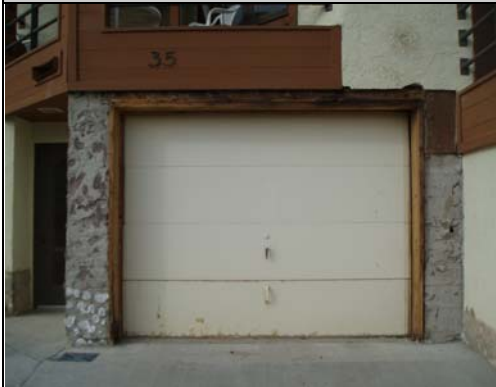
<p>5/01/12 – Photo 53 Unit 35</p> <p>Header and jamb trim appear to be in a usable condition.</p>	<p>Note</p>

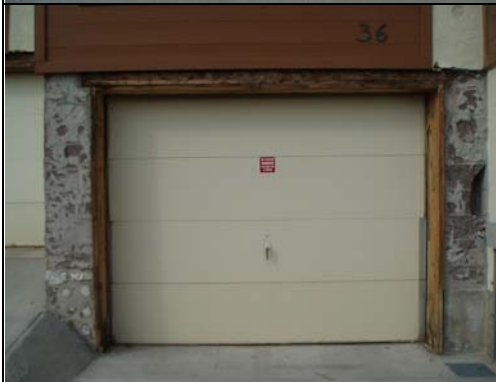
<p>5/01/12 – Photo 54 Unit 36</p> <p>Header is in a degraded condition. Recommend replacement.</p>	<p>Note</p>

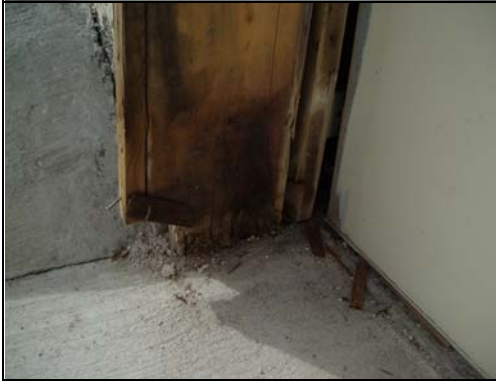
<p>5/01/12 – Photo 55 Unit 36 Detail</p> <p>Detail of degraded jamb trim.</p>	<p>Note</p>

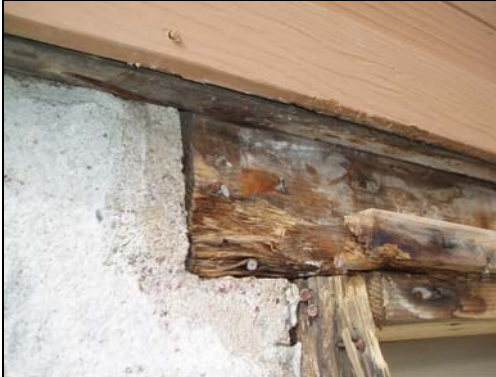
<p>5/01/12 – Photo 56 Unit 36 Detail</p> <p>Detail of degraded header.</p>	<p>Note</p>

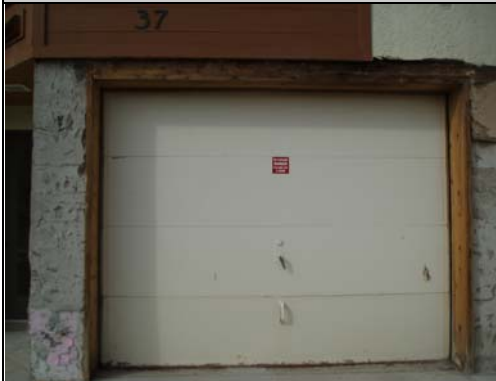
<p>5/01/12 – Photo 57 Unit 37</p> <p>Header and jamb trim appear to be in a usable condition.</p>	<p>Note</p>

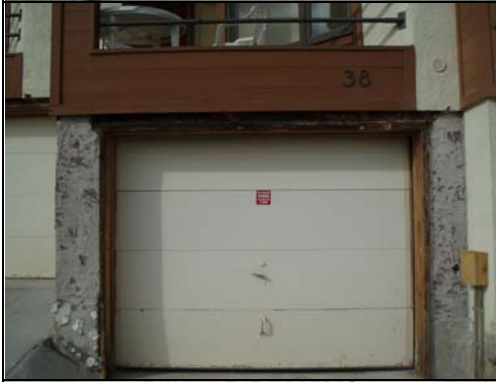
<p>5/01/12 – Photo 58 Unit 38</p> <p>Header is in a degraded condition. Recommend replacement.</p>	<p>Note</p>

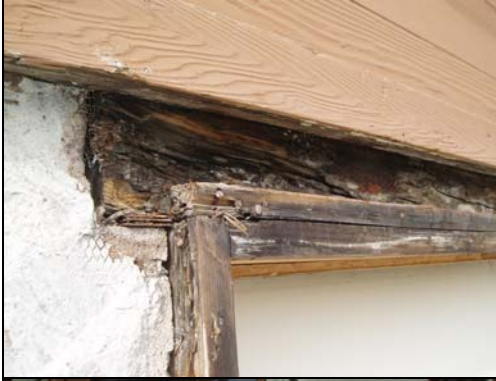
<p>5/01/12 – Photo 59 Unit 38 Detail</p> <p>Detail of dry rot header.</p>	<p>Note</p>

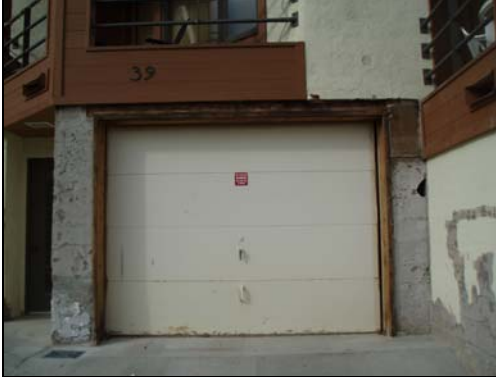
<p>5/01/12 – Photo 60 Unit 39</p> <p>Header and jamb trim appear to be in a usable condition.</p>	<p>Note</p>

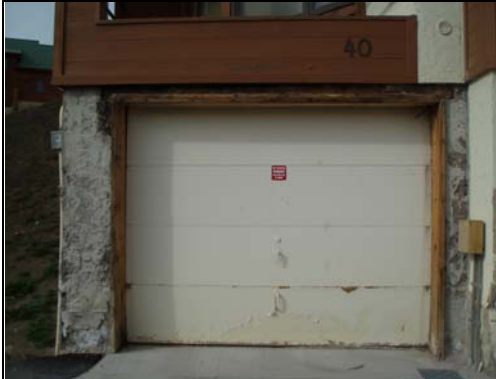
<p>5/01/12 – Photo 61 Unit 40</p> <p>Header appears to be in a usable condition.</p> <p>South jamb trim, bottom 2' should be replaced as the board is degraded.</p>	<p>Note</p>

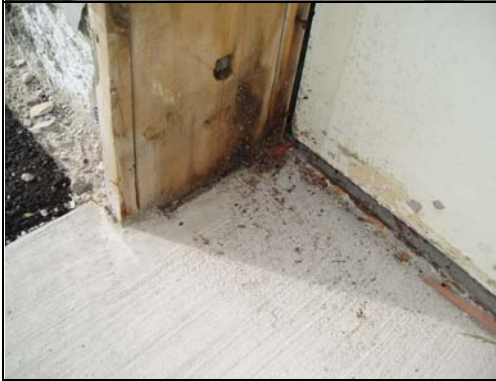
<p>5/01/12 – Photo 62 Unit 40 Detail</p> <p>Degraded south jamb trim.</p>	<p>Note</p>
