ARCHITECT'S FIELD REPORT

141

PROJECT	Eagle's Nest Townhouses 11 Morning Glory Way & 31 Marcellina Lane Mt. Crested Butte, CO 81225	DATE	5/27/14
----------------	--	-------------	---------

WORK OBSERVED	
Phase II Concrete Repairs	
TRADES PRESENT	
Lacy Construction, CSI, United

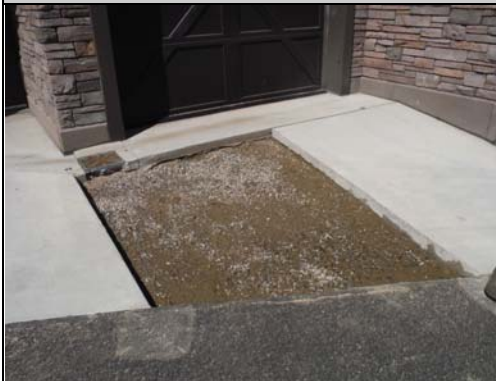
<p>5/27/13 – Photo 1 Unit 19</p> <p>Portion of the concrete apron has been removed and structural fill is in place.</p>	<p>Note</p>

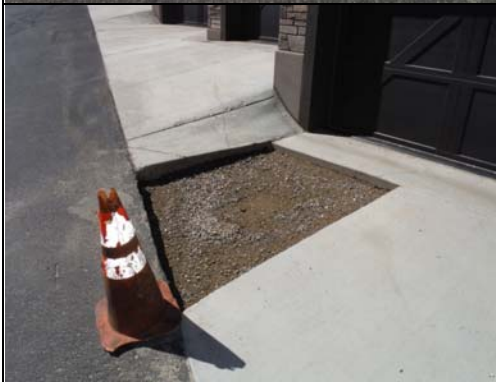
<p>5/27/13 – Photo 2 Unit 20</p> <p>Structural fill is in place.</p>	<p>Note</p>

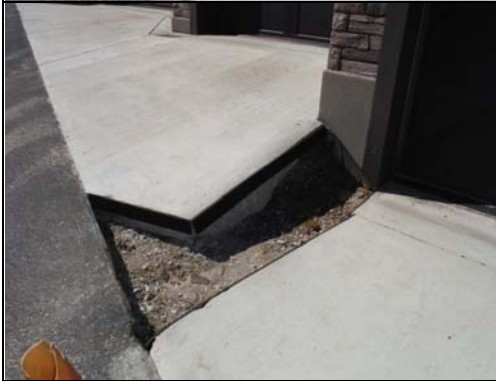
<p>5/27/13 – Photo 3 Unit 26</p> <p>Transition area has been removed. A small portion of the adjacent slab was also removed.</p>	<p>Note</p>

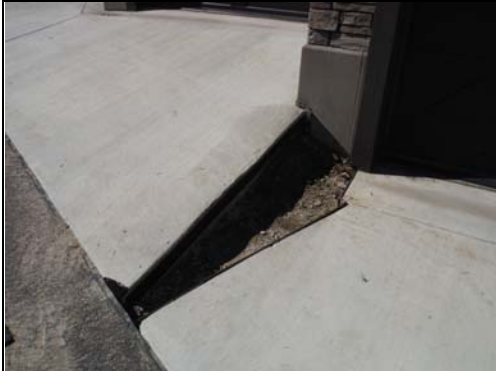
<p>5/27/13 – Photo 5 Unit 28</p> <p>Concrete transition has been removed. Typical condition for Units 26, 28, 30, 34, 36, and 38.</p>	<p>Note</p>

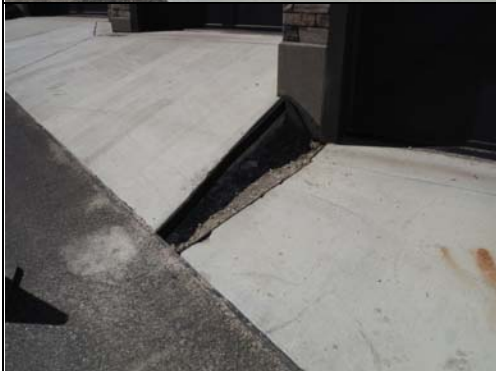
<p>5/27/13 – Photo 6 Unit 30</p> <p>Transition area prepared for new concrete.</p>	<p>Note</p>

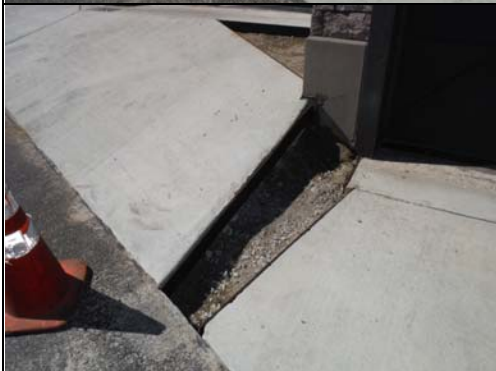
<p>5/27/13 – Photo 7 Unit 34</p> <p>Transition area prepared for new concrete. Portion of the Unit 35 apron repair is visible in the background.</p>	<p>Note</p>

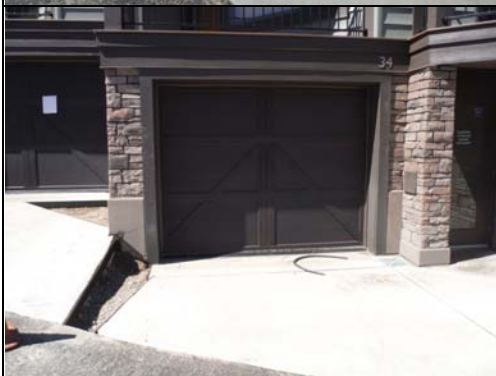
<p>5/27/13 – Photo 8 Unit 34</p> <p>Precast concrete base on the left side of Unit 34 was cracked due to frost heave of the slab.</p>	<p>Note</p>

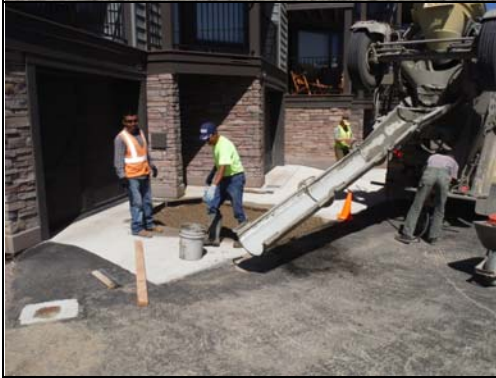
<p>5/27/13 – Photo 10 Unit 40</p> <p>Concrete testing is underway prior to placement.</p>	<p>Note</p>
 	<p>5/27/13 – Photo 11 Units 20 & 19</p> <p>Concrete finishing underway.</p>	<p>Note</p>
 	<p>5/27/13 – Photo 12 Unit 30</p> <p>Concrete finishing underway.</p>	<p>Note</p>
