**ARCHITECT'S FIELD REPORT**

**063**

<b>PROJECT</b>	<b>Eagle's Nest Townhouses</b> 11 Morning Glory Way & 31 Marcellina Lane Mt. Crested Butte, CO 81225	<b>DATE</b>	10/19/11
----------------	--	-------------	----------

<b>WORK OBSERVED</b>	
Installation of Vinyl Garage Sill at Unit 32	
<b>TRADES PRESENT</b>	
None

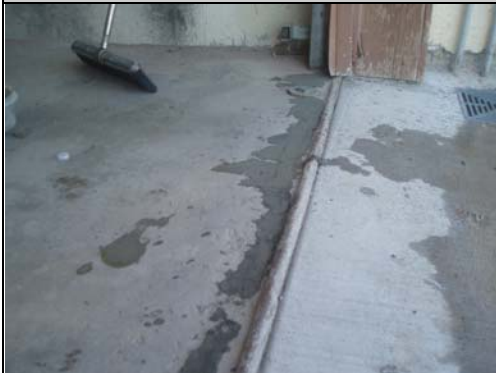
<p>10/19/11 – Photo 5 Threshold Looking North</p> <p>Concrete repair complete.</p>	<p>Note</p>
 	<p>10/19/11 – Photo 6 Detail of Sewer Cleanout</p> <p>Concrete repair around cleanout.</p>	<p>Note</p>

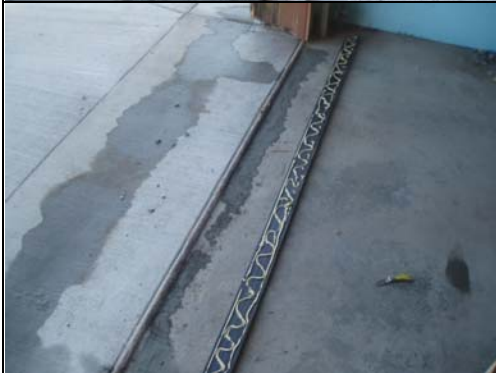
<p>10/19/11 – Photo 7 Threshold Looking South</p> <p>Concrete patch cures in 30 minutes. Vinyl sill is cut to width. Note application of Liquid Nails per installation instructions.</p>	<p>Note</p>

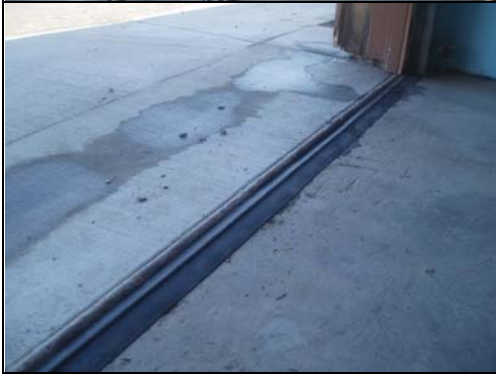
<p>10/19/11 – Photo 8 Threshold Looking South</p> <p>Vinyl sill in place.</p>	<p>Note</p>

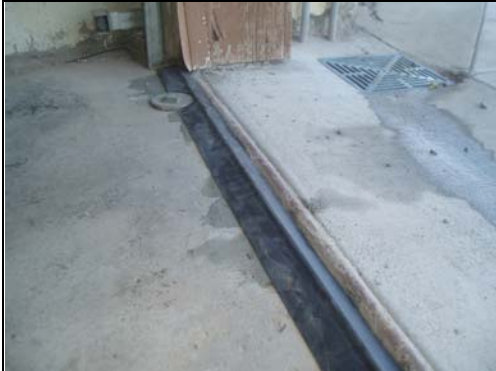
<p>10/19/11 – Photo 9 Threshold Looking North</p> <p>Vinyl sill in place.</p>	<p>Note</p>

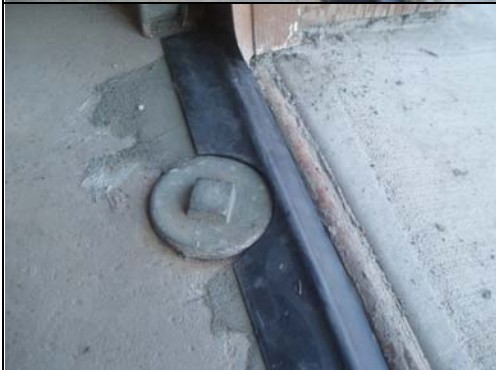
<p>10/19/11 – Photo 10 Sewer Cleanout Detail</p> <p>Sill was cut around cleanout.</p>	<p>Note</p>

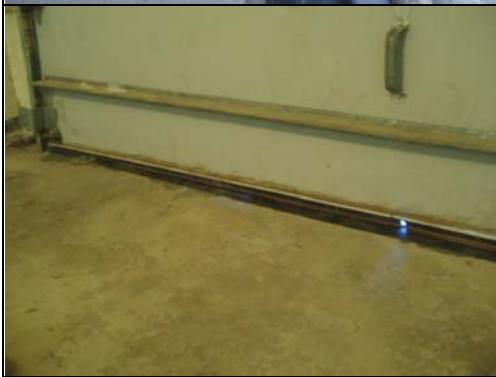
<p>10/19/11 – Photo 11 Interior Threshold North</p> <p>Note light coming through approximately mid-span due to damaged rubber sill attached to bottom of garage door.</p>	<p>Note</p>

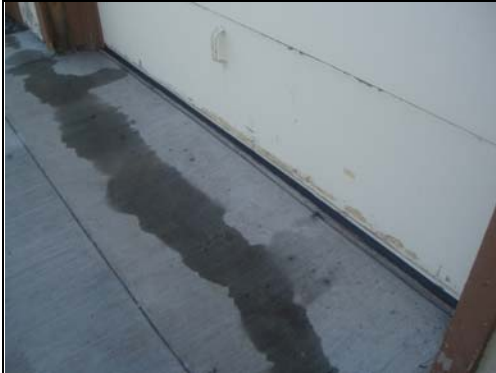
<p>A photograph showing a view of the sill at the leading edge of a garage door. The floor is concrete, and the wall is white with some staining.</p>	<p>10/19/11 – Photo 12 Exterior Threshold</p> <p>View of sill at leading edge of garage door.</p>	<p>Note</p>

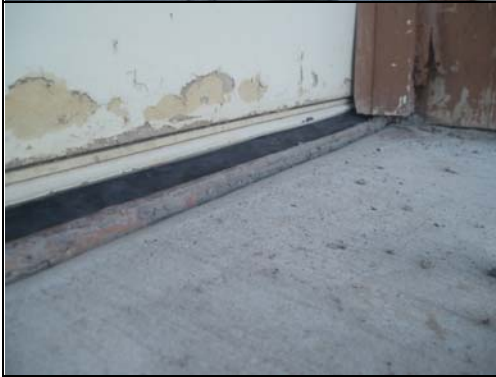
<p>A photograph showing a detail of the north threshold. It highlights the location of the sill behind an existing metal threshold bar. The wall is white and shows signs of peeling paint.</p>	<p>10/19/11 – Photo 13 Detail North Threshold</p> <p>Note location of sill behind existing metal threshold bar.</p>	<p>Note</p>
