ARCHITECT'S FIELD REPORT

034

PROJECT	Eagle's Nest Townhouses 11 Morning Glory Way & 31 Marcellina Lane Mt. Crested Butte, CO 81225	DATE	2/10/11
----------------	------------------------------------------------------------------------------------------------------------	-------------	---------

WORK OBSERVED	
Phase I – Construction	
TRADES PRESENT	
Holgate Construction Company

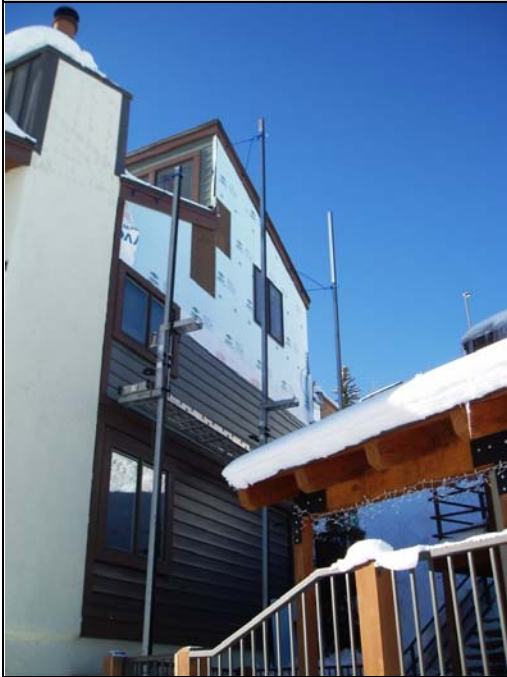
<p>2/10/11 – Photo 1 Unit 17</p> <p>Demolition and window installation is complete. Insulation, window trim, brown siding & belly band work has been installed.</p>	<p>None</p>
 	<p>2/10/11 – Photo 2 Unit 17</p> <p>End elevation awaiting loft level window trim and remainder of green siding.</p>	<p>None</p>

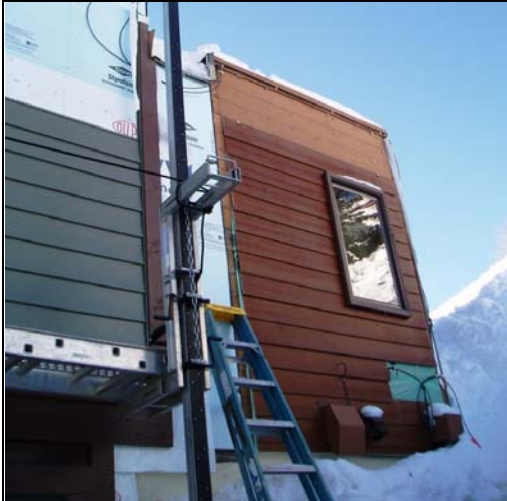
<p>2/10/11 – Photo 3 Unit 17</p> <p>Back elevation awaiting corrugated metal siding.</p>	<p>None</p>

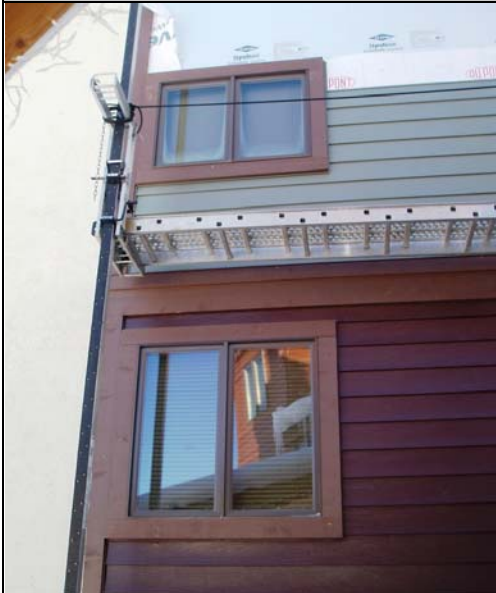
<p>2/10/11 – Photo 4 Unit 17</p> <p>Trim around existing windows is complete.</p>	<p>None</p>

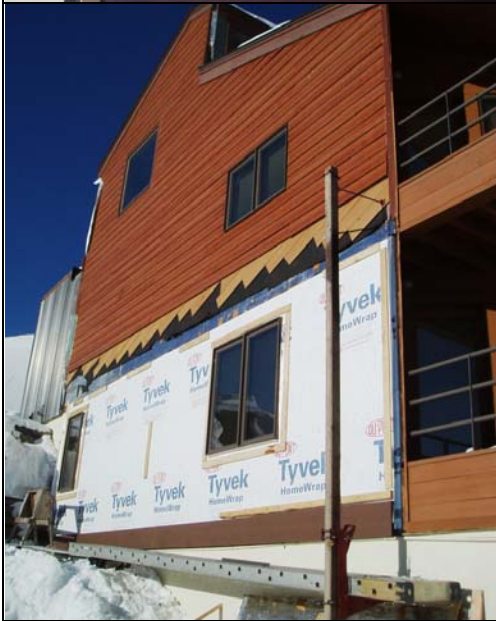
<p>2/10/11 – Photo 5 Unit 40</p> <p>Demolition of Unit 40 is approximately 40% complete. House wrap and furring strips have been added to the second story level.</p>	<p>None</p>

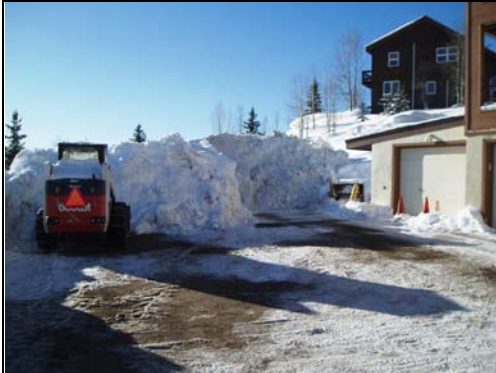
<p>2/10/11 – Photo 6 Upper Level Work Area</p> <p>The dumpster has been removed. The site and work area are in good order.</p>	<p>None</p>
