ARCHITECT'S FIELD REPORT

072

PROJECT	Eagle's Nest Townhouses 11 Morning Glory Way & 31 Marcellina Lane Mt. Crested Butte, CO 81225	DATE	5/14/12
----------------	--	-------------	---------

WORK OBSERVED	
Phase II Warranty Item Review & Phase III – Finish Carpentry	
TRADES PRESENT	
Holgate Construction

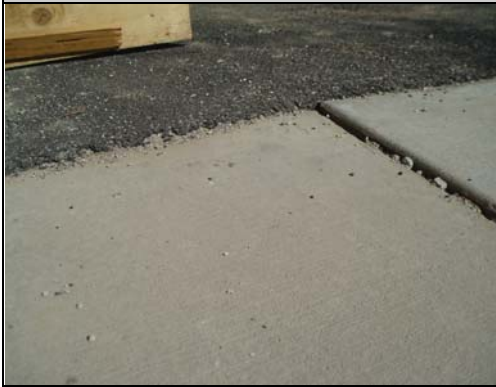
<p>5/14/12 – Photo 1 Phase II Warranty Item Review</p> <p>Unit 17 Apron Condition</p>	<p>Note</p>

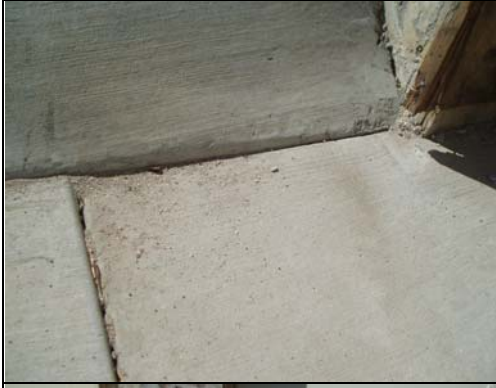
<p>5/14/12 – Photo 2 Phase II Warranty Item Review</p> <p>Unit 18 Apron Condition</p>	<p>Note</p>

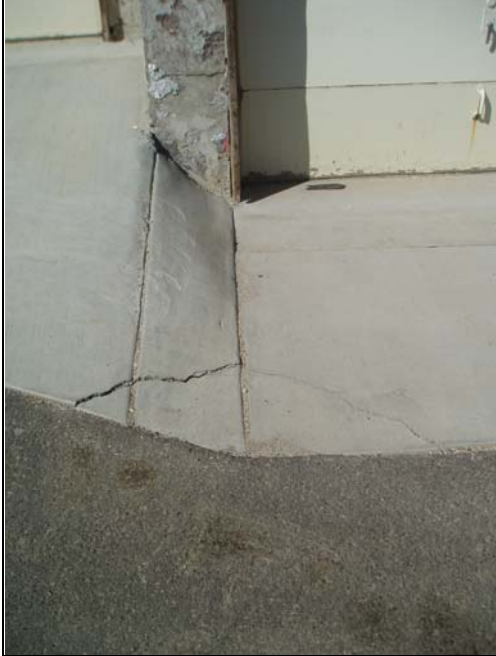
<p>5/14/12 – Photo 3 Phase II Warranty Item Review</p> <p>Unit 18 Apron Condition</p>	<p>Note</p>

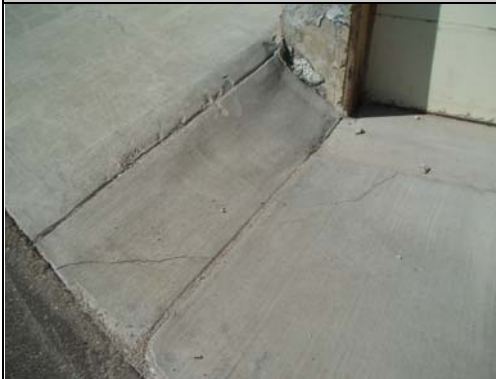
<p>5/14/12 – Photo 4 Phase II Warranty Item Review</p> <p>Unit 20 Apron Condition</p>	<p>Note</p>

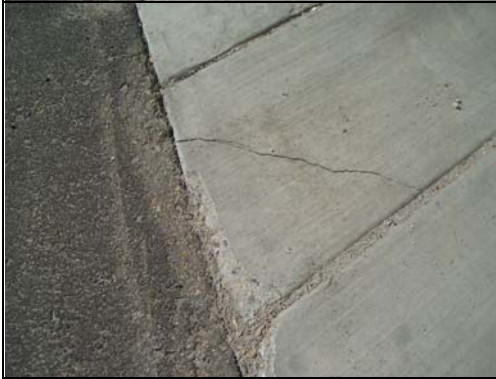
<p>5/14/12 – Photo 5 Phase II Warranty Item Review</p> <p>Unit 20 Apron Condition</p>	<p>Note</p>

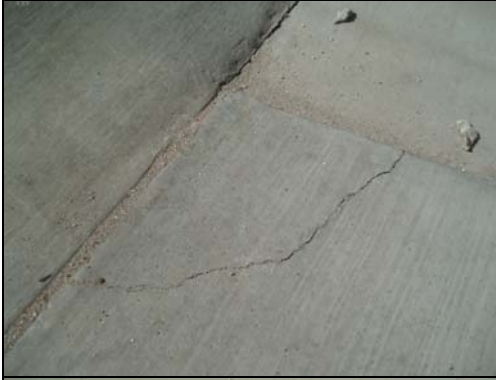
<p>5/14/12 – Photo 6 Phase II Warranty Item Review</p> <p>Unit 20 Apron Condition</p>	<p>Note</p>

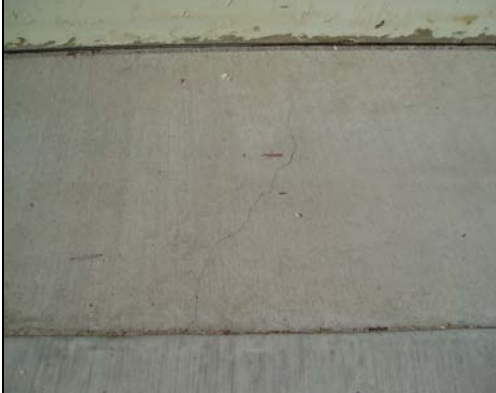
<p>5/14/12 – Photo 7 Phase II Warranty Item Review</p> <p>Unit 20 Apron Condition</p>	<p>Note</p>
