ARCHITECT'S FIELD REPORT

089

PROJECT	Eagle's Nest Townhouses 11 Morning Glory Way & 31 Marcellina Lane Mt. Crested Butte, CO 81225	DATE	9/12/12
----------------	--	-------------	---------

WORK OBSERVED	
Phase III Construction – Stone Installation; Electrical Meter Covers; Unit 20 Asphalt	
TRADES PRESENT	
Holgate Construction

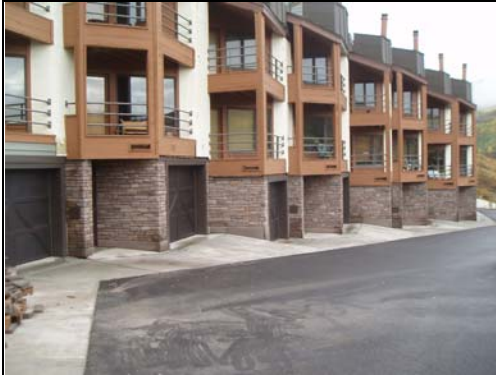
PHOTO –WORK ITEM	DESCRIPTION	ACTION
 	<p>9/12/12 – Photo 1 Upper Level Building 'B'</p> <p>Stone work is 90% complete on Building 'B'.</p>	<p>Note</p>
 	<p>9/12/12 – Photo 2 Upper Level Hot Tub Area</p> <p>Precast base and stone work is not yet finished on the north corner of Unit 16 and the Hot Tub knee wall.</p>	<p>Note</p>

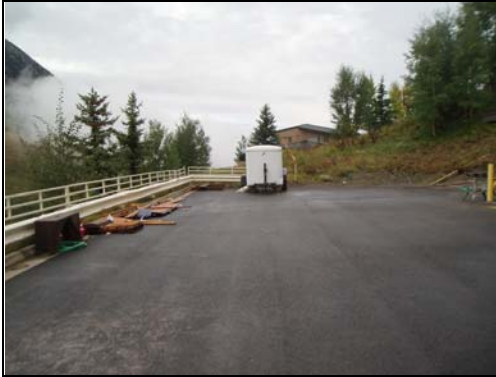
<p>9/12/12 – Photo 8 Upper Level Work Area Looking North</p> <p>Area is relatively clean. Parking is still displaced.</p>	<p>Note</p>

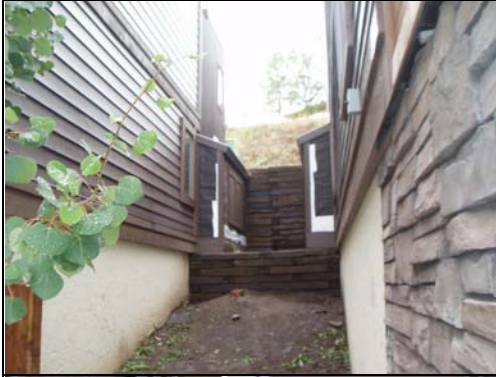
<p>9/12/12 – Photo 9 Upper Level Work Area Looking South</p> <p>Area is clean and organized.</p>	<p>Note</p>
