**ARCHITECT'S FIELD REPORT**

**058**

<b>PROJECT</b>	<b>Eagle's Nest Townhouses</b>	<b>DATE</b>	7/8/11
	11 Morning Glory Way & 31 Marcellina Lane	<b>REVISED</b>	7/13/11
	Mt. Crested Butte, CO 81225

<b>WORK OBSERVED</b>	
Phase II – Sewer and Asphalt; Site Walk	
<b>TRADES PRESENT</b>	
None

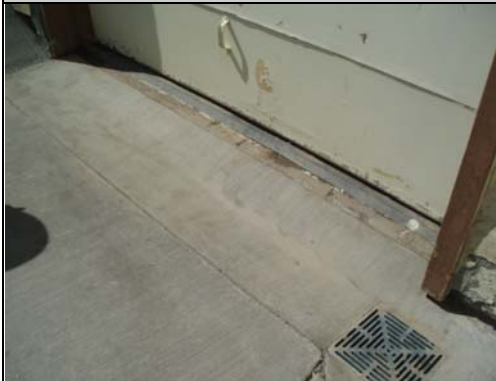
<p>7/8/11 – Photo 1 Lower Level Valley Pan</p> <p>Garage door threshold conditions vary. Threshold seals recommended.</p>	<p>Note</p>

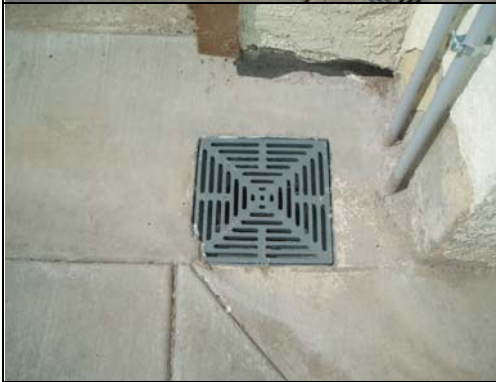
<p>7/8/11 – Photo 2 Lower Level Area Drain</p> <p>Note concrete obstructing the area drain lid.</p>	<p>LC</p>

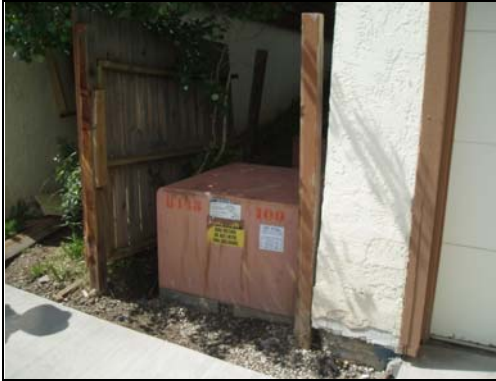
<p>7/8/11 – Photo 3 Lower Level Missing Concrete</p> <p>Typical of Units 24, 25, 32 &amp; 33. Additional concrete valley pans requested.</p>	<p>LC</p>

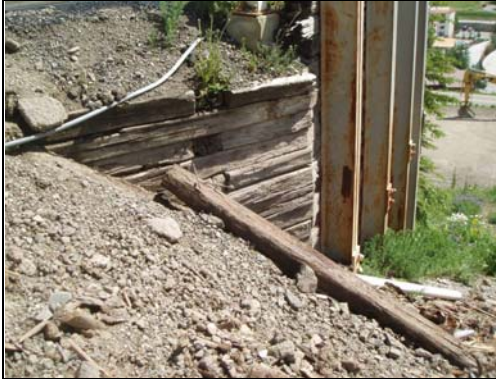
<p>7/8/11 – Photo 4 Lower Level South Retaining Wall</p> <p>Backfill deposits and debris are present at the south retaining wall.</p>	<p>Note</p>

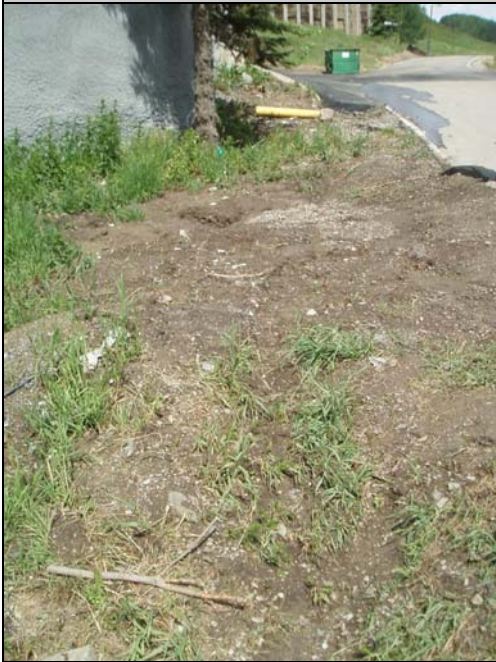
<p>7/8/11 – Photo 9 Lower Level Road Swale</p> <p>Road swale will need to be redefined. Runoff and silt deposits are filling the recently discovered drywell and sewer manholes.</p>	<p>Note</p>

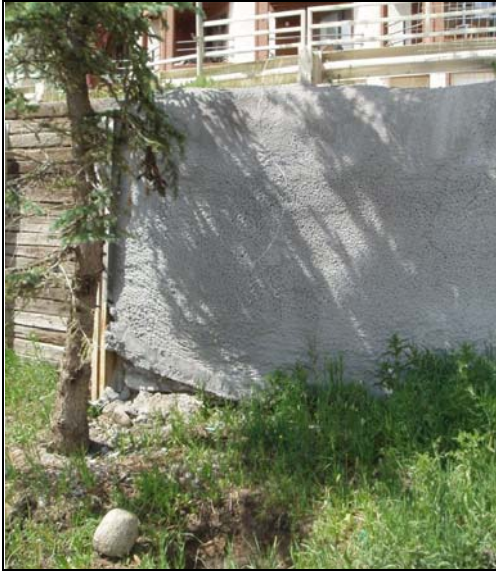
<p>7/8/11 – Photo 10 Lower Level Retaining Wall</p> <p>Lower south corner not complete.</p>	<p>MC</p>

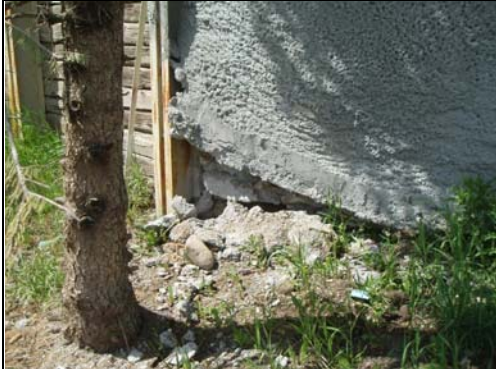
<p>7/8/11 – Photo 11 Lower Level Retaining Wall Detail</p> <p>Detail of photo above. Snow possibly obscured this area during shotcrete installation.</p>	<p>MC</p>

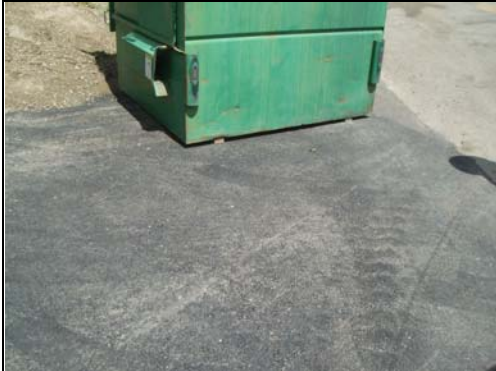
<p>7/8/11 – Photo 12 Lower Level Dumpster</p> <p>Repeated pick-ups could cause tire depressions in the asphalt front of the dumpster.</p>	<p>Note</p>

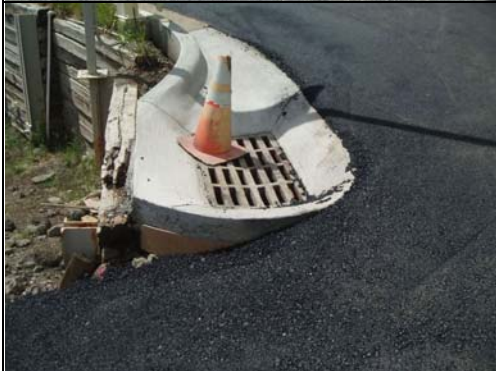
<p>7/8/11 – Photo 13 Upper Level Area Drain</p> <p>Curb around new area drain will likely be damaged by vehicles and snow removal.</p>	<p>Note</p>

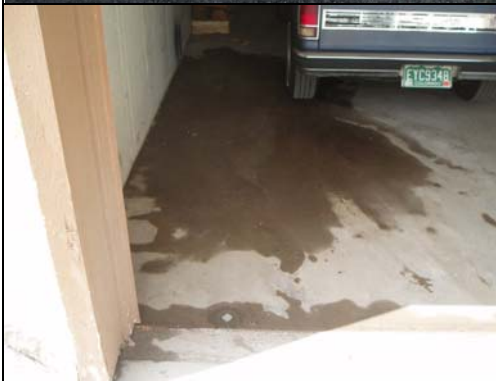
<p>7/8/11 – Photo 14 Unit 7 Garage Slab</p> <p>Sunken slab is causing water to collect in the garage. This condition may be typical in several units.</p>	<p>Note</p>

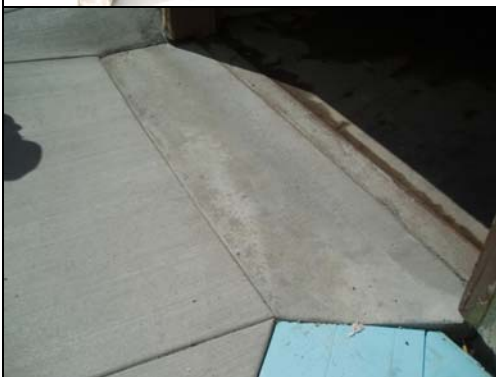
<p>7/8/11 – Photo 15 <i>Unit 7 Garage Valley Pan</i></p> <p>Owners are concerned that the valley pan may not be deep enough.</p>	<p>Note</p>

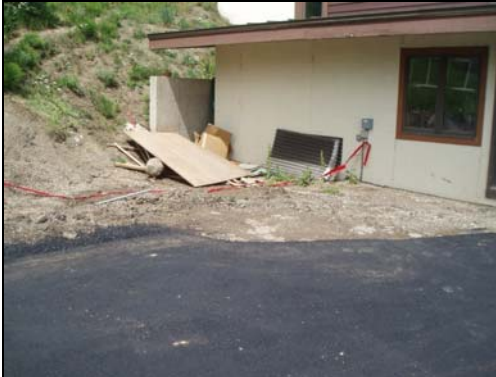
1.12	Replace Bollard	0%	After asphalt is in place
1.13	Asphalt	95%	Area around Maintenance Shed in question.
2.00	<b>Lower Level – Sewer &amp; Asphalt</b>

<p>7/8/11 – Photo 16 Upper Level Maintenance Shed</p> <p>Asphalt in this area may be incomplete.</p>	<p>BWA BL</p>
 	<p>7/8/11 – Photo 17 Upper Level Apron/Asphalt Junction</p> <p>Asphalt at Building A is higher than the concrete apron.</p>	<p>Note</p>

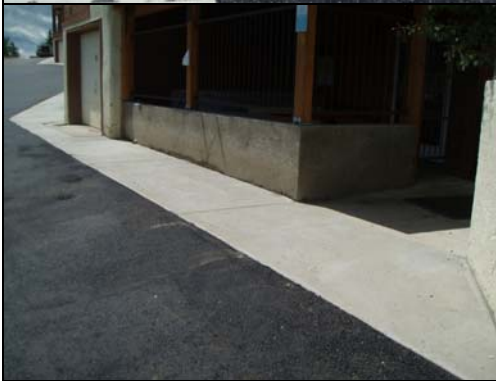
<p>7/8/11 – Photo 18 Upper Level Hot Tub Sidewalk</p> <p>Slab in this area does not drain properly.</p>	<p>BL</p>

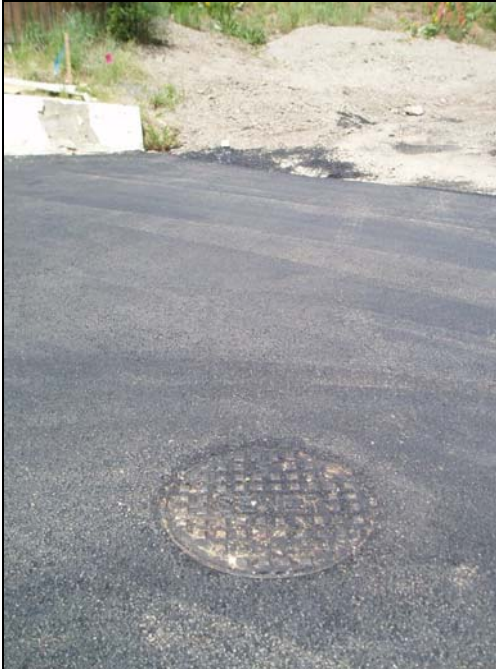
<p>7/8/11 – Photo 19 Upper Level Manhole #2</p> <p>Manhole cover is slightly above the level of asphalt and maybe damaged during snow removal.</p>	<p>BL</p>

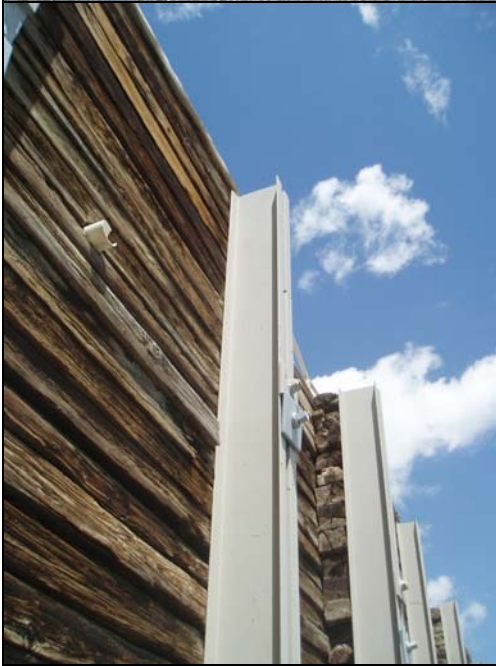
<p>7/8/11 – Photo 20 Upper Level Retaining Wall</p> <p>New soil nail plate is resting against an existing plate. BWA to relay to Mays Construction for comment.</p>	<p>BWA MC</p>
