**ARCHITECT'S FIELD REPORT****108**

PROJECT	<b>Eagle's Nest Townhouses</b> 11 Morning Glory Way & 31 Marcellina Lane Mt. Crested Butte, CO 81225	DATE	5/29/13
---------	--	------	---------

WORK OBSERVED	
Phase IV Construction	
TRADES PRESENT	
Holgate Construction Co.

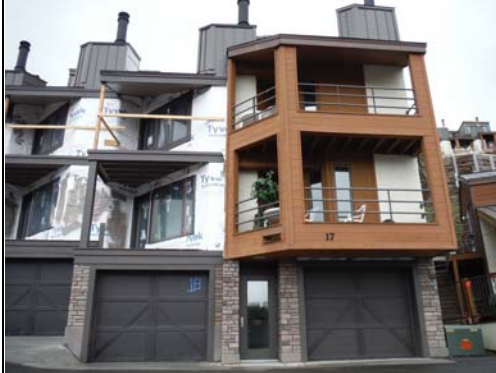
<p>5/29/13 – Photo 5 Unit 18</p> <p>2<sup>nd</sup> Floor Windows &amp; Doors Installed 2<sup>nd</sup> Floor Deck Installed 3<sup>rd</sup> Floor Window &amp; Door Trim Installed Fascia Trim Installed and Painted</p>	Note

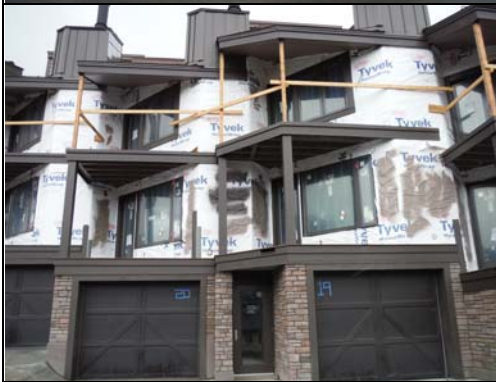
<p>5/29/13 – Photo 6 Units 19 &amp; 20</p> <p>2<sup>nd</sup> Floor Windows &amp; Doors Installed 2<sup>nd</sup> Floor Deck Installed 3<sup>rd</sup> Floor Window &amp; Door Trim Installed Fascia Trim Installed and Painted</p>	Note

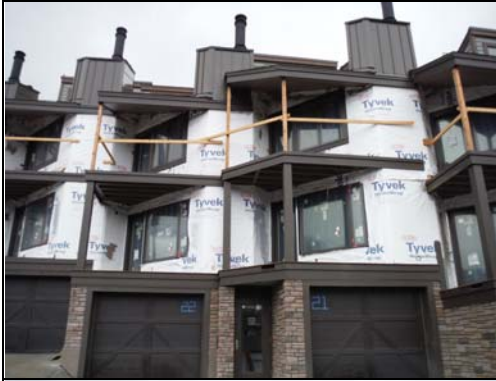
<p>5/29/13 – Photo 7 Units 21 &amp; 22</p> <p>2<sup>nd</sup> Floor Windows &amp; Doors Installed 2<sup>nd</sup> Floor Deck Installed 3<sup>rd</sup> Floor Window &amp; Door Trim Installed Fascia Trim Installed and Painted</p>	Note

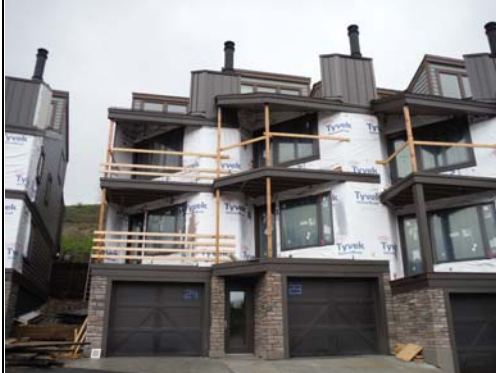
<p>5/29/13 – Photo 8 Units 23 &amp; 24</p> <p>2<sup>nd</sup> Floor Windows &amp; Doors Installed 3<sup>rd</sup> Floor Window &amp; Door Trim Installed Fascia Trim Installed and Painted</p>	Note

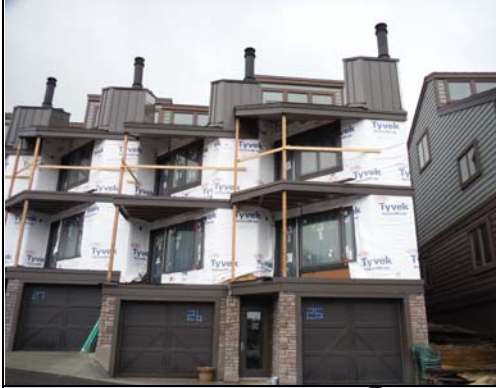
<p>5/29/13 – Photo 9 Units 25 &amp; 26</p> <p>2<sup>nd</sup> Floor Windows &amp; Doors Installed 3<sup>rd</sup> Floor Window &amp; Door Trim Installed Fascia Trim Installed and Painted</p>	Note

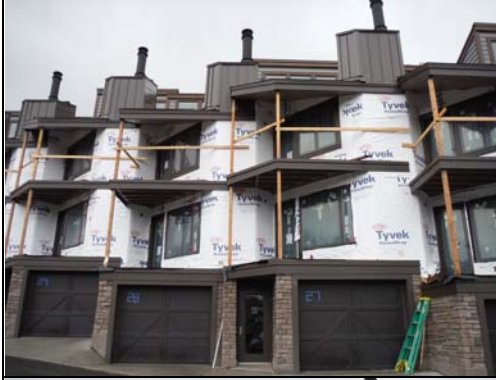
<p>5/29/13 – Photo 10 Units 27 &amp; 28</p> <p>2<sup>nd</sup> Floor Windows &amp; Doors Installed 3<sup>rd</sup> Floor Window &amp; Door Trim Installed Fascia Trim Installed and Painted</p>	Note

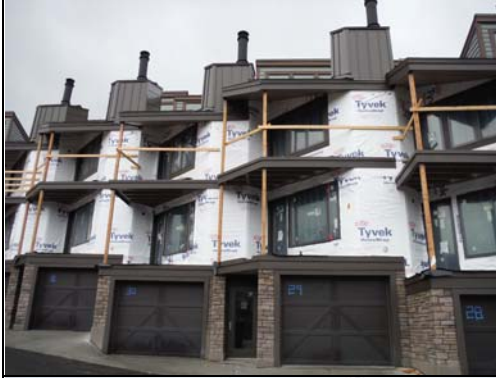
<p>5/29/13 – Photo 11 Units 29 &amp; 30</p> <p>2<sup>nd</sup> Floor Windows &amp; Doors Installed 3<sup>rd</sup> Floor Window &amp; Door Trim Installed Fascia Trim Installed and Painted</p>	Note

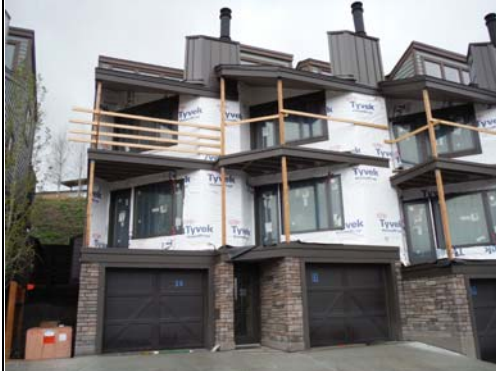
<p>5/29/13 – Photo 12 Units 31 &amp; 32</p> <p>2<sup>nd</sup> Floor Windows &amp; Doors Installed 3<sup>rd</sup> Floor Window &amp; Door Trim Installed Fascia Trim Installed and Painted</p>	Note

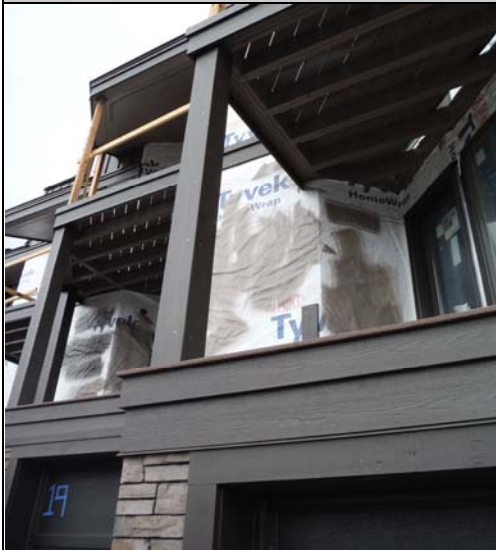
<p>5/29/13 – Photo 13 Unit 18 Detail</p> <p>Installed 2<sup>nd</sup> Floor Post Wrap.</p>	Note

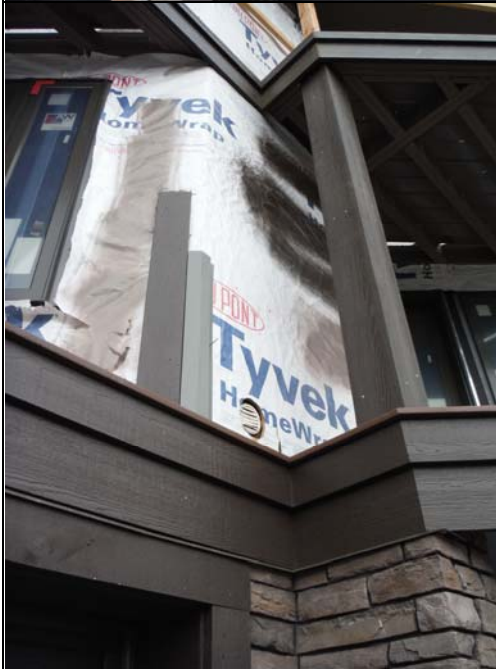
<p>5/29/13 – Photo 14 Unit 19</p> <p>Installed 2<sup>nd</sup> Floor Post Wrap.</p> <p>Guardrail trim and green corner trim (mock-up corner trim) are installed to the left.</p>	Note

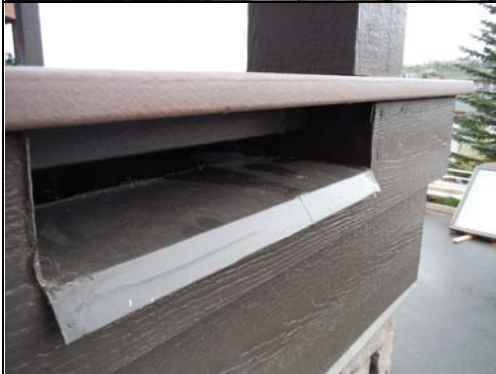
<p>5/29/13 – Photo 15 2<sup>nd</sup> Floor Deck Scupper Detail</p> <p>Scupper is draining water. The drip edge is clearing the stone veneer below.</p>	Note

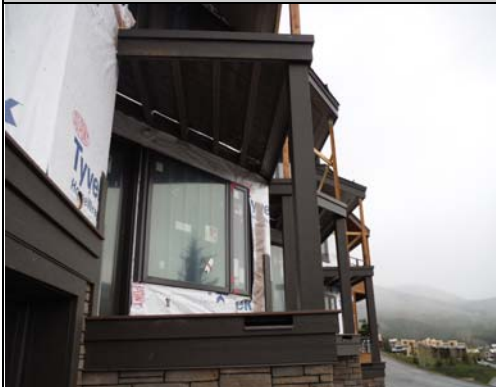
<p>5/29/13 – Photo 16 Unit 20 South Deck Elevation</p> <p>Post wrap is installed per the drawings.</p>	Note

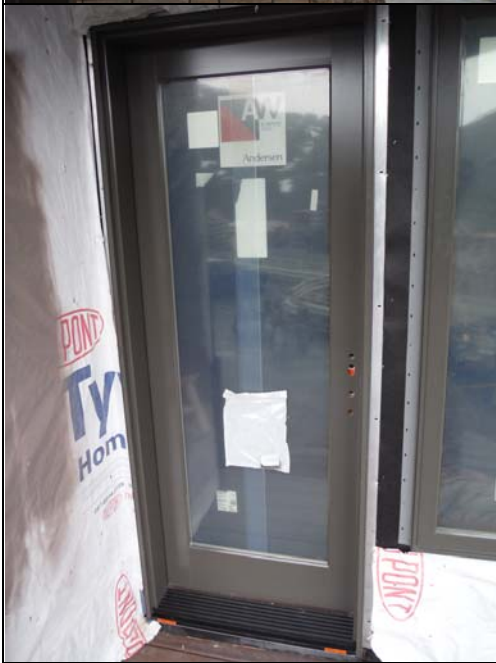
<p>5/29/13 – Photo 17 Unit 20</p> <p>Detail of the installed 2<sup>nd</sup> Floor Door.</p>	Note

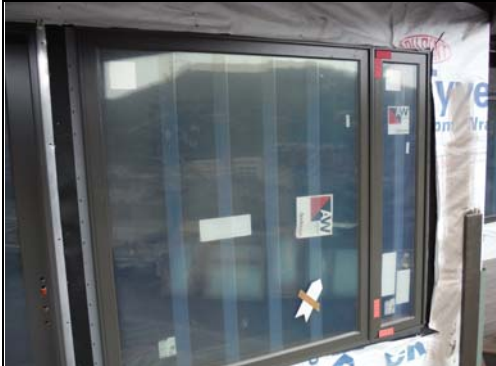
<p>5/29/13 – Photo 18 Unit 20</p> <p>Detail of the installed 2<sup>nd</sup> Floor Window.</p>	Note

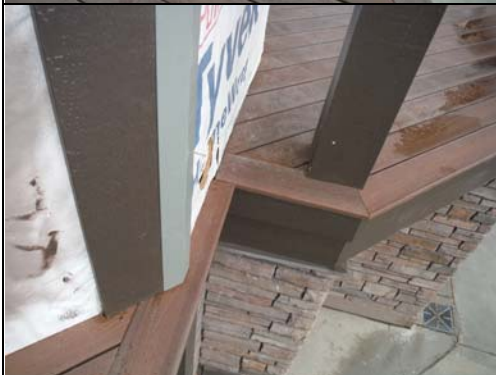
<p>5/29/13 – Photo 20 Unit 19 &amp; 20</p> <p>Detail of deck edge board extension and junction with adjacent deck.</p>	Note

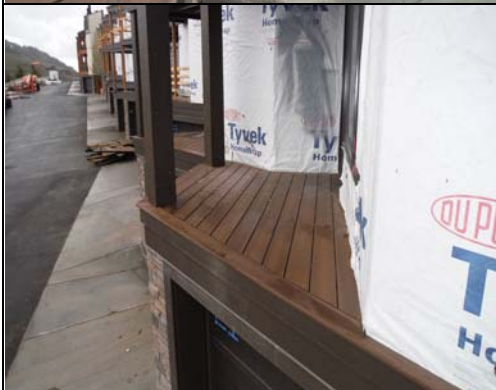
<p>5/29/13 – Photo 21 Unit 21</p> <p>View of adjacent deck. Note the edge board extension in the bottom right corner. This allows for a consistent look from the front.</p>	Note
 	<p>5/29/13 – Photo 22 Unit 20</p> <p>Detail of green corner trim at the deck.</p>	Note
