# ARCHITECT'S FIELD REPORT

<b>PROJECT</b>	<b>Eagle's Nest Townhouses</b> 11 Morning Glory Way & 31 Marcellina Lane Mt. Crested Butte, CO 81225	<b>DATE</b>	4/28/14
----------------	--	-------------	---------

WORK OBSERVED	
Existing West Window Condition	
TRADES PRESENT	
None

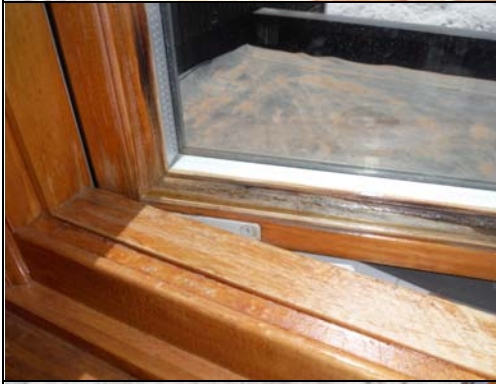
PHOTO –WORK ITEM	DESCRIPTION	ACTION
 	<p>4/25/13 – Photo 1 Unit 37, 4<sup>th</sup> Floor West Windows</p> <p>Outside frame edge. Note degraded condition of wood window stop. Finish has flaked off and wood is turning black.</p>	<p>Note</p>

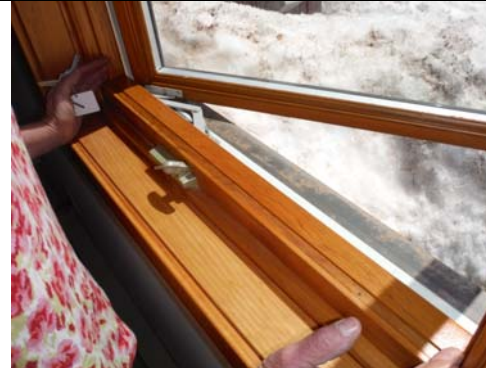
<p>4/25/13 – Photo 5 Unit 38, 3<sup>rd</sup> Floor West Windows</p> <p>Interior window frame after repair work.</p>	<p>Note</p>

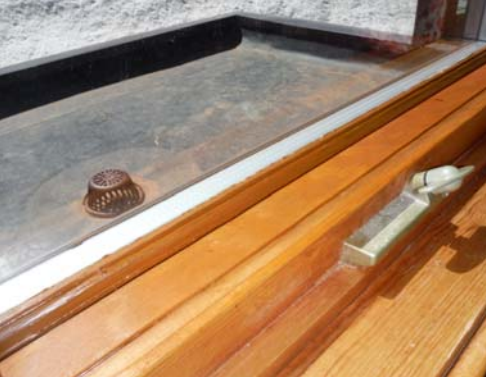
<p>4/25/13 – Photo 6 Unit 38, 4<sup>th</sup> Floor West Window</p> <p>Interior window frame after repair work.</p>	<p>Note</p>

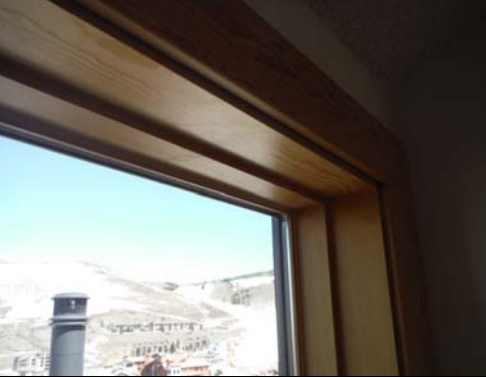
<p>4/25/13 – Photo 7 Unit 38, 4<sup>th</sup> Floor East Loft Windows</p> <p>Comparison photo of fixed loft windows. No degradation or condensation marks evident.</p>	<p>Note</p>

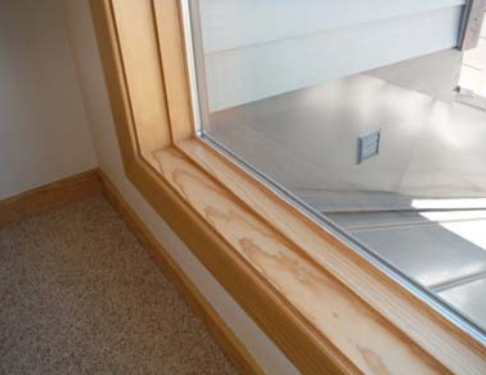
<p>4/25/13 – Photo 8 Unit 38, 4<sup>th</sup> Floor East Loft Windows</p> <p>Window sill detail. No water marks visible. Windows were installed during Phase I.</p>	<p>Note</p>
