ARCHITECT'S FIELD REPORT

082

PROJECT	Eagle's Nest Townhouses 11 Morning Glory Way & 31 Marcellina Lane Mt. Crested Butte, CO 81225	DATE	7/18/12
----------------	--	-------------	---------

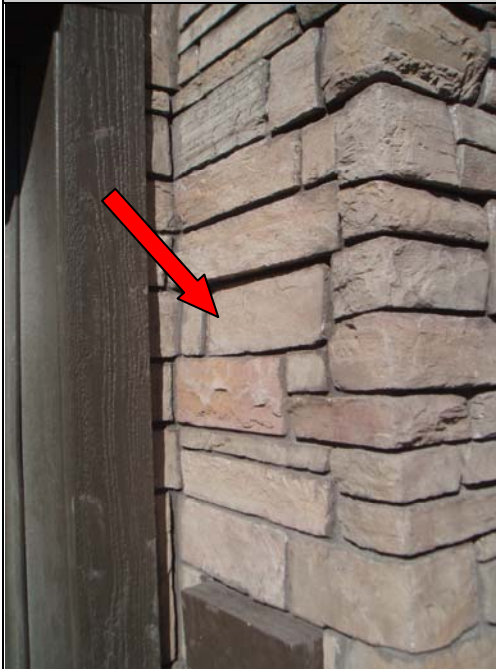
<p>7/18/12 – Photo 5 Unit 37</p> <p>Stone is recessed beyond project tolerances and will be removed and replaced.</p>	<p>Note</p>

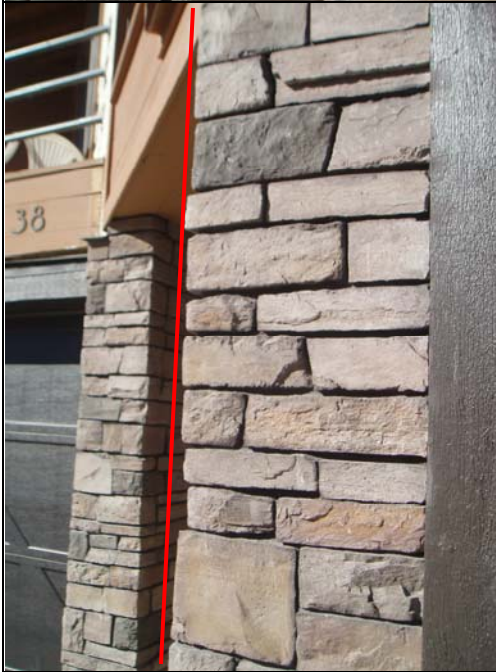
<p>7/18/12 – Photo 6 Unit 37</p> <p>Corner stone alignment is not within project tolerances. Stone in this area will be removed and replaced.</p> <p>Red line serves as a reference.</p>	<p>Note</p>

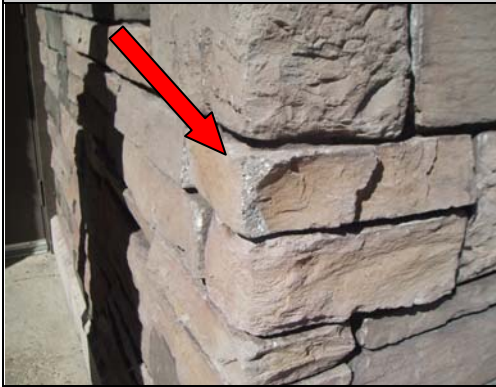
<p>7/18/12 – Photo 7 Unit 31</p> <p>Corner of manufactured stone has been clipped by the masons and will be replaced.</p>	<p>Note</p>

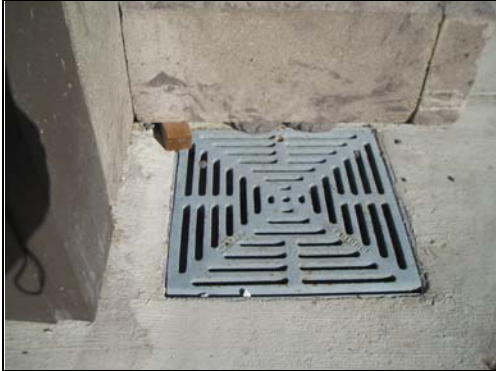
<p>7/18/12 – Photo 8 Unit 36 Area Drain</p> <p>Precast base is covering the lip of the area drain. MH is aware of the condition and working on a solution.</p>	<p>MHC</p>

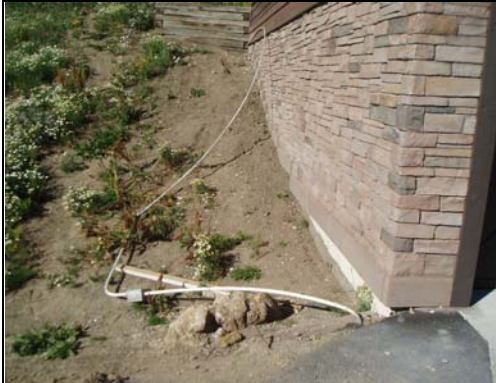
<p>7/18/12 – Photo 9 Unit 40 Electrical Conduit</p> <p>Electrical conduit will be buried adjacent to the foundation wall.</p>	<p>Note</p>

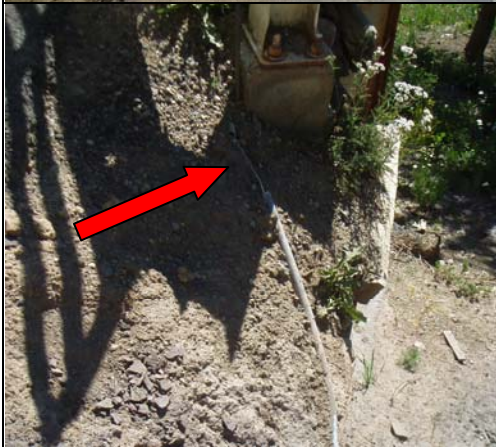
<p>7/18/12 – Photo 10 Lower Level, South Lot</p> <p>Conduit supplying power to light posts is damaged and electrical wires are exposed.</p>	<p>Note</p>

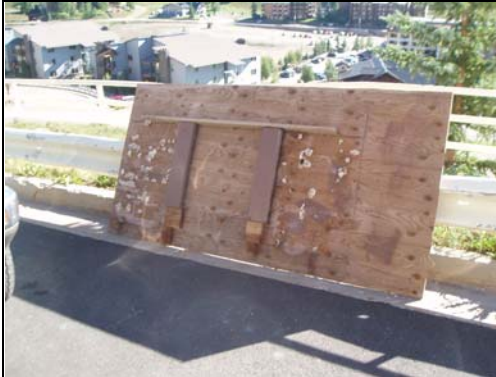
<p>7/18/12 – Photo 11 Lower Level</p> <p>Mock-up panel has been stripped and plywood will be removed.</p>	<p>MHC</p>

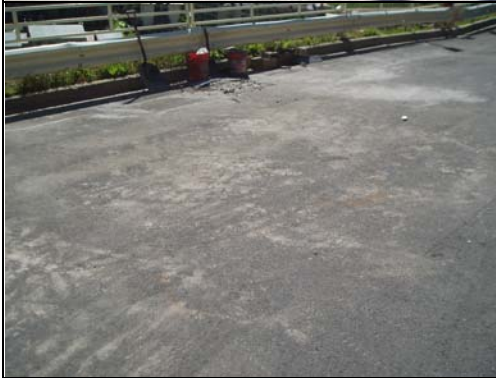
<p>7/18/12 – Photo 12 Lower Level Work Area</p> <p>Masonry dust will be power-washed. Additional tools and equipment will be removed.</p>	<p>MHC</p>
 	<p>7/18/12 – Photo 13 Phase II Construction Lower Level Asphalt Patch</p> <p>Lacy Construction is aware of this condition.</p>	<p>LC</p>

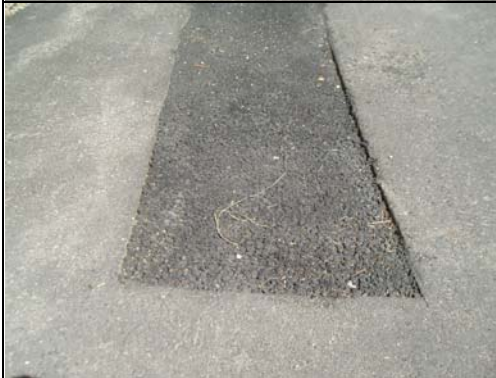
<p>7/18/12 – Photo 14 Phase II Construction Lower Level Asphalt Patch</p> <p>Lacy Construction is aware of this condition.</p>	<p>LC</p>

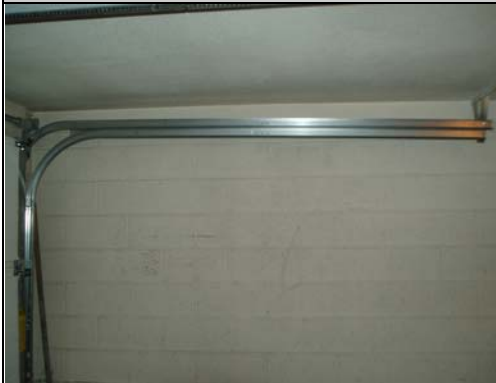
<p>7/18/12 – Photo 15 Garage Door Track</p> <p>Typical low-headroom track installation.</p> <p>Note track slopes to the back making manual operation difficult.</p>	<p>Note</p>

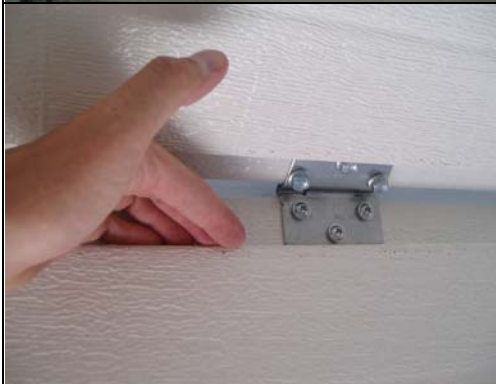
<p>7/18/12 – Photo 16 Garage Door Panel</p> <p>Slight lip at top of panel can serve as a handle although somewhat difficult to manipulate.</p>	<p>Note</p>

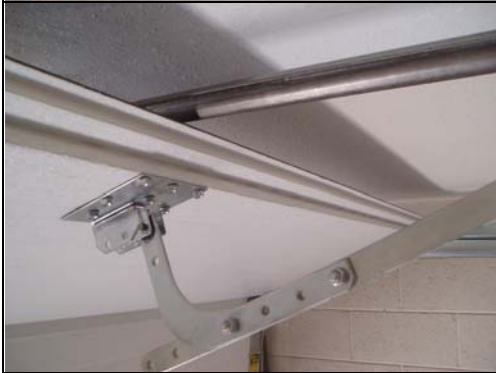
<p>7/18/12 – Photo 17 Garage Door in Up Position</p> <p>Note that top of panel occasional touches the drive arm on some of the older garage door openers. This is due to the 3-panel design of the new garage doors.</p>	<p>Note</p>

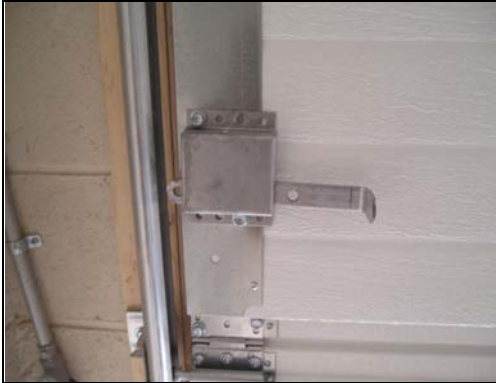
<p>7/18/12 – Photo 18 Garage Door – Cane Bolt Latch</p> <p>Cane bolt latch installed on doors without garage door openers. If the latch is accidentally left in the locked position, it can be bent when the garage door is closed.</p>	<p>Note</p>

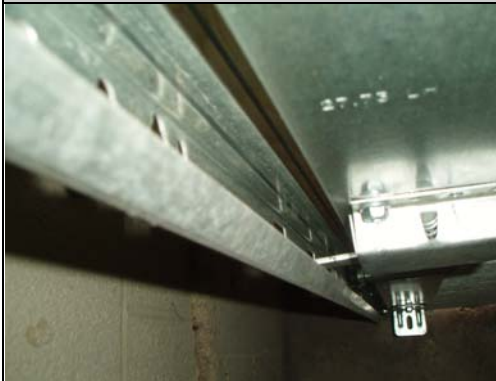
<p>7/18/12 – Photo 19 Garage Door – Cane Bolt Latch</p> <p>View from the top of the latch.</p> <p>Note latch no longer engages the frame to secure the door.</p>	<p>MHC</p>
 	<p>7/18/12 – Photo 20 Unit 28 Garage</p> <p>Garage being used as a storage area is generally well-kept and clean.</p>	<p>Note</p>
 	<p>7/18/12 – Photo 21 Upper Level Building 'A'</p> <p>Precast installation underway.</p>	<p>Note</p>
 	<p>7/18/12 – Photo 22 Upper Level Building 'A'</p> <p>Precast installation underway.</p> <p>Base is being cut for all 8 units.</p>	<p>Note</p>
