**ARCHITECT'S FIELD REPORT**

**020**

<b>PROJECT</b>	<b>Eagle's Nest Townhouses</b> 11 Morning Glory Way & 31 Marcellina Lane Mt. Crested Butte, CO 81225	<b>DATE</b>	10/13/10
----------------	--	-------------	----------

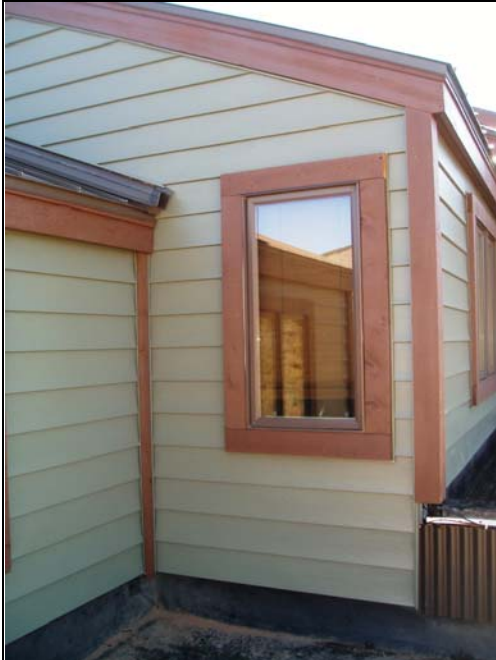
<p>10/13/10 – Photo 5 Unit 4</p> <p>Note window trim needs additional paint.</p>	<p>MHC</p>
 	<p>10/13/10 – Photo 6 Unit 6</p> <p>Window trim end needs paint.</p>	<p>MHC</p>
 	<p>10/13/10 – Photo 7 Unit 1</p> <p>Waterproofing membrane needs to be trimmed.</p>	<p>MHC</p>

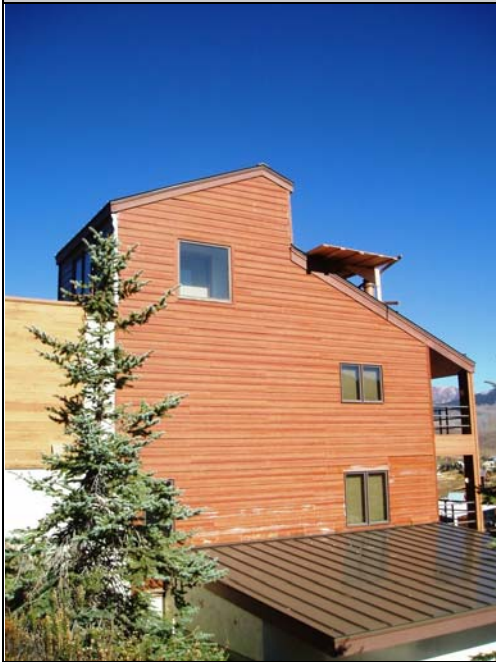
<p>10/13/10 – Photo 8 Unit 1, End View</p> <p>Platforms have been constructed for loft window replacement and residing.</p>	<p>None</p>

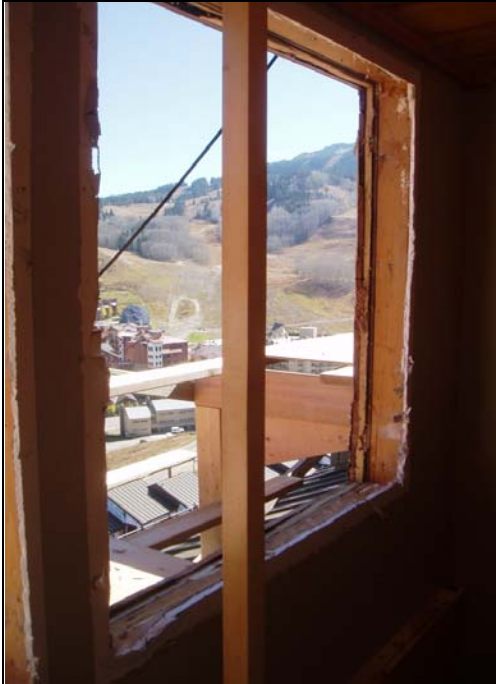
<p>10/13/10 – Photo 9 Unit 4, Interior from Loft</p> <p>Old windows have been removed. Sills appear to be in good condition.</p>	<p>None</p>

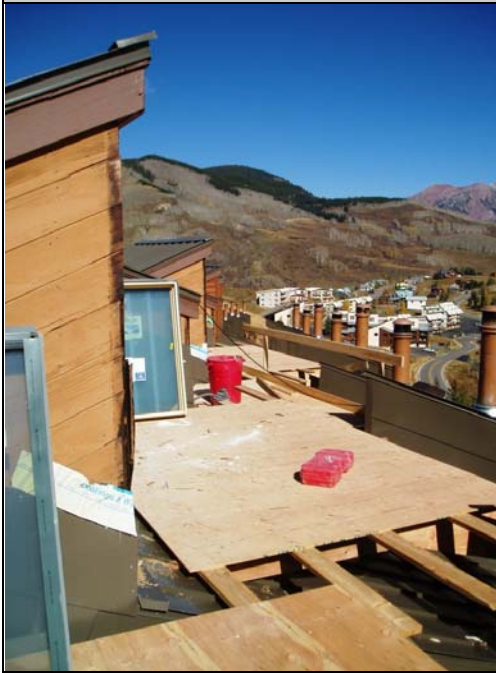
<p>10/13/10 – Photo 10 Unit 2 Looking North</p> <p>Temporary plywood platforms have been installed. Platform legs are padded to protect the new roof.</p>	<p>None</p>

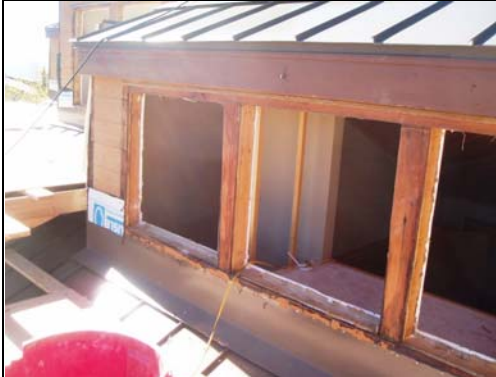
<p>10/13/10 – Photo 11 Unit 3</p> <p>Loft windows have been removed.</p>	<p>None</p>

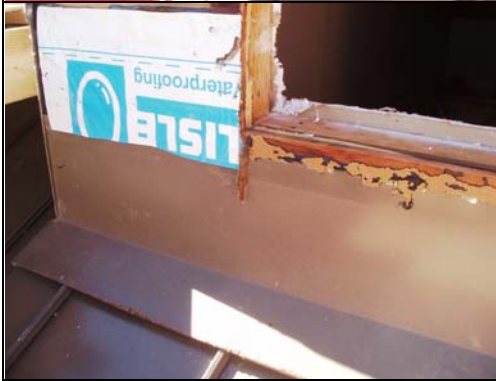
<p>10/13/10 – Photo 12 Unit 3, Sill Detail</p> <p>Note the window sills are in good condition. New metal roof flashing extends to the bottom of the window opening and will not be affected by construction.</p>	<p>None</p>

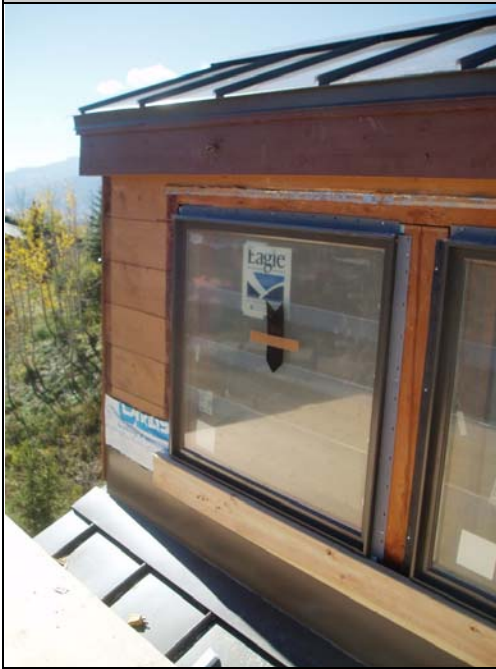
<p>10/13/10 – Photo 15 Unit 1, New Loft Windows</p> <p>Note Hardie siding has been removed. Due to existing roof flashing, the original siding will remain. A waterproof membrane will be installed under the new metal siding.</p>	<p>None</p>

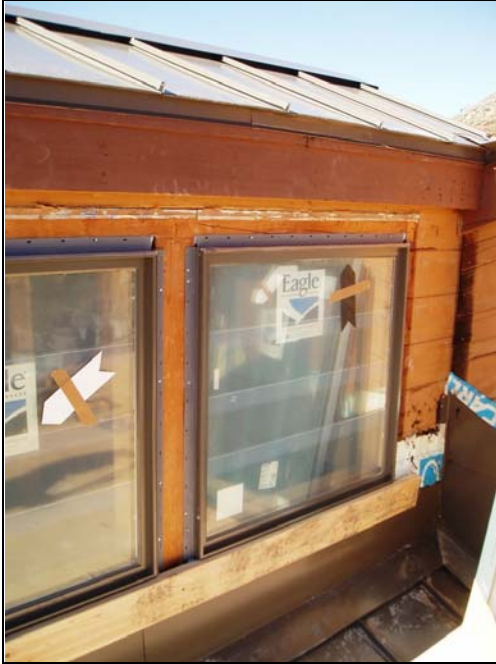
<p>10/13/10 – Photo 16 Unit 1, New Loft Windows</p> <p>Note the 2x6 bottom trim example.</p>	<p>None</p>
