**ARCHITECT'S FIELD REPORT**

**154**

<b>PROJECT</b>	<b>Eagle's Nest Townhouses</b> 11 Morning Glory Way & 31 Marcellina Lane Mt. Crested Butte, CO 81225	<b>DATE</b>	7/14/2015
		<b>REV</b>

<b>WORK OBSERVED</b>	
Phase V – Manager's Units Renovations	
<b>TRADES PRESENT</b>	
Holgate Construction

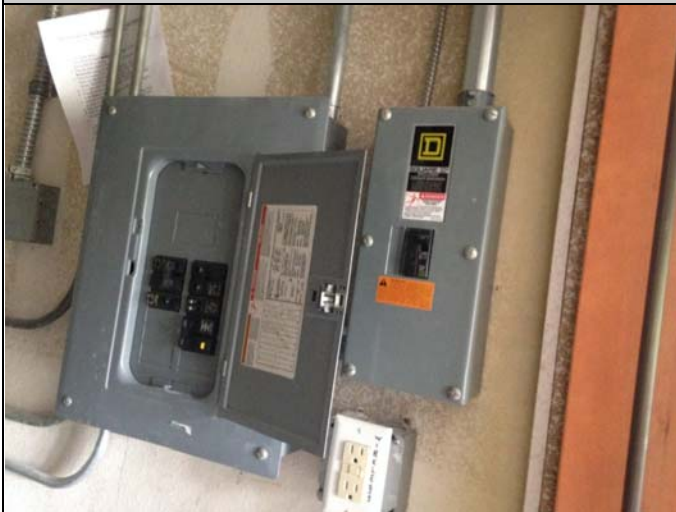
<p>7/14/15 – Photo 12 Lower Level Manager’s Unit</p> <p>Detail of electrical panel in the hot tub equipment room.</p>	<p>Note</p>

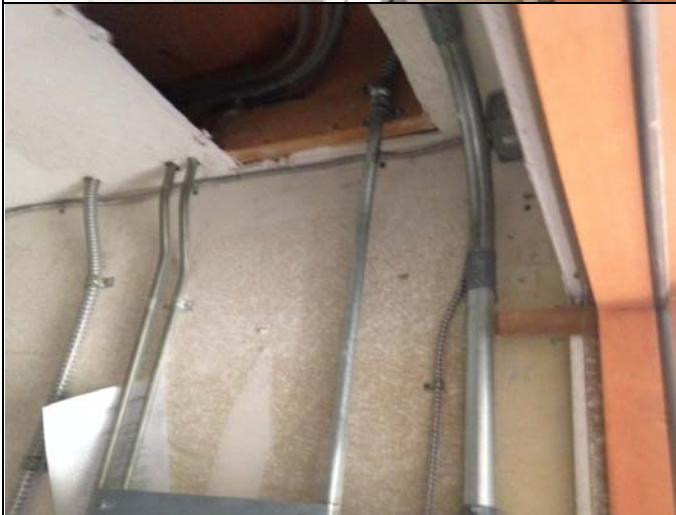
<p>7/14/15 – Photo 13 Lower Level Manager’s Unit</p> <p>Electrical panel, looking high. Access hole used to pull wire to the hot tub.</p>	<p>Note</p>

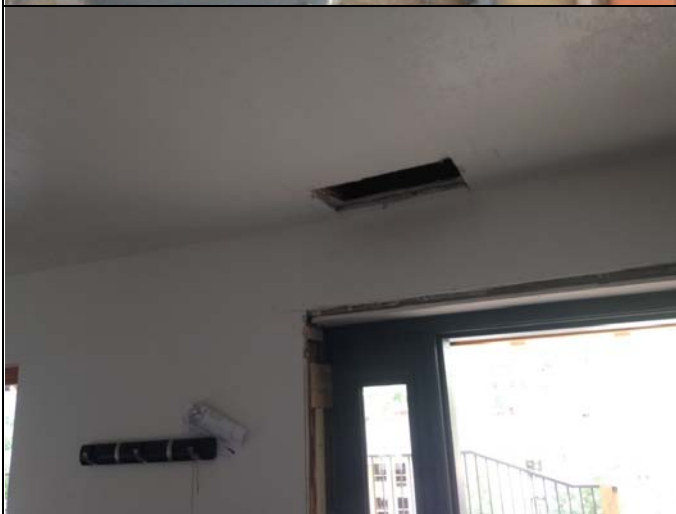
<p>7/14/15 – Photo 14 Lower Level Manager’s Unit</p> <p>Hole in ceiling used to pull the electrical wire.</p>	<p>Note</p>
