ARCHITECT'S FIELD REPORT

014

PROJECT **Eagle's Nest Townhouses** **DATE** 8/27/10
 11 Morning Glory Way & 31 Marcellina Lane
 Mt. Crested Butte, CO 81225

WORK OBSERVED
Phase I – Construction Field Report 06
TRADES PRESENT
Holgate Construction

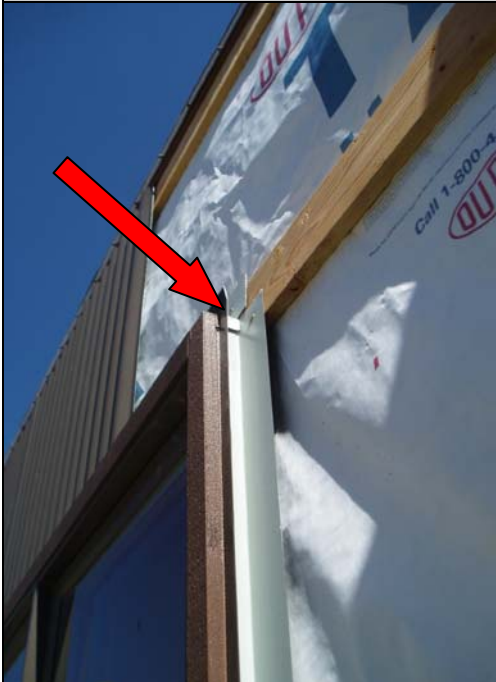
<p>8/25/10 – Photo 4 Unit 2 – Window Head Detail</p> <p>Installation of corrugated siding underway. Note “J” Channel install around window. At top corner, head channel is correctly lapped over the top of the jamb channel.</p>	<p>None</p>

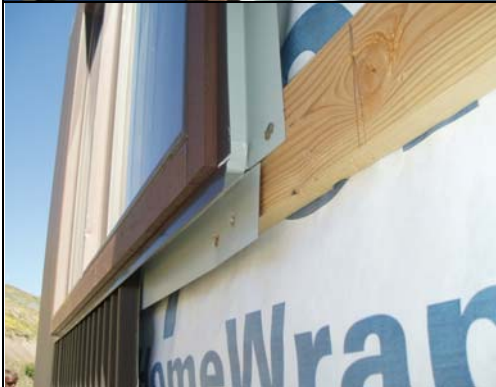
<p>8/25/10 – Photo 5 Unit 2 – Window Sill Detail</p> <p>Installation of corrugated siding at bottom of window.</p>	<p>None</p>

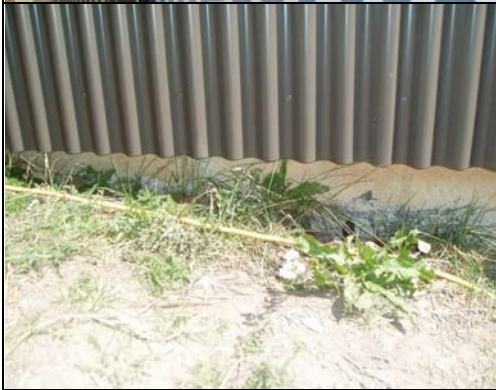
<p>8/25/10 – Photo 6 Unit 2 – Condition at Grade</p> <p>Metal siding extends past bottom of wall and is approximately 4 inches above grade. Metal Sales installation instructions state “To minimize corrosion, siding panels should not be installed all the way to the ground.”</p>	<p>None</p>

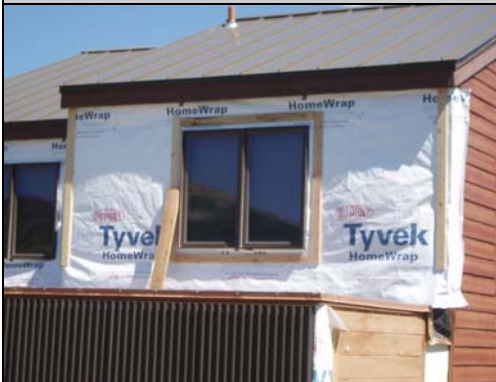
<p>8/25/10 – Photo 7 Unit 1 – 4th Floor</p> <p>Tyvek has been installed. Furring strips have been installed around the window to accommodate wood window trim and “J” channels.</p>	<p>None</p>

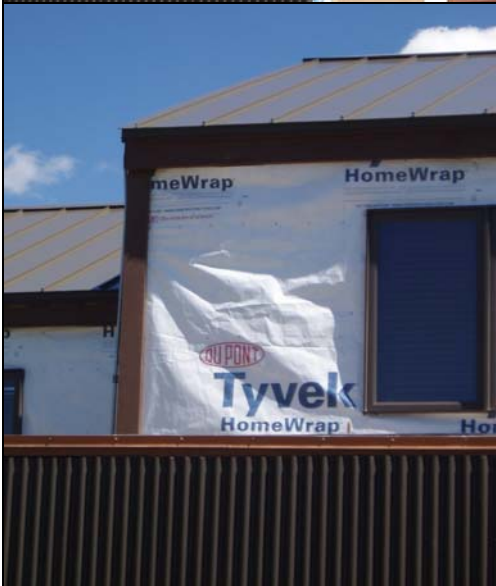
<p>8/25/10 – Photo 8 Unit 2 – 4th Floor</p> <p>Note the test wood corner piece installed on Unit 2.</p>	<p>None</p>

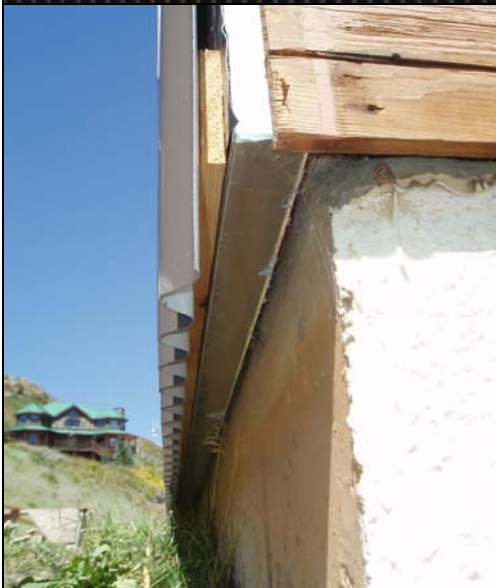
<p>8/25/10 – Photo 9 Unit 1 – Wall Assembly Detail</p> <p>View of the completed wall assembly on Unit 1. Note the 7/8” corrugated siding extends below the wall assembly – this will cover electrical conduit powering roof snow melt systems. Furring strip secures the bottom edge of the Grace Ultra to 1” of rigid insulation. Metal “L” shaped flashing protects the bottom of the insulation and existing gypsum board sheathing. (Not visible.) Existing siding on unit end awaits demolition.</p>	<p>None</p>

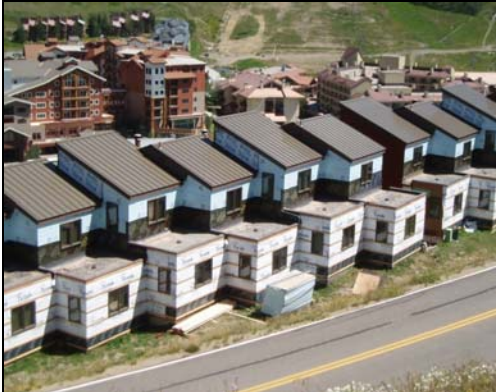
<p>8/25/10 – Photo 10 Units 28 through 32</p> <p>Grace Ice & Water Shield has been repaired on damaged units.</p>	<p>None</p>

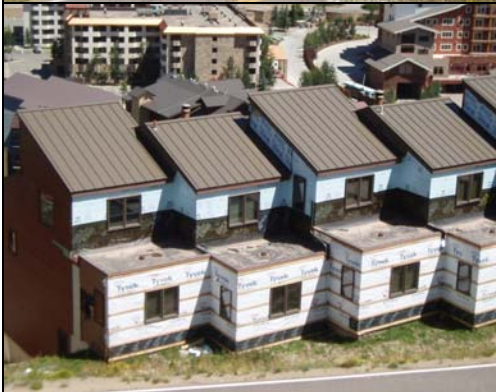
<p>8/25/10 – Photo 11 Unit 33</p> <p>Ice & Water Shield has been repaired.</p>	<p>None</p>

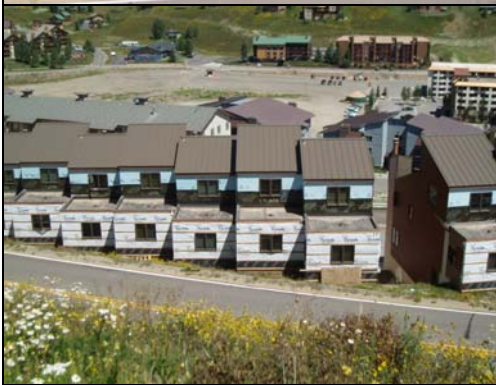
<p>8/25/10 – Photo 12 Lower Level Units 18 through 23</p> <p>Ice & Water Shield has been repaired.</p>	<p>None</p>
