ARCHITECT'S FIELD REPORT

086

PROJECT	Eagle's Nest Townhouses 11 Morning Glory Way & 31 Marcellina Lane Mt. Crested Butte, CO 81225	DATE	8/21/12
----------------	--	-------------	---------

WORK OBSERVED	
Phase III Construction – Stone Installation; Electrical Meter Covers	
TRADES PRESENT	
Holgate Construction

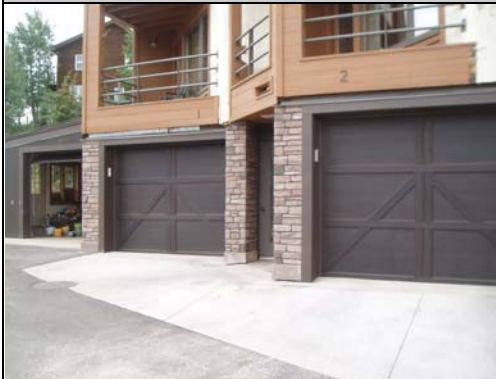
<p>8/21/12 – Photo 1 Upper Level Units 1 & 2</p> <p>Stone installation is complete on Building 'A' with the exception of the north wall of Unit 8.</p>	<p>Note</p>

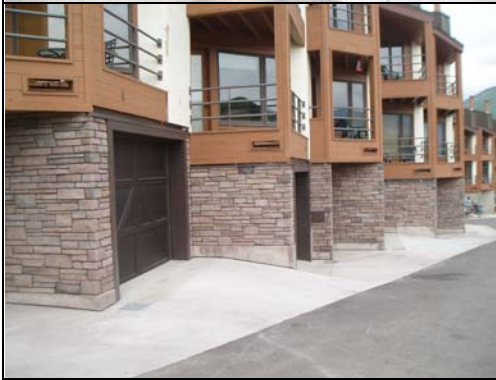
<p>8/21/12 – Photo 2 Upper Level, Units 4, 5, 6, 7 & 8</p> <p>Stone installation complete. Awaiting cleaning.</p>	<p>Note</p>

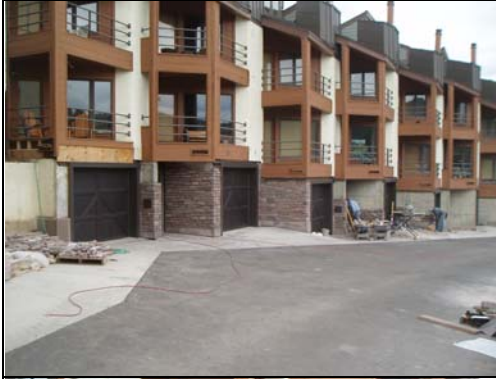
<p>8/21/12 – Photo 3 Upper Level, Units 9, 10, 11 & 12</p> <p>Stone installation underway on Building 'B'</p>	<p>Note</p>

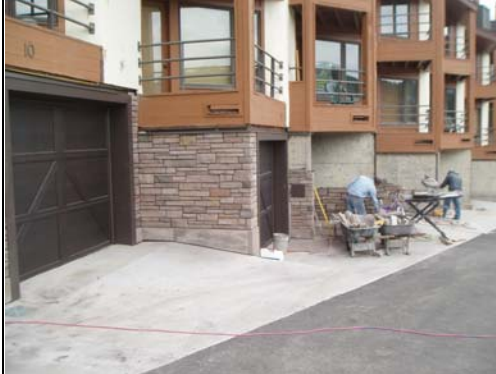
<p>8/21/12 – Photo 4 Units 11 & 12</p> <p>Masons working on Units 12 & 13.</p>	<p>Note</p>

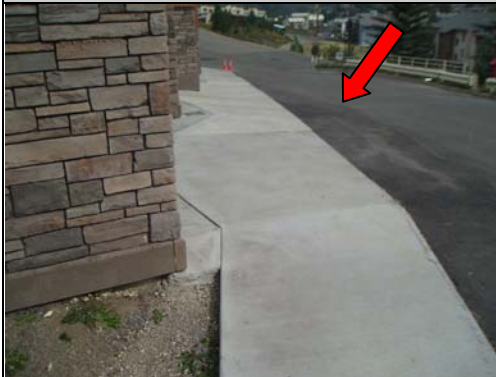
<p>8/21/12 – Photo 21 Unit 23 Side Yard to Asphalt Leak</p> <p>Note: The red arrow indicates the area of the asphalt leak</p>	<p>Note</p>

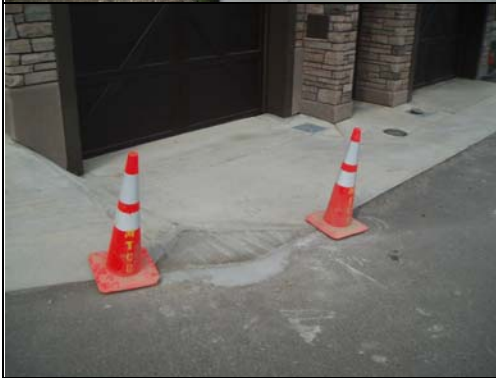
<p>8/21/12 – Photo 22 Unit 18 Concrete Repair</p> <p>Area of concrete repair.</p>	<p>Note</p>

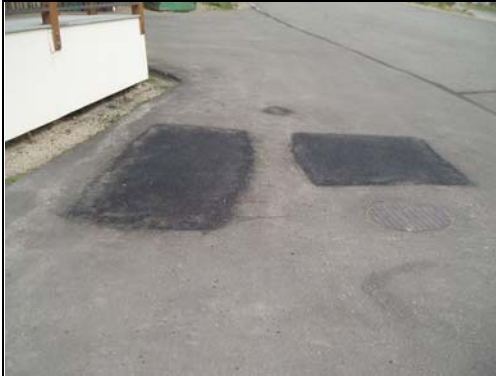
<p>8/21/12 – Photo 23 Lower Level Service Unit Asphalt Patches</p> <p>Asphalt patches are complete. It appears that the 3rd divot has been filled as well.</p>	<p>Note</p>

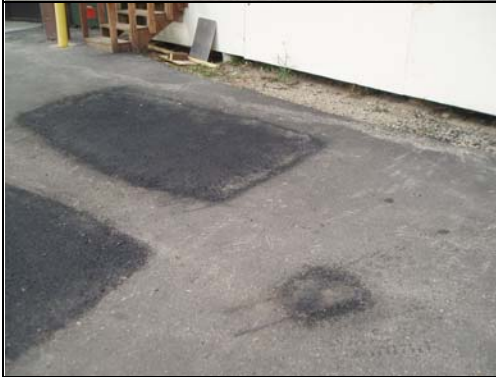
<p>8/21/12 – Photo 24 Lower Level Service Unit Asphalt Patches</p> <p>Asphalt patches looking south.</p>	<p>Note</p>
