ARCHITECT'S FIELD REPORT

098

| PROJECT | Eagle's Nest Townhouses 11 Morning Glory Way & 31 Marcellina Lane Mt. Crested Butte, CO 81225 | DATE | 1/25/13 |

| WORK OBSERVED | |
|---|--|
| Sloped Roofs on Units 17 & 18 | |

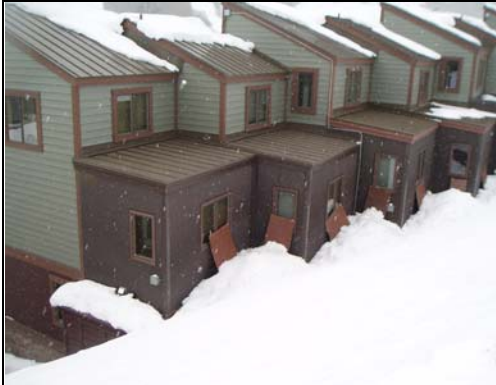
| PHOTO –WORK ITEM | DESCRIPTION | ACTION |
|---|---|---|
| | <p>1/24/13 – Photo 1 Completed Roofs on Units 17 & 18</p> <p>Roofs appear to be covered with standing seam metal roofs in a color consistent with adjacent roofs.</p> | Note |

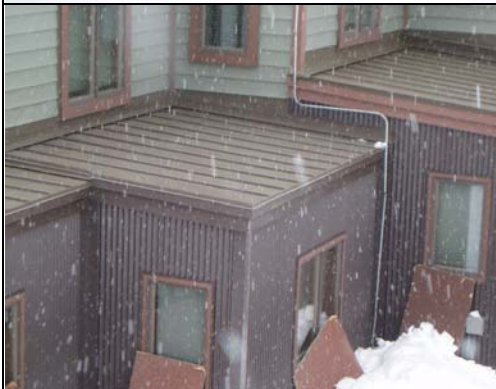
| PHOTO –WORK ITEM | DESCRIPTION | ACTION |
|---|---|---|
| | <p>1/24/13 – Photo 2 Detail of Roof at Unit 18</p> <p>Wood Fascia appears to be sized consistent with work on Units 19 & 20. Paint color is the new “ENT Brown”.</p> | Note |

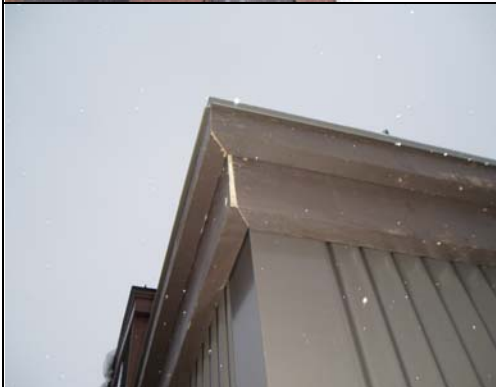
| PHOTO –WORK ITEM | DESCRIPTION | ACTION |
|---|---|---|
| | <p>1/24/13 – Photo 3 Detail of Unit 18 Corner Condition</p> <p>Corner detail could use touch-up paint. Wood was likely painted prior to installation.</p> | Note |

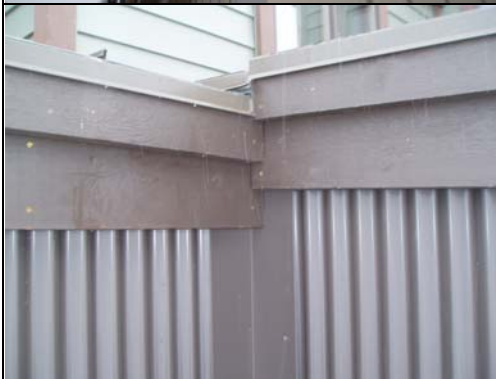
| PHOTO –WORK ITEM | DESCRIPTION | ACTION |
|---|---|---|
| | <p>1/24/13 – Photo 4 Detail of Corner Condition</p> <p>Roof junction condition differs slightly from Units 19 & 20.</p> | Note |

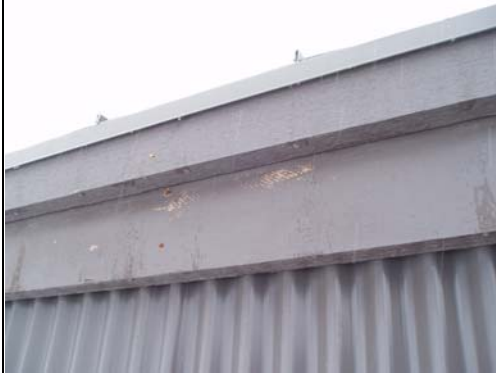
| PHOTO –WORK ITEM | DESCRIPTION | ACTION |
|--|---|---|
| | <p>1/24/13 – Photo 5 Detail of Fascia Condition</p> <p>Fascia wood could use slight touch-up paint.</p> | Note |

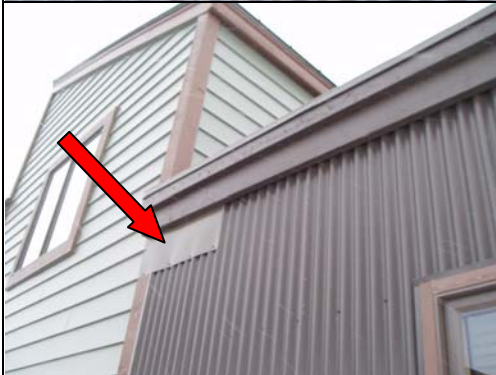
| PHOTO –WORK ITEM | DESCRIPTION | ACTION |
|--|---|---|
| | <p>1/24/13 – Photo 6 Detail of Over-Flow Scupper</p> <p>Metal siding at the abandoned over-flow scupper was not detailed or discussed. Recommend infilling this area with a new piece of corrugated siding.</p> | Note |
