ARCHITECT'S FIELD REPORT

PROJECT	Eagle's Nest Townhouses 11 Morning Glory Way & 31 Marcellina Lane Mt. Crested Butte, CO 81225	DATE	5/14/14
----------------	--	-------------	---------

WORK OBSERVED	
Radon Mitigation, Building A Units 1-8	
TRADES PRESENT	
None

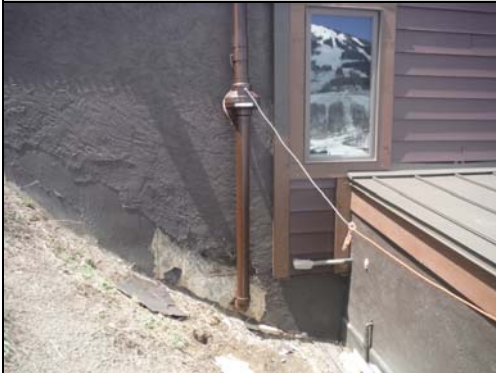
<p>5/14/13 – Photo 1 North Elevation, Unit 1</p> <p>Radon vent and fan on the exterior.</p>	<p>Note</p>

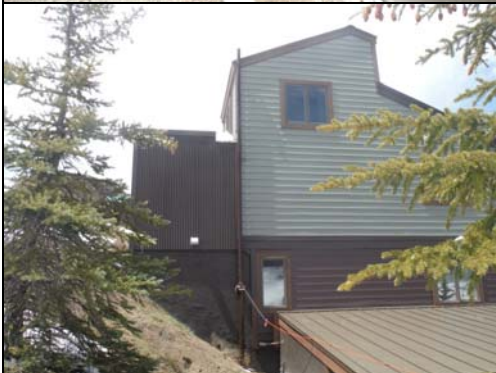
<p>5/14/13 – Photo 2 North Elevation, Unit 1</p> <p>Radon vent extended above the roof line. Vent runs along the rear trim line.</p>	<p>Note</p>

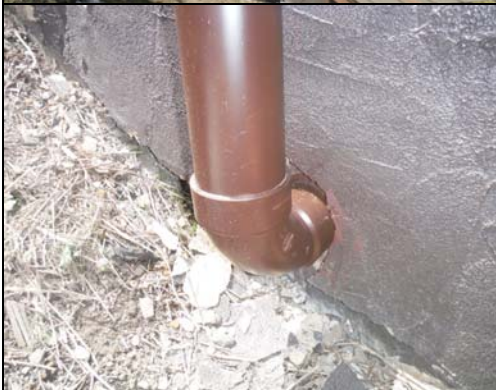
<p>5/14/13 – Photo 3 North Elevation, Unit #1</p> <p>Pipe penetration on the exterior wall.</p>	<p>Note</p>

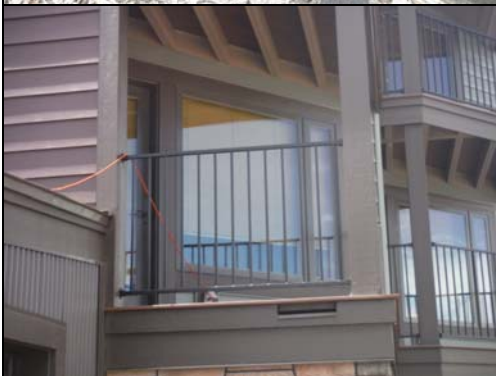
<p>5/14/13 – Photo 4 Unit #1</p> <p>Temporary electrical connection to the outlet on Unit #1.</p>	<p>Note</p>

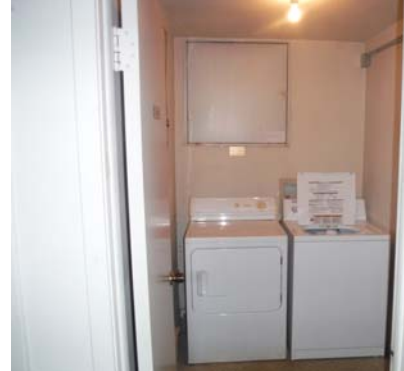
<p>5/14/13 – Photo 5 Unit #1 Laundry Room</p> <p>Laundry Room and Garage are clean. No sign of construction debris.</p>	<p>Note</p>

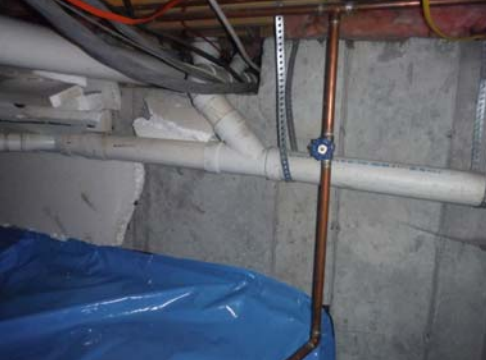
<p>5/14/13 – Photo 6 Unit #1 Looking North</p> <p>Radon Pipe runs horizontally in the upper left corner. Membrane barrier has been installed and sealed to the concrete stem wall.</p>	<p>Note</p>

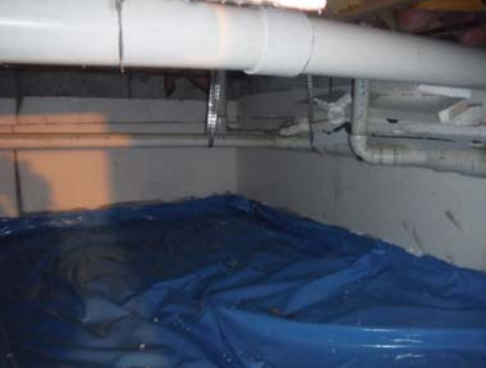
<p>5/14/13 – Photo 7 Unit #1 Looking Northwest</p> <p>Membrane barrier installed over the exposed soil in the crawlspace.</p>	<p>Note</p>

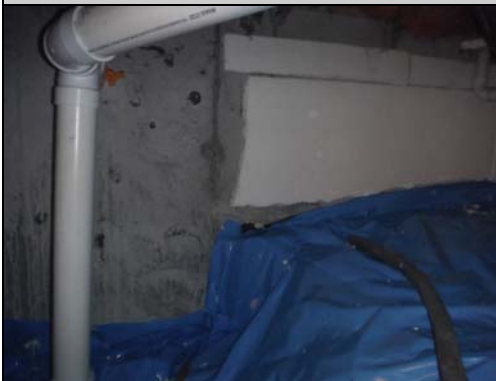
<p>5/14/13 – Photo 9 Unit #1 Looking South</p> <p>Membrane installed around the perimeter of the crawlspace. Black pipe in the foreground is the water supply.</p>	<p>Note</p>

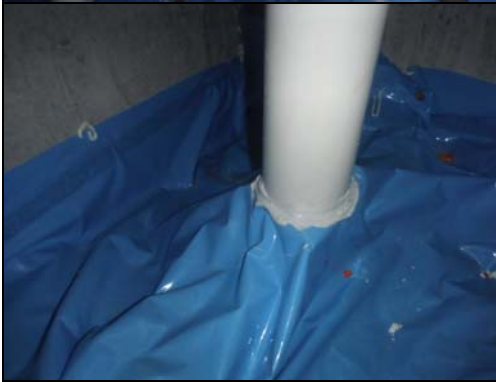
<p>5/14/13 – Photo 10 Unit #1, Soil Gas Pipe</p> <p>Pipe has been sealed at the junction with the membrane barrier.</p>	<p>Note</p>

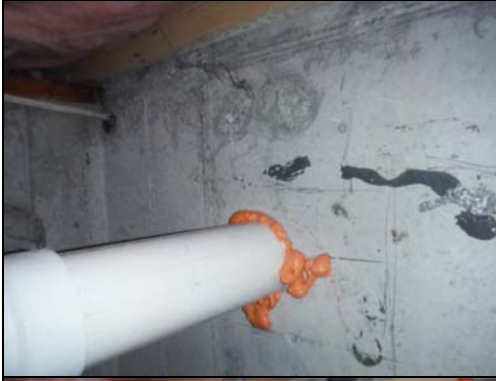
<p>5/14/13 – Photo 11 Unit #1, Exterior Discharge</p> <p>Pipe discharge location is 12” below the wood sill plate and above grade. Space around the pipe has been sealed with expanding foam insulation.</p>	<p>Note</p>

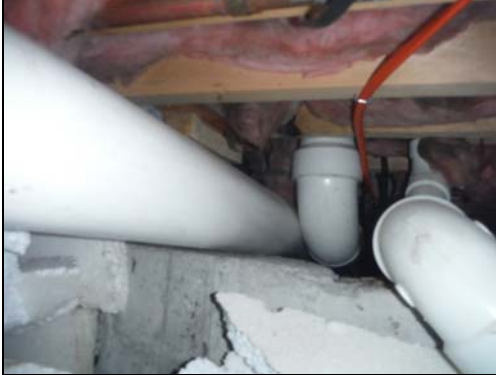
<p>5/14/13 – Photo 12 Unit #1, Pipe Path</p> <p>Radon pipe (on left) extends through an existing opening in the foundation.</p>	<p>Note</p>

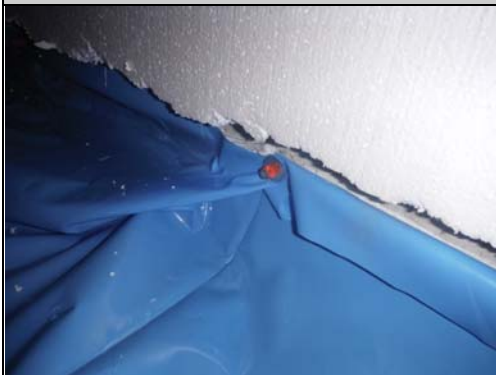
<p>5/14/13 – Photo 13 Unit #1, Radon Barrier</p> <p>Detail of the membrane to wall attachment. The perimeter is sealed with a bead of caulk and intermittently attached with a red-head nail.</p>	<p>Note</p>

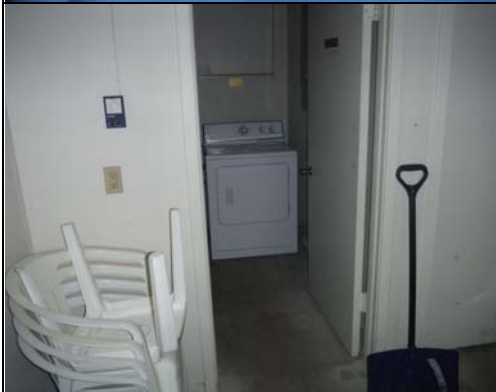
<p>5/14/13 – Photo 14 Unit #2 Laundry Room</p> <p>Laundry Room and Garage are clean. No sign of construction debris.</p>	<p>Note</p>

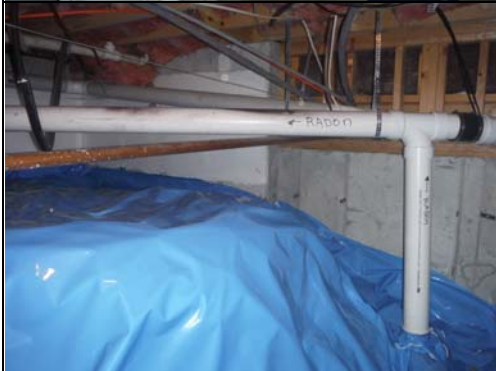
<p>5/14/13 – Photo 15 Unit #2 Looking North</p> <p>Membrane is installed and vent pipes are in place.</p>	<p>Note</p>

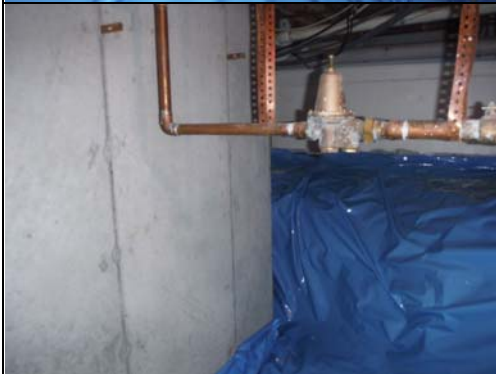
<p>5/14/13 – Photo 16 Unit #2 Looking West</p> <p>Membrane follows the slope of the crawlspace floor.</p>	<p>Note</p>

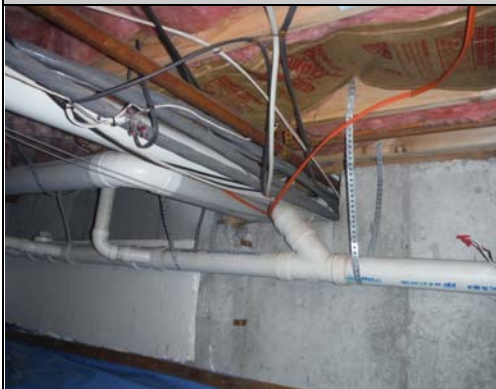
<p>5/14/13 – Photo 25 Unit #3, Pipe Chase</p> <p>Vent pipe extends through an existing pipe chase.</p>	<p>Note</p>

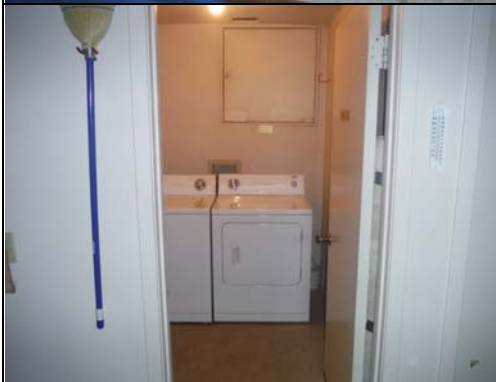
<p>5/14/13 – Photo 26 Unit #4 Laundry Room</p> <p>Laundry Room and Garage are clean. No sign of construction debris.</p>	<p>Note</p>

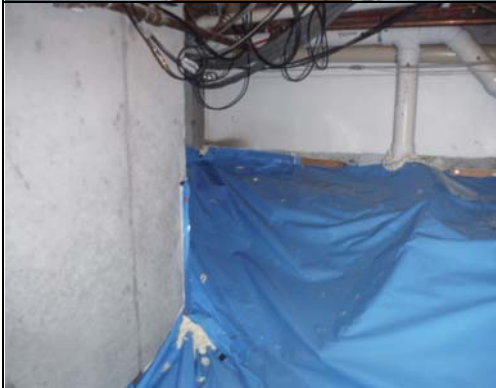
<p>5/14/13 – Photo 27 Unit #4 Looking West</p> <p>Membrane barrier follows the contours of the crawlspace.</p>	<p>Note</p>

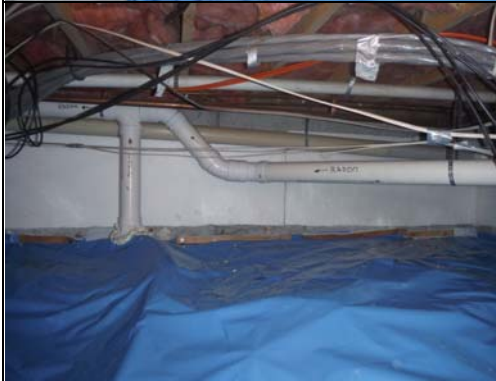
<p>5/14/13 – Photo 28 Unit #4 Looking Northwest</p> <p>Soil gas pipe is to the left.</p>	<p>Note</p>

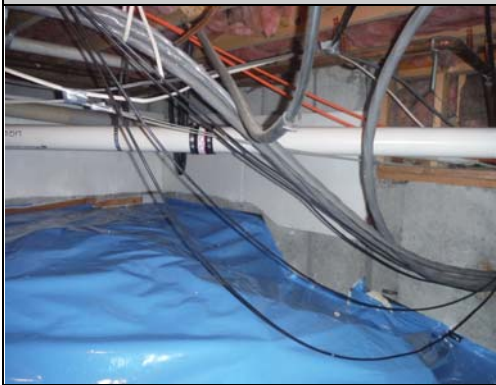
<p>5/14/13 – Photo 29 Unit #4, Looking Northwest</p> <p>Membrane barrier is sealed to the foundation wall.</p>	<p>Note</p>

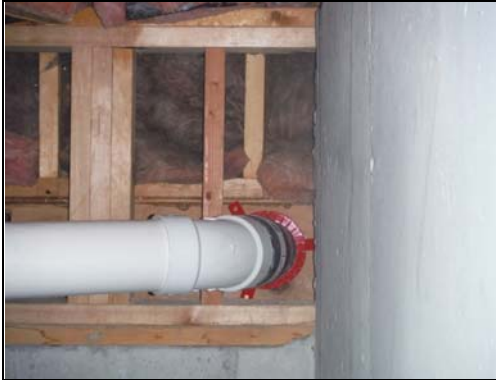
<p>5/14/13 – Photo 30 Unit #4, Pipe Penetration</p> <p>Metacaulk fire collar has been installed at the pipe penetration.</p>	<p>Note</p>

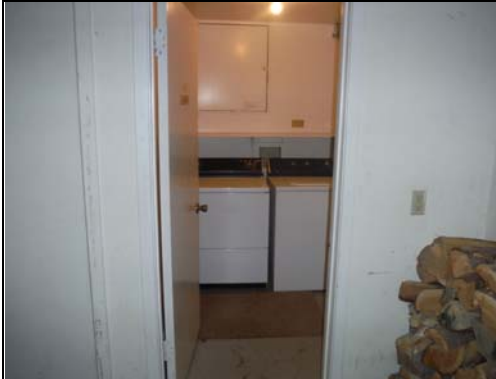
<p>5/14/13 – Photo 31 Unit #1 Laundry Room</p> <p>Laundry Room and Garage are clean. No sign of construction debris.</p>	<p>Note</p>

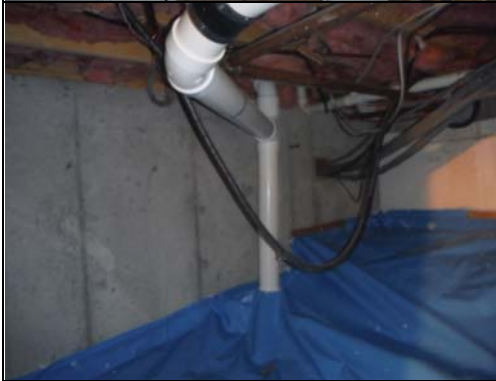
<p>5/14/13 – Photo 32 Unit #5 Looking South</p> <p>Detail of the soil gas pipe.</p>	<p>Note</p>

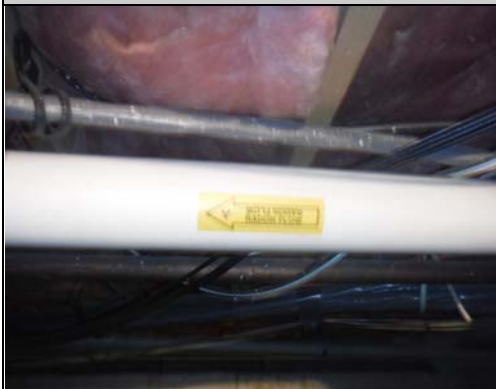
<p>5/14/13 – Photo 33 Unit #5 Pipe Identification</p> <p>Pipes have been labeled as “Radon”.</p>	<p>Note</p>

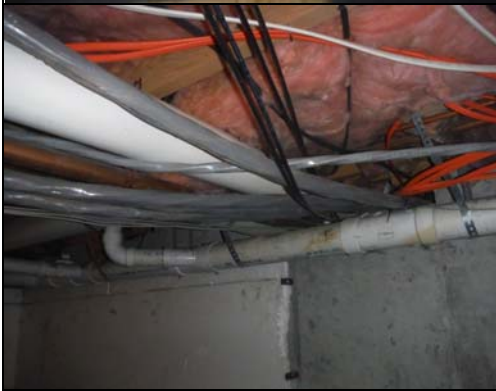
<p>5/14/13 – Photo 34 Unit #5 Looking North</p> <p>Vent pipe extends to Unit #6.</p>	<p>Note</p>

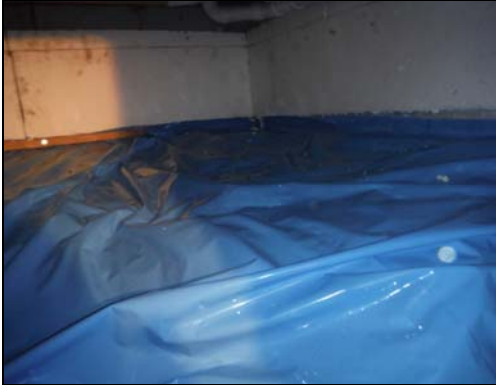
<p>5/14/13 – Photo 35 Unit #5 Looking Northwest</p> <p>Membrane barrier is in place.</p>	<p>Note</p>
