**ARCHITECT'S FIELD REPORT**

**028**

<b>PROJECT</b>	<b>Eagle's Nest Townhouses</b> 11 Morning Glory Way & 31 Marcellina Lane Mt. Crested Butte, CO 81225	<b>DATE</b>	1/5/11
----------------	--	-------------	--------

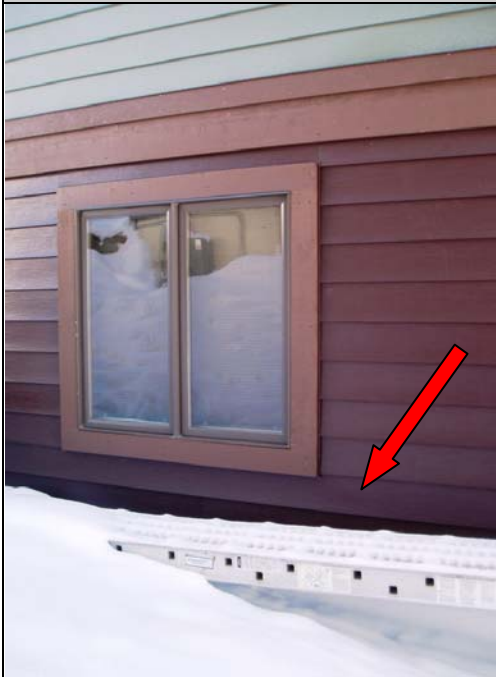
<p>1/5/11 – Photo 6 Units 9 End Elevation</p> <p>2<sup>nd</sup> Floor window trim. Note: siding at the bottom of window is a full course. Photo 7 shows Unit 8 for comparison.</p>	<p>None</p>

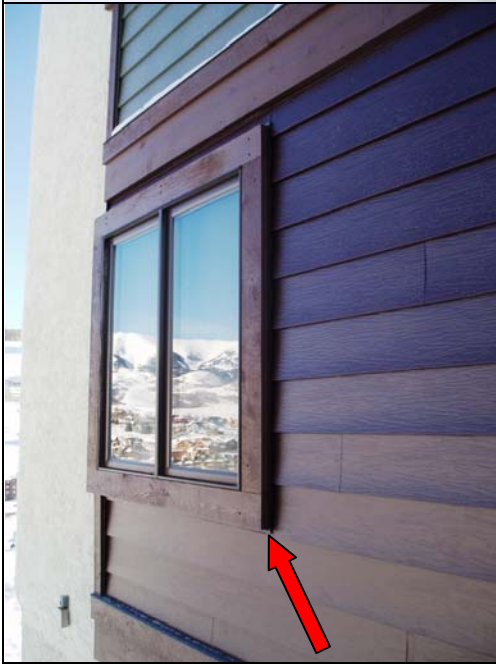
<p>1/5/11 – Photo 7 Unit 8 Comparison Photo</p> <p>Mick has adjusted coursing to allow for a full course below the window trim.</p>	<p>None</p>

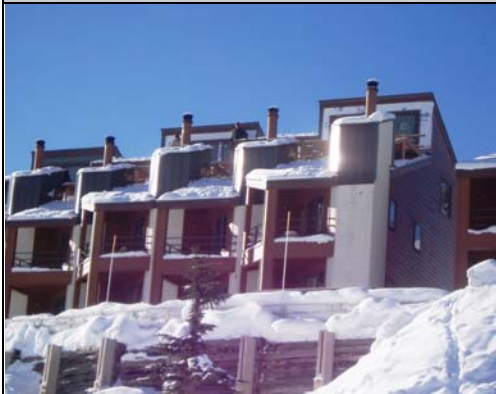
<p>1/5/11 – Photo 8 Units 33 through 36</p> <p>Loft window replacement and trim work complete. Siding will be installed today and the scaffolding moved tomorrow.</p>	<p>None</p>

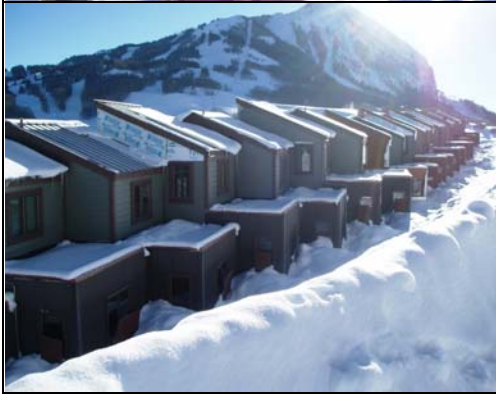
<p>1/5/11 – Photo 9 Lower Level Units from Unit 17</p> <p>Snow has been removed since 12/22/10. Gable ends will be completed in sequence with the loft window work.</p>	<p>None</p>

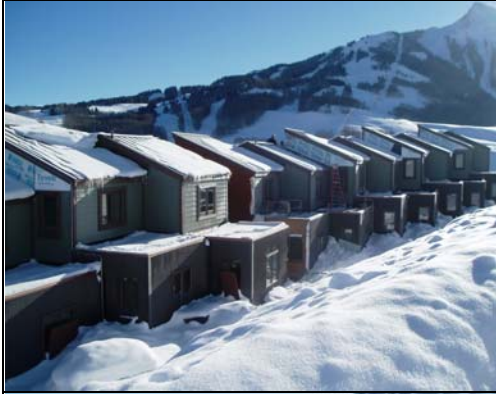
<p>1/5/11 – Photo 10 Lower Level Units from Unit 31</p> <p>Snow is approximately 5 feet deep behind the units</p>	<p>None</p>

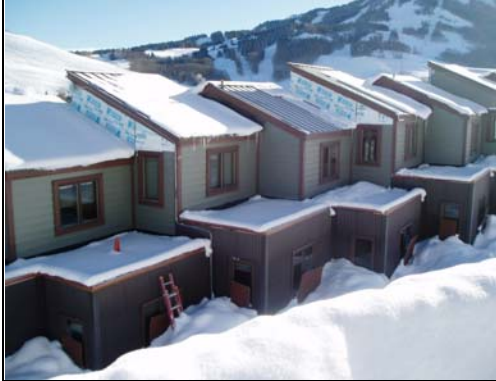
<p>1/5/11 – Photo 11 Units 26 through 30</p> <p>Note: Roof snow against exposed waterproofing is minimal.</p>	<p>None</p>

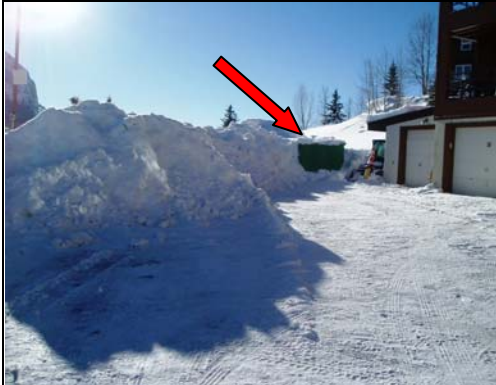
<p>1/5/11 – Photo 16 Upper Level Work Area</p> <p>Dumpster is still on site awaiting removal.</p>	<p>None</p>

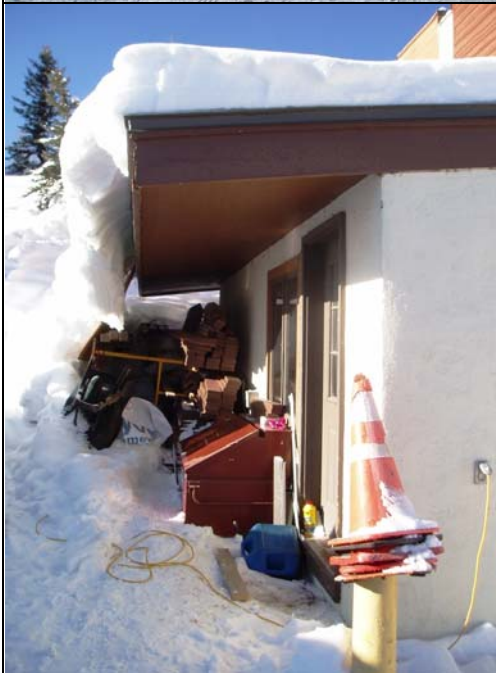
<p>1/5/11 – Photo 17 Upper Level Work Area</p> <p>Tools and trim are stored out of the way and under the overhang.</p>	<p>None</p>
