ARCHITECT'S FIELD REPORT

005

PROJECT **Eagle's Nest Townhouses** **DATE** 4/16/10
 11 Morning Glory Way & 31 Marcellina Lane
 Mt. Crested Butte, CO 81225

WORK OBSERVED
Observations of moisture in crawlspaces – week number 2.
TRADES PRESENT
None.

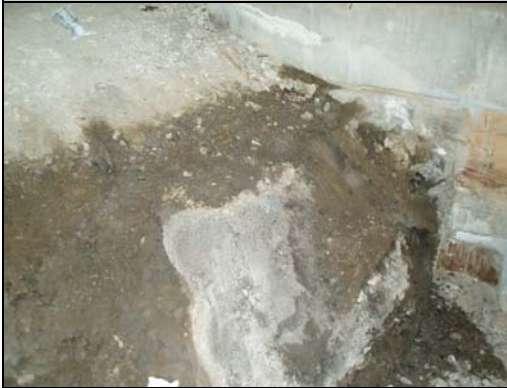
<p>4/15/10 – Photo 1 Unit 9</p> <p>Moisture in bedrock in crawlspace. No running water noted.</p>	<p>None</p>
 	<p>4/15/10 – Photo 2 Unit 9</p> <p>Moisture in bedrock in crawlspace. No running water noted.</p>	<p>None</p>
 	<p>4/15/10 – Photo 3 Unit 17</p> <p>Moisture in bedrock in crawlspace. No running water noted.</p>	<p>None</p>
 	<p>4/15/10 – Photo 4 Unit 17</p> <p>Moisture in bedrock in crawlspace. No running water noted.</p>	<p>None</p>

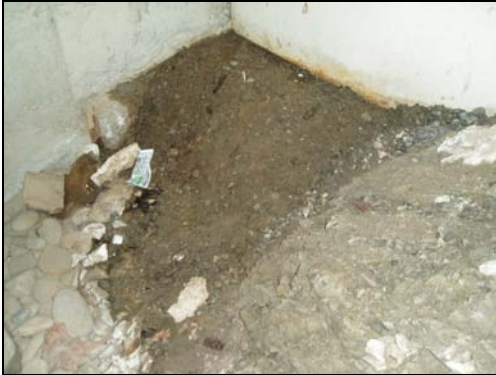
<p>4/15/10 – Photo 5 Unit 17 No pooled water visible.</p> <p>Ref Photo 2, Field Report 004</p>	<p>None</p>

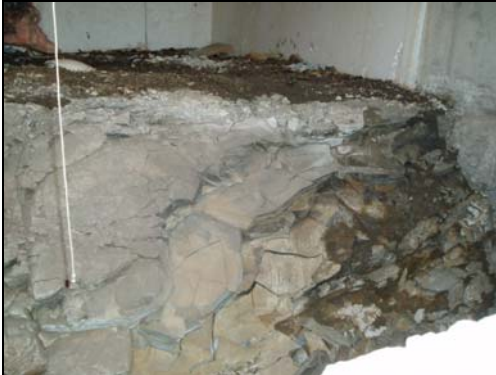
<p>4/15/10 – Photo 6 Unit 17</p> <p>Moisture still evident on bedrock. No running water noted.</p>	<p>None</p>

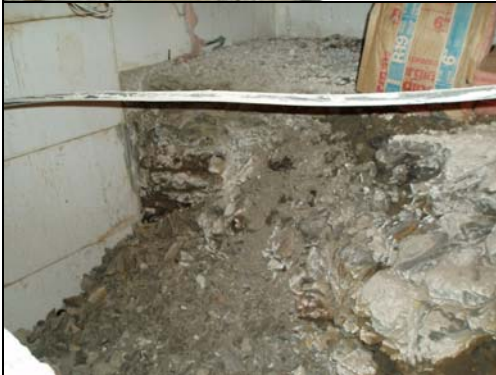
<p>4/15/10 – Photo 7 Unit 24</p> <p>Minimal moisture noted in crawlspace. No running water observed.</p>	<p>None</p>

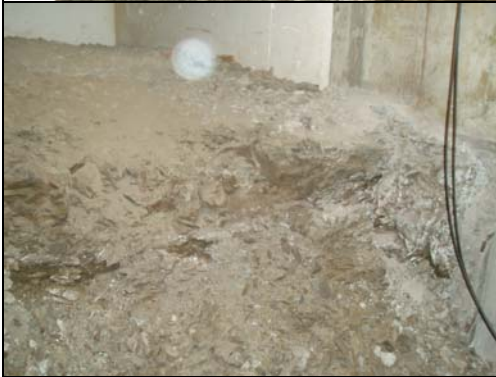
<p>4/15/10 – Photo 8 Unit 40</p> <p>Minimal moisture visible on bedrock. Crawlspace appeared dry.</p>	<p>None</p>

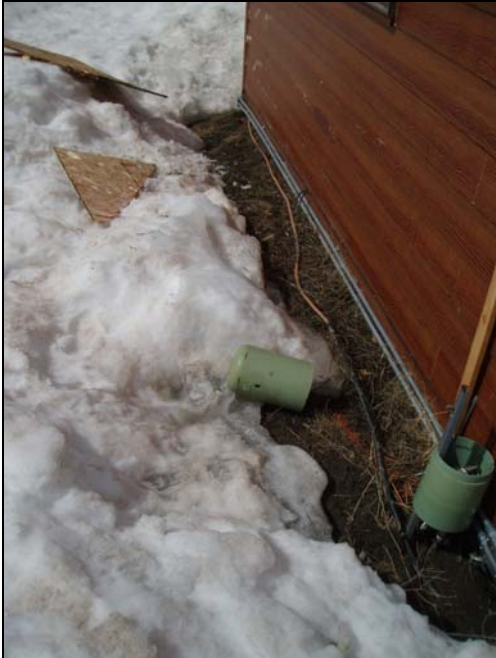
<p>4/15/10 – Photo 9 Unit 9</p> <p>Condition of snowpack behind unit. Note that solar radiation from the structure has melted snow from the face of the siding.</p>	<p>None</p>

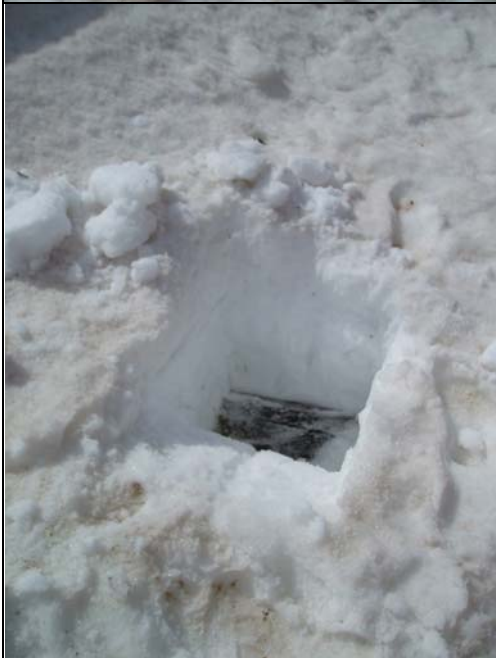
<p>4/15/10 – Photo 10 Unit 9</p> <p>Test pit behind Unit 9. Depth approximately 2'-8". Crystallized and slushy snow throughout.</p>	<p>None</p>

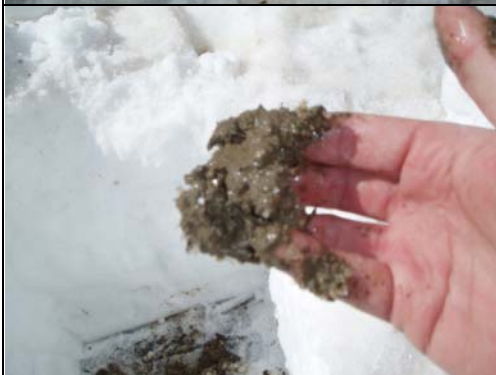
<p>4/15/10 – Photo 11 Unit 9</p> <p>From test pit behind Unit 9. Soil is saturated.</p>	<p>None</p>

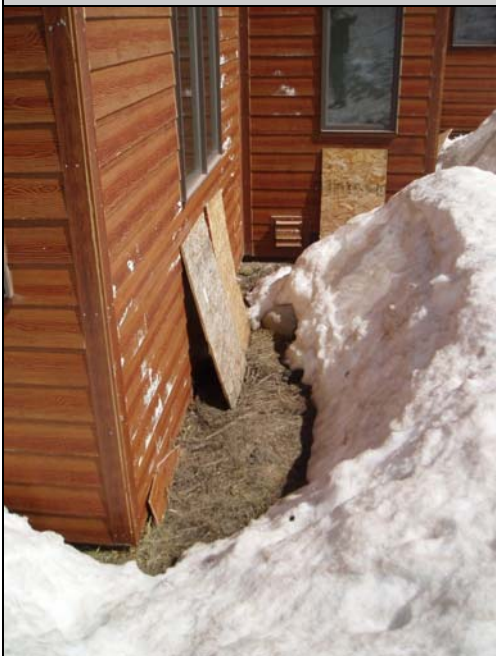
<p>4/15/10 – Photo 12 Unit 17</p> <p>Condition of snowpack behind Unit 17. Bare ground exposed with approximately 4'-6" of snow adjacent to structure.</p>	<p>None</p>

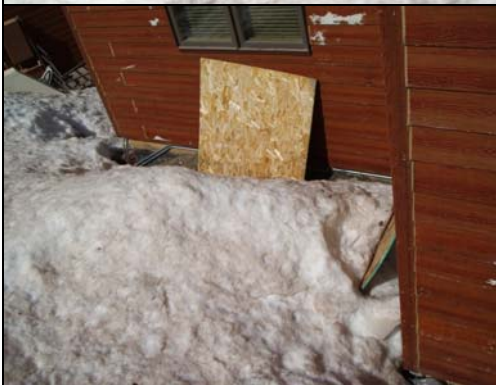
<p>4/15/10 – Photo 13 Unit 24</p> <p>Condition of snowpack typical behind all units.</p>	<p>None</p>

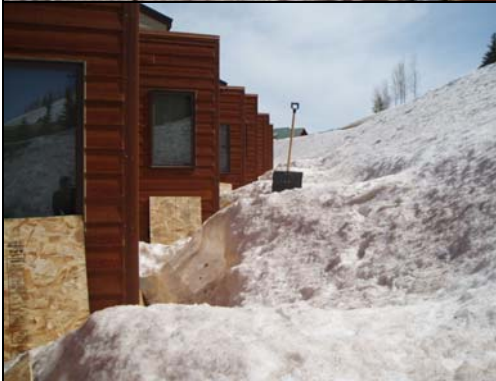
<p>4/15/10 – Photo 14 Unit 17 thru 24</p> <p>Snowpack still approximately 4 to 6 feet deep behind Lower Units.</p>	<p>None</p>
