**ARCHITECT'S FIELD REPORT****021**

PROJECT	<b>Eagle's Nest Townhouses</b> 11 Morning Glory Way & 31 Marcellina Lane Mt. Crested Butte, CO 81225	DATE	10/22/10
		REVISED	10/28/10

WORK OBSERVED	
Phase I – Construction	
TRADES PRESENT	
Holgate Construction Company

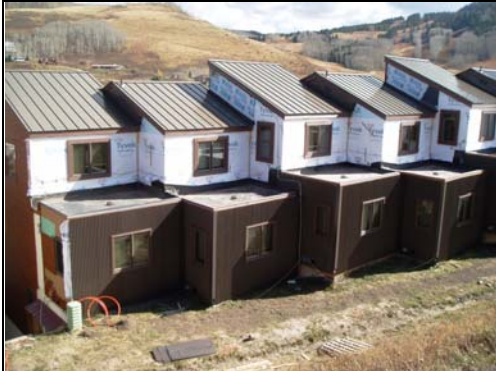
<p>10/21/10 – Photo 5 Units 33 through 36</p> <p>Rear vertical metal siding and metal corner trim installation is complete.</p>	None

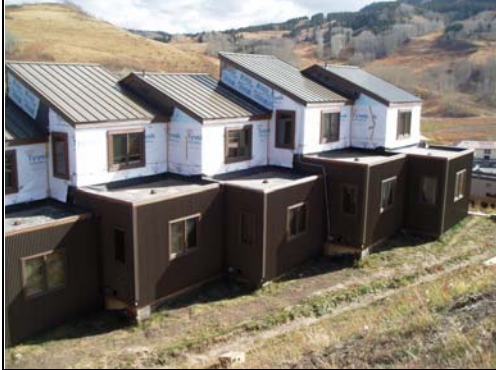
<p>10/21/10 – Photo 6 Units 37 through 40</p> <p>Rear vertical metal siding and metal corner trim installation is complete.</p>	None

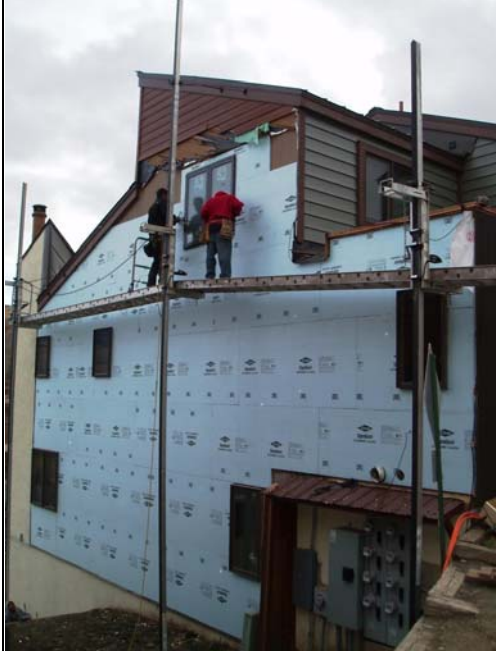
<p>10/21/10 – Photo 7 Unit 8</p> <p>Demolition nearing completion. New rigid insulation has been installed. New 4<sup>th</sup> Floor end window has been installed. Metal flashing at existing windows is complete.</p> <p>BWA to issue drawings for Electrical Meter Covers ASAP.</p>	BWA

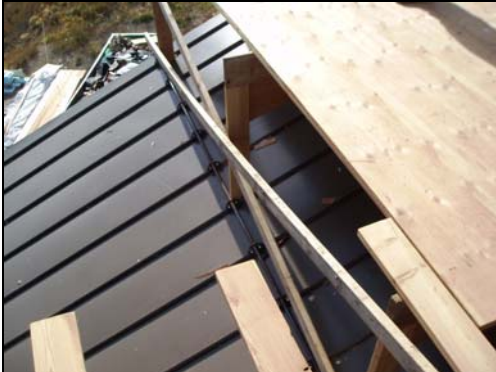
<p>10/21/10 – Photo 13 Unit 1</p> <p>Scaffolding rests on roof structure of Unit #1. BWA to inspect roof following relocation of scaffolding.</p>	BWA

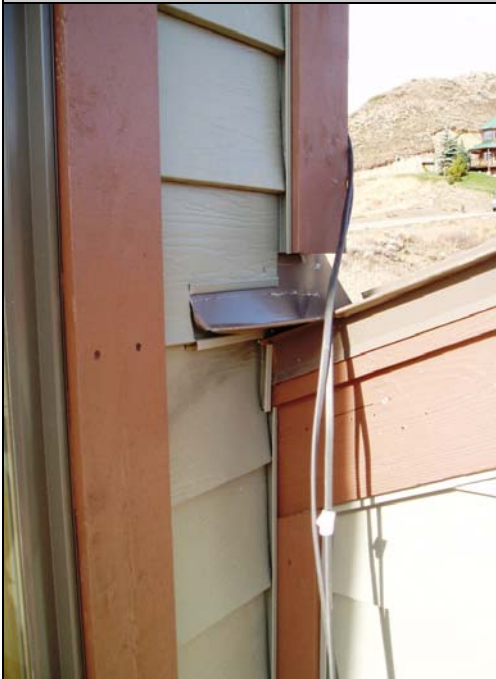
<p>10/21/10 – Photo 17 Unit 2 and 3</p> <p>Note the additional fitting of siding and J-channel at this location.</p> <p>Wires feed roof eave snowmelt system.</p>	None

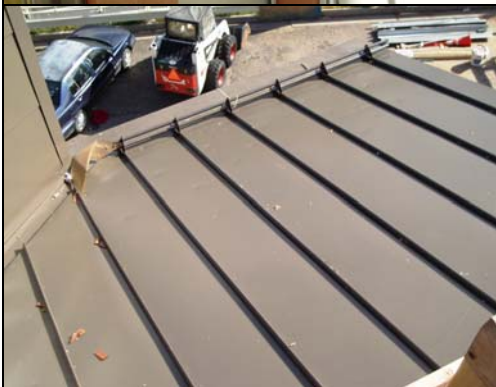
<p>10/21/10 – Photo 18 Unit 3 – Roof</p> <p>Roof shows evidence of denting likely from snow removal. Condition has been documented as pre-existing.</p>	None

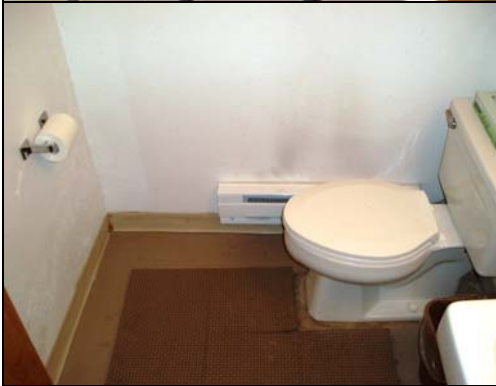
<p>10/21/10 – Photo 19 Lower Level Service Restroom</p> <p>Restroom is clean and presentable.</p>	None

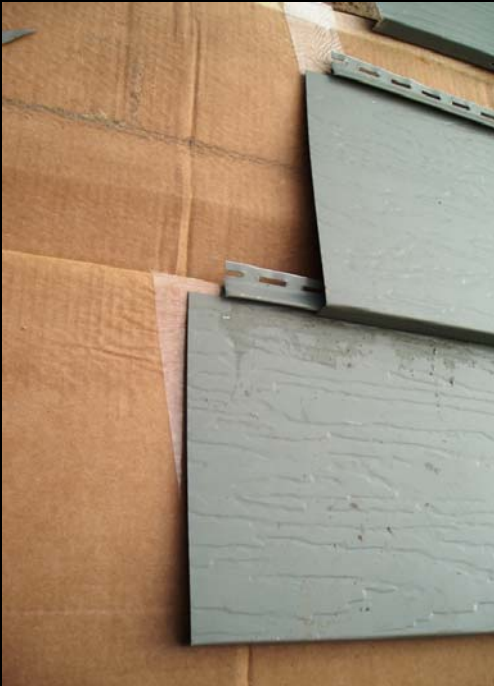
<p>10/21/10 – Photo 20</p> <p>Series Slide #1 Siding Installation at Flat Roofs</p> <p>Mock-Up example of assembly of horizontal steel siding. Typically, the bottom course is held with a starter strip.</p>	None

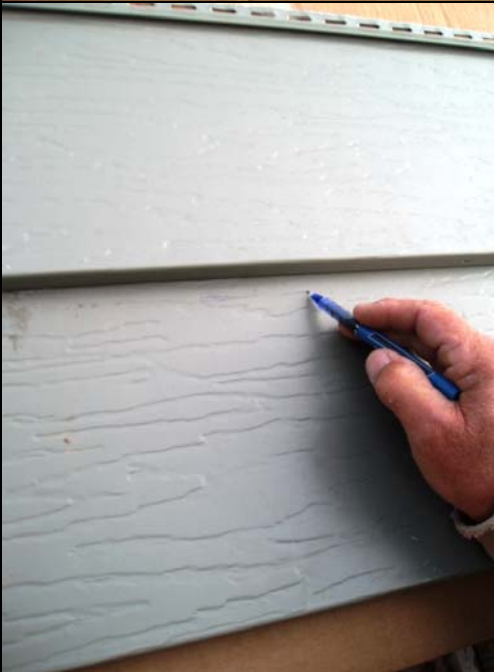
<p>10/21/10 – Photo 21</p> <p>Series Slide #2 Siding Installation at Flat Roofs</p> <p>Lowest course at perimeter of flat roofs at 4<sup>th</sup> Floors is measured and cut long-ways approximately 3/8" below the next course.</p>	None

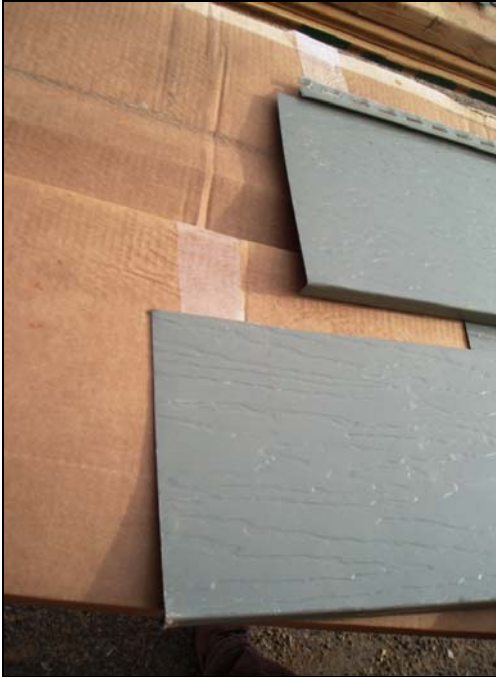
<p>10/21/10 – Photo 22</p> <p>Series Slide #3 Siding Installation at Flat Roofs</p> <p>Top flange of the bottom course is nailed to the wall. Trimmed bottom course is show without top flange.</p>	None

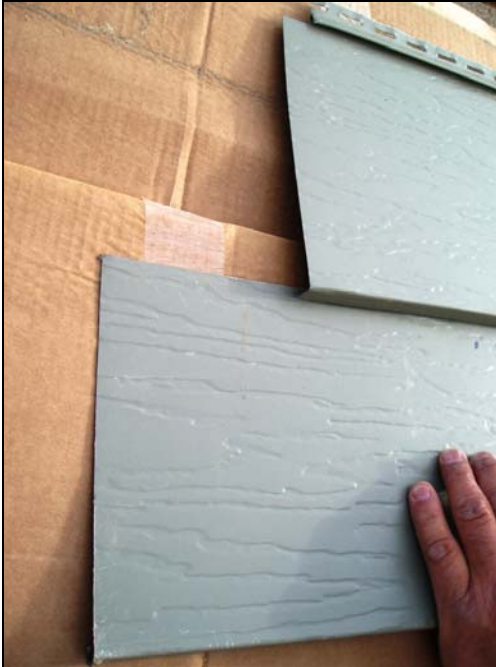
<p>10/21/10 – Photo 23</p> <p>Series Slide #4 Siding Installation at Flat Roofs</p> <p>Bottom course without flange is then face-screwed to the wall. This allows for ease of removal to repair flat membrane roofs.</p>	None

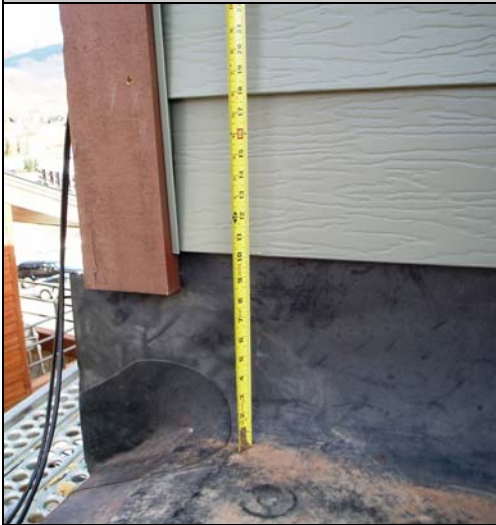
<p>10/21/10 – Photo 24 Unit 8 – Example Photo</p> <p>Detail of typical condition at flat roofs. Siding extends to approximately 10" above the flat roofs.</p>	None

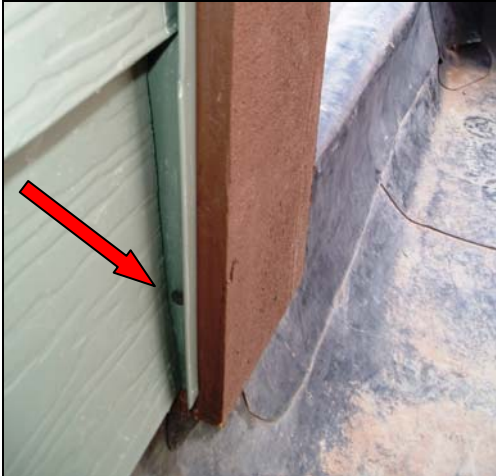
<p>10/21/10 – Photo 25 Unit 8 – Example Photo</p> <p>Corner trim at outside corner. Note the small screw holding the green J-Channel to the corner board. This attachment location secures the J-Channel without unnecessarily penetrating the roof membrane and Ice &amp; Water Shield waterproof flashing.</p>	None

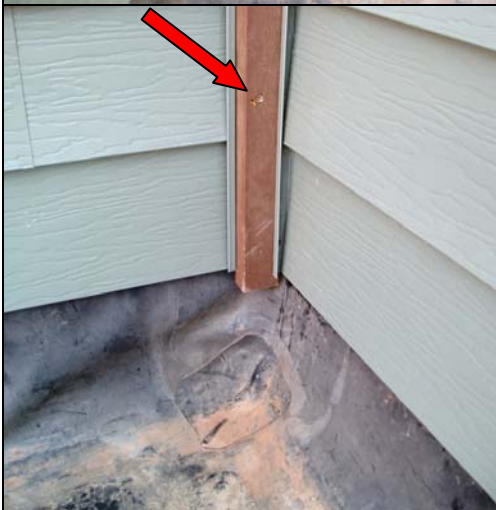
<p>10/21/10 – Photo 26 Unit 8 – Example</p> <p>Inside Corner Trim. Note the attachment screw is located a minimum of 18" up the wall to avoid unnecessary perforations in the waterproof flashing.</p> <p>Corner trim will need to be removed to replace flat roof membranes. Screws are approximately 4" long.</p>	None
