ARCHITECT'S FIELD REPORT

025

PROJECT	Eagle's Nest Townhouses 11 Morning Glory Way & 31 Marcellina Lane Mt. Crested Butte, CO 81225	DATE	12/01/10
----------------	--	-------------	----------

WORK OBSERVED	
Phase I – Construction	
TRADES PRESENT	
Holgate Construction Company

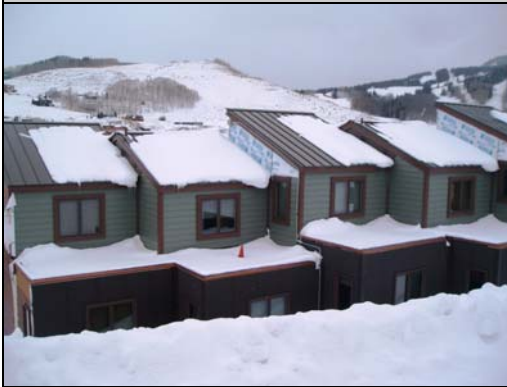
<p>12/01/10 – Photo 1 Units 17 through 20</p> <p>Final siding installation on Units 19 and 21 pending.</p>	<p>MHC</p>

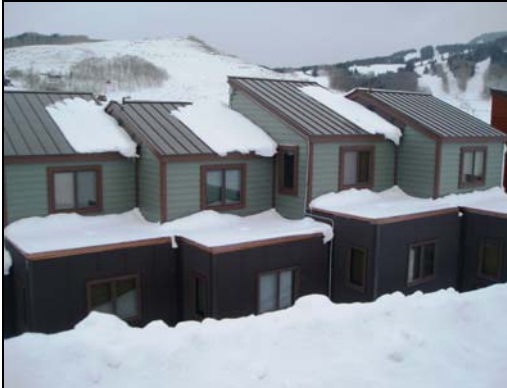
<p>12/01/10 – Photo 2 Units 21 through 24</p> <p>Siding installation complete on 22, 23, & 24.</p>	<p>None</p>

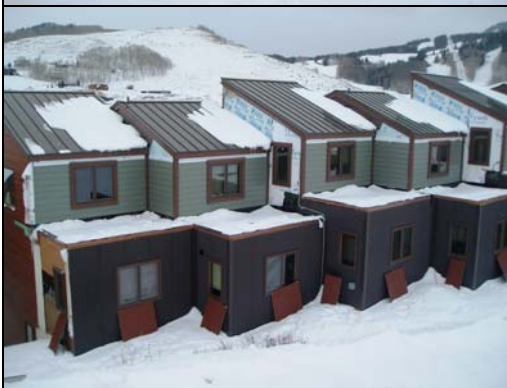
<p>12/01/10 – Photo 3 Units 25 through 28</p> <p>Siding installation underway. Units 27 & 29 lack bottom courses; remainder of Units are now protected from snow.</p>	<p>MHC</p>

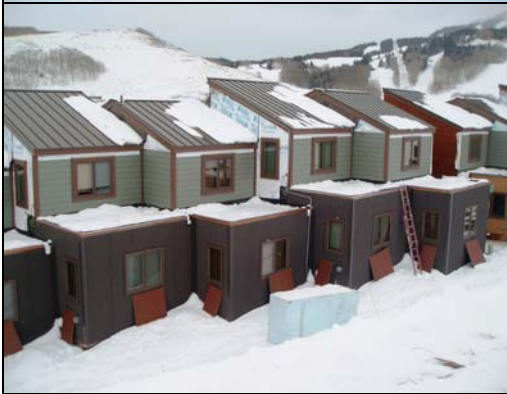
<p>12/01/10 – Photo 4 Units 29 through 32</p> <p>Unit 31 lacks bottom courses. All Units lack finish strip at top course.</p>	<p>MHC</p>

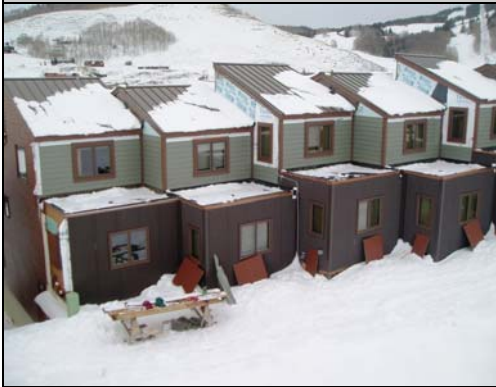
<p>12/01/10 – Photo 5 Units 33 through 36</p> <p>Siding installation underway.</p>	<p>MHC</p>
 	<p>12/01/10 – Photo 6 Units 37 through 40</p> <p>Siding installation underway. Mick is awaiting additional materials.</p>	<p>MHC</p>

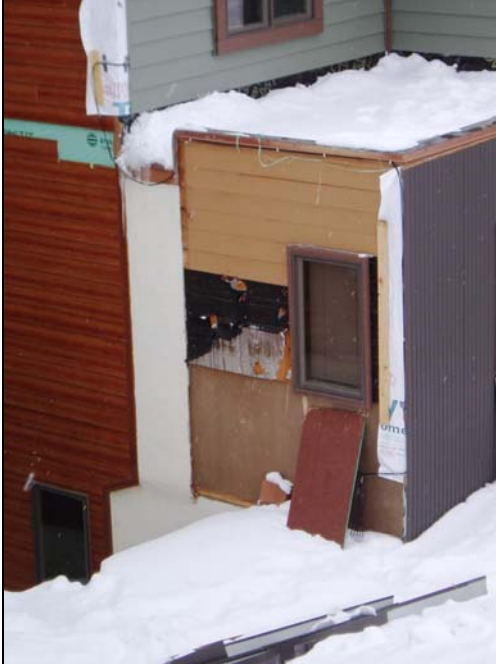
<p>12/01/10 – Photo 7 Unit 25</p> <p>Exposed exterior sheathing needs temporary weather protection. MH to address.</p>	<p>MHC</p>

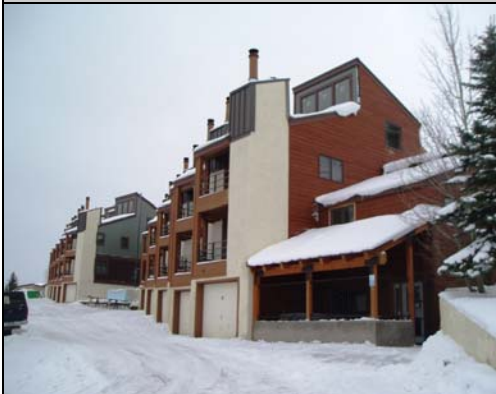
<p>12/01/10 – Photo 8 Upper Level Units</p> <p>View of completed loft windows and siding on Unit 16.</p>	<p>None</p>

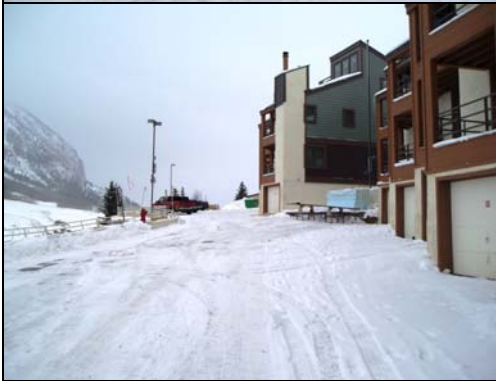
<p>12/01/10 – Photo 9 Upper Level Units</p> <p>View of completed end of Unit 8.</p>	<p>None</p>

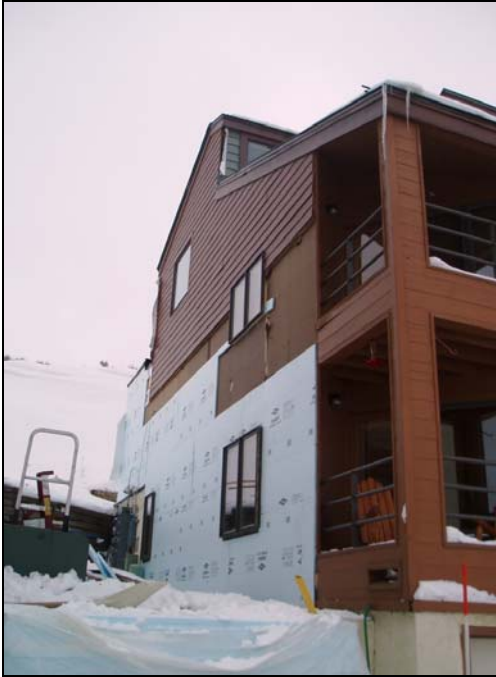
<p>12/01/10 – Photo 10 Unit 9 End Elevation</p> <p>End elevation underway. 2nd floor windows have metal nailing flashing installed.</p>	<p>None</p>

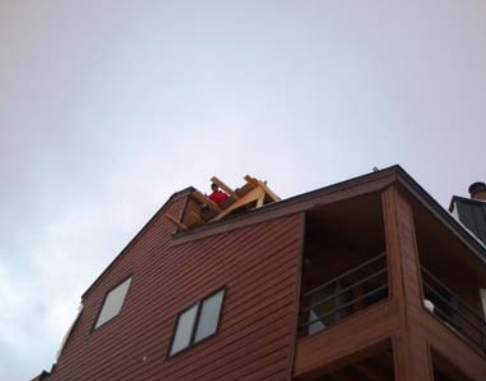
<p>12/01/10 – Photo 11 Unit 40</p> <p>Scaffolding in place and loft window replacement underway on Units 40, 39, 38, and 37.</p>	<p>None</p>

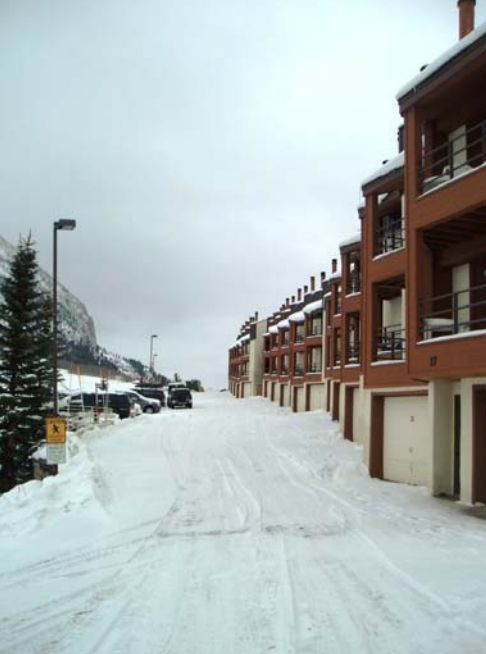
<p>12/01/10 – Photo 12 Lower Level Units – Front</p> <p>Site is orderly and in good condition.</p>	<p>None</p>

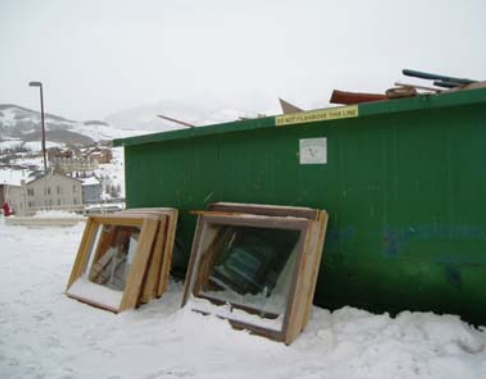
<p>12/01/10 – Photo 13 Lower Level Dumpster</p> <p>Dumpster is full and will be removed by December 17th.</p>	<p>MHC</p>
