**ARCHITECT'S FIELD REPORT**

**006**

**PROJECT**      **Eagle's Nest Townhouses**      **DATE**      4/28/10  
 11 Morning Glory Way & 31 Marcellina Lane  
 Mt. Crested Butte, CO 81225

WORK OBSERVED	
Observations of moisture in crawlspaces – week number 3.	
TRADES PRESENT	
None.

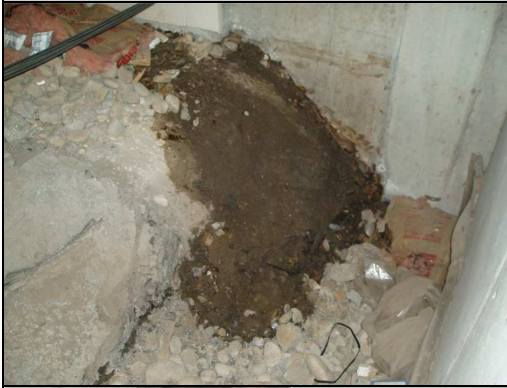
<p>4/27/10 – Photo 1 Unit 9</p> <p>Moisture apparent in bedrock.</p>	<p>None</p>

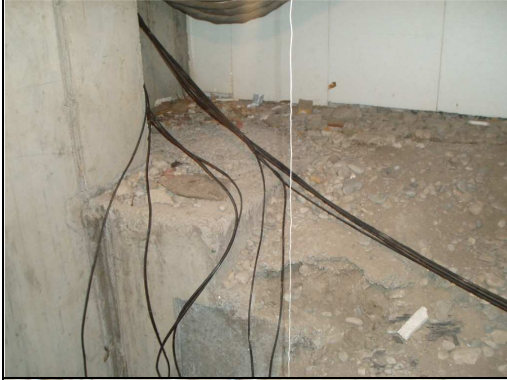
<p>4/27/10 – Photo 2 Unit 9</p> <p>Interior corner appears to be dry.</p>	<p>None</p>

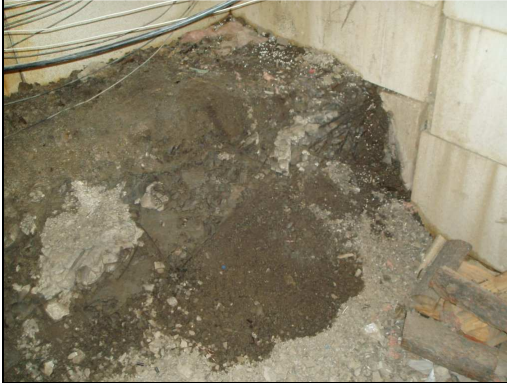
<p>4/27/10 – Photo 3 Unit 17</p> <p>Moisture (dark grey) apparent in crawlspace. Area appears to be more extensive compared with previous Field Report.</p>	<p>None</p>

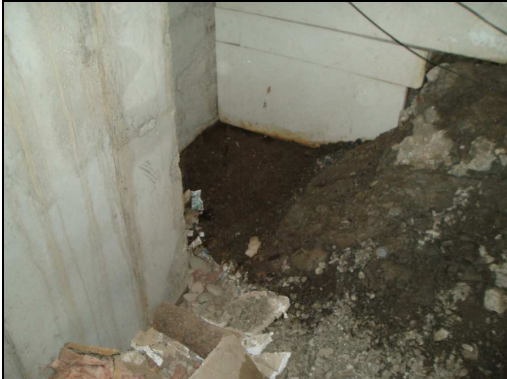
<p>4/27/10 – Photo 4 Unit 17</p> <p>Test corner has standing water.</p>	<p>None</p>

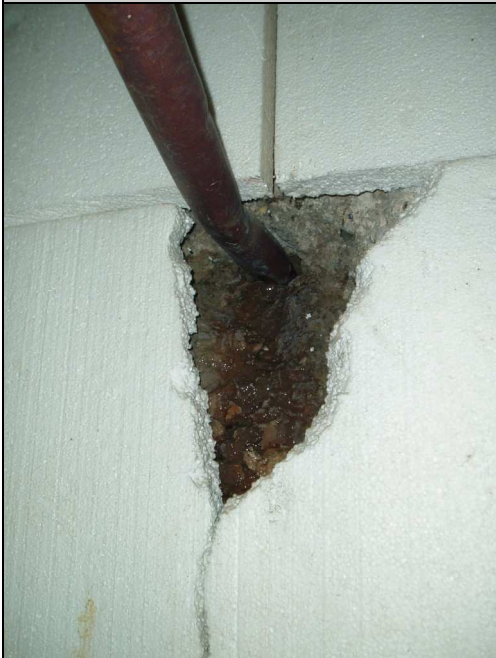
<p>4/27/10 – Photo 5 Unit 17</p> <p>Water supply pipe penetration along back wall is allowing water entry into the crawspace of Unit 17. Water was flowing at a steady rate.</p>	<p>None</p>

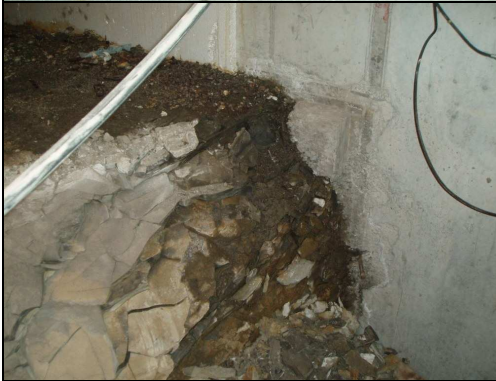
<p>4/27/10 – Photo 6 Unit 24</p> <p>Moisture along north foundation wall. Flowing water was observed.</p>	<p>None</p>

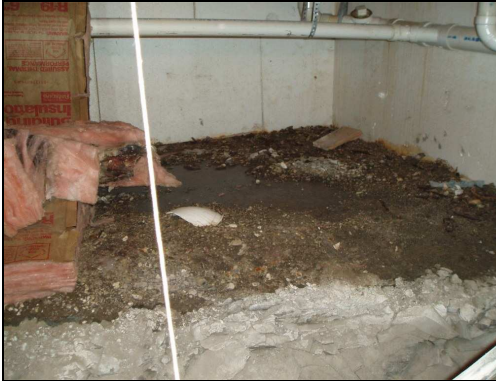
<p>4/27/10 – Photo 7 Unit 24</p> <p>Standing water was observed on the upper portion of the crawlspace.</p>	<p>None</p>

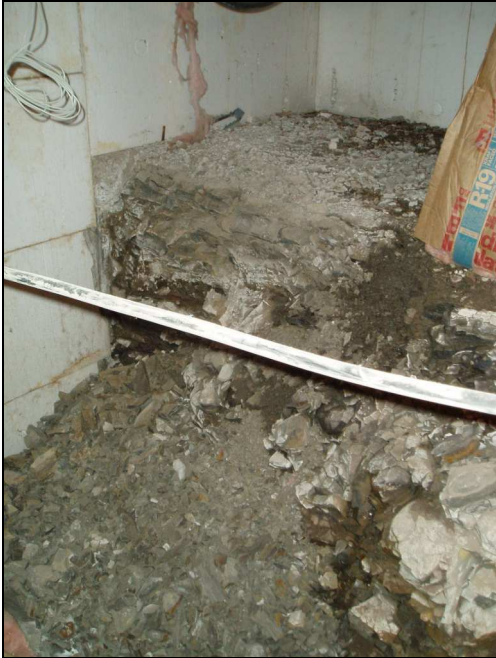
<p>4/27/10 – Photo 8 Unit 24</p> <p>Southern foundation wall with moisture in bedrock.</p>	<p>None</p>

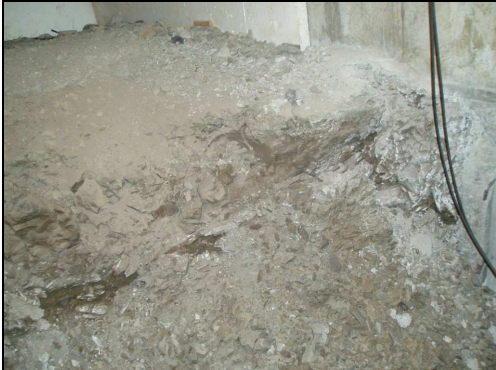
<p>4/27/10 – Photo 9 Unit 40</p> <p>Crawlspace appeared dry.</p>	<p>None</p>

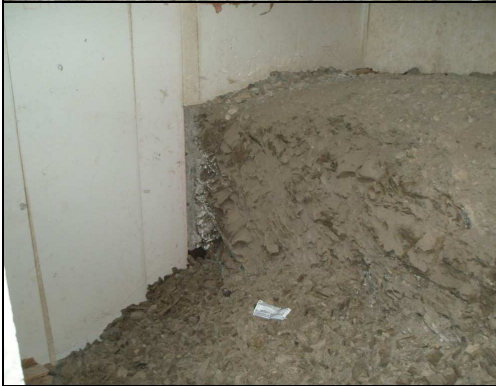
<p>4/27/10 – Photo 10 Unit 40</p> <p>Crawlspace appeared dry.</p>	<p>None</p>
