ARCHITECT'S FIELD REPORT

037

PROJECT	Eagle's Nest Townhouses 11 Morning Glory Way & 31 Marcellina Lane Mt. Crested Butte, CO 81225	DATE	3/09/11
----------------	------------------------------------------------------------------------------------------------------------	-------------	---------

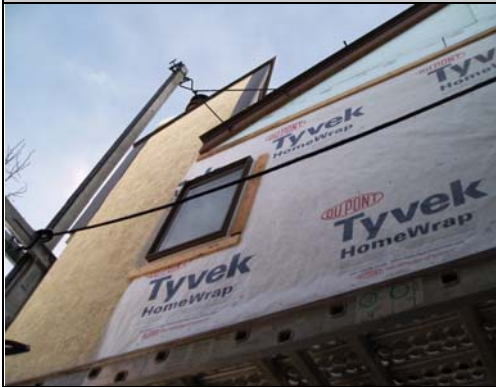
<p>3/09/11 – Photo 5 Unit 32</p> <p>Elevation is ready for green siding.</p>	<p>CBL MHC</p>

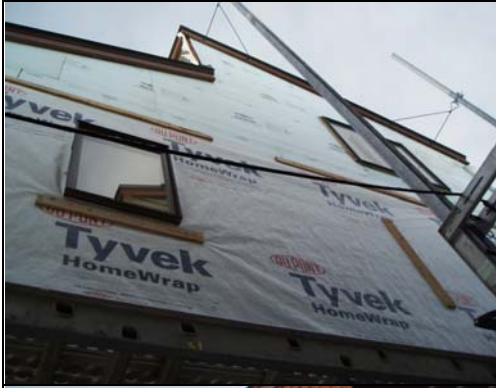
<p>3/09/11 – Photo 6 Unit 32</p> <p>Elevation is ready for green siding.</p>	<p>None</p>

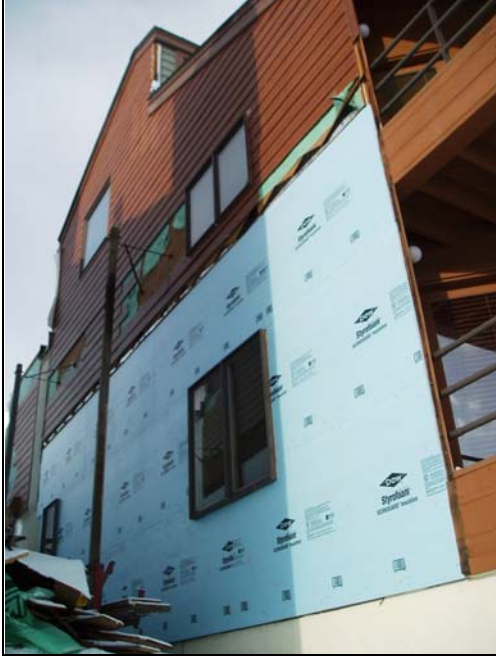
<p>3/09/11 – Photo 7 Unit 24</p> <p>Demolition is 50% complete. New rigid insulation has been installed on the second level.</p>	<p>None</p>

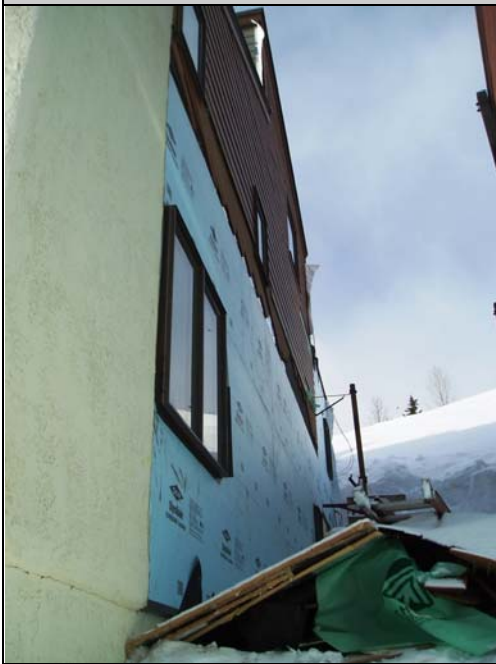
<p>3/09/11 – Photo 8 Unit 25</p> <p>Demolition is 50% complete and new insulation has been installed on the second level.</p>	<p>None</p>

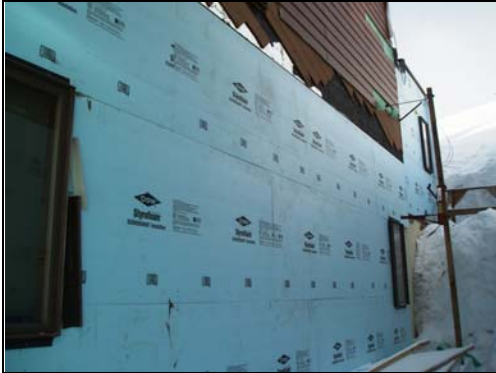
<p>3/09/11 – Photo 9 Unit 25</p> <p>Detail of new siding on back elevation.</p>	<p>None</p>

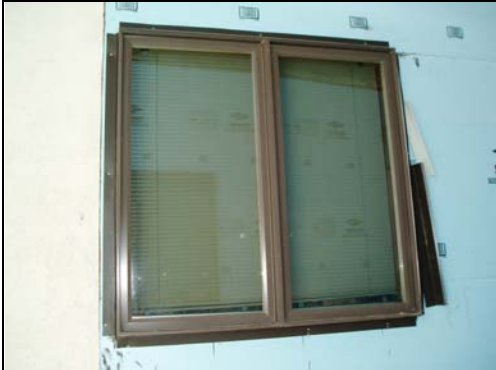
<p>3/09/11 – Photo 10 Unit 25</p> <p>Existing windows have new metal “fins” installed around the perimeter.</p>	<p>None</p>

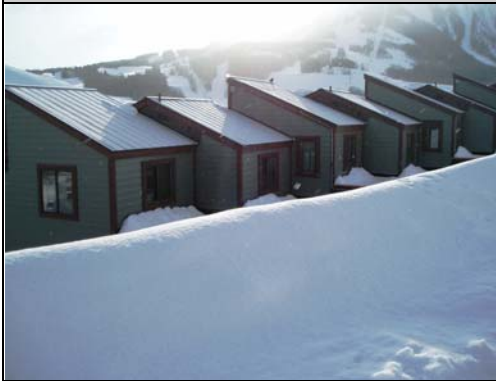
<p>3/09/11 – Photo 11 Units 17 through 21</p> <p>Unit 19 gable end is complete.</p>	<p>CBL MHC</p>

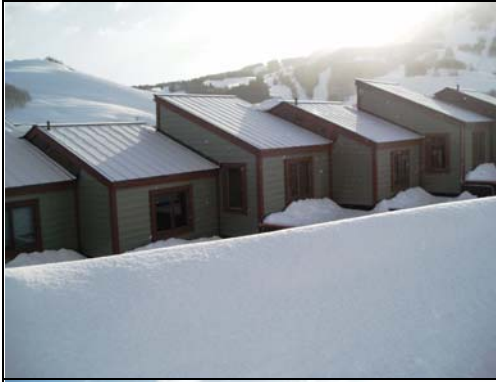
<p>3/09/11 – Photo 12 Units 20 through 23</p> <p>Unit 21 gable end is complete.</p>	<p>None</p>

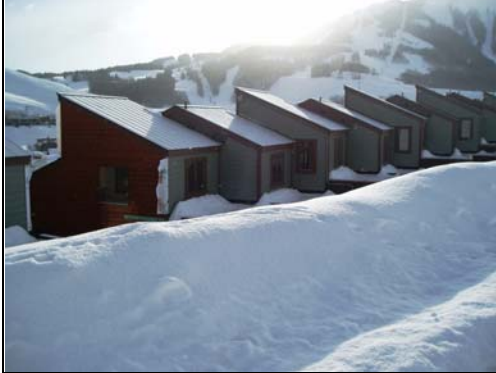
<p>3/09/11 – Photo 14 Units 25 through 31</p> <p>Unit 27 gable end is complete.</p>	<p>None</p>

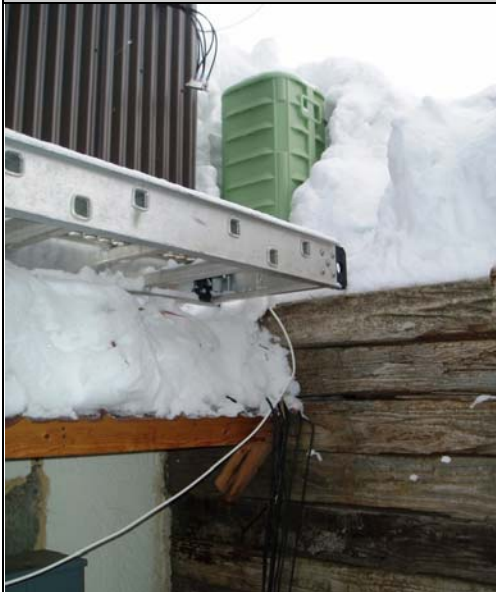
<p>3/09/11 – Photo 19 Unit 33 Cable Box</p> <p>Cable box at Unit 33 appears to be in good condition despite snow coverage.</p>	<p>CBL MHC</p>

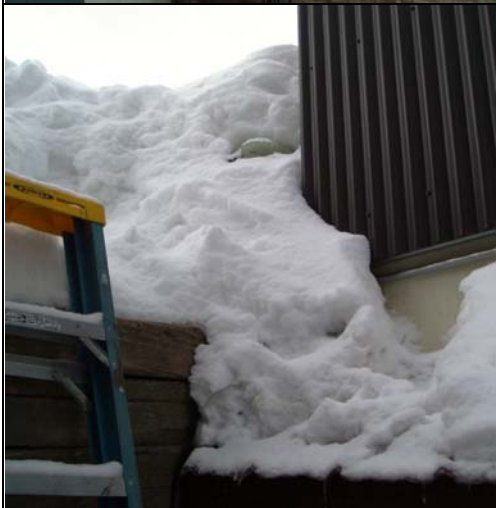
<p>3/09/11 – Photo 20 Unit 32 Cable Box</p> <p>Cable box is buried by snow.</p>	<p>None</p>

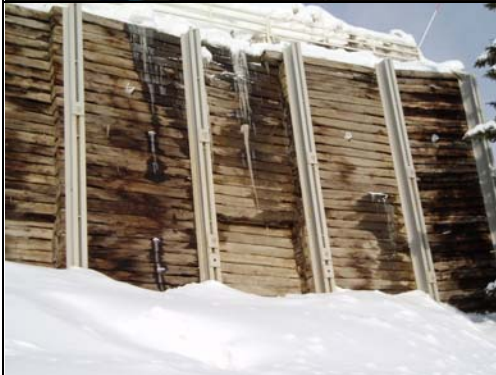
<p>3/09/11 – Photo 21 Upper Level Mid Retaining Wall</p> <p>Note: First appearance of water seepage through the retaining wall. This is most likely from the snow storage directly above the wall.</p>	<p>None</p>
