ARCHITECT'S FIELD REPORT

078

| PROJECT | Eagle's Nest Townhouses 11 Morning Glory Way & 31 Marcellina Lane Mt. Crested Butte, CO 81225 | DATE | 6/22/12 |

| WORK OBSERVED | |
|--|--|
| Phase III - Exposed 1 st Floor Deck Sills | |

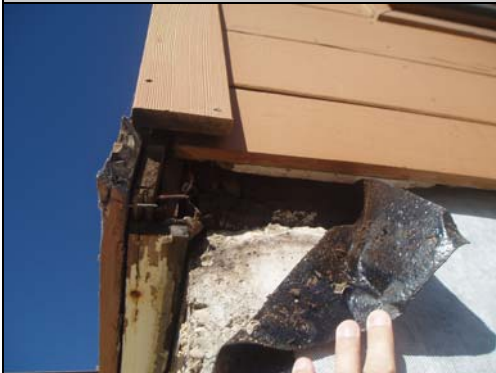
| PHOTO –WORK ITEM | DESCRIPTION | ACTION |
|---|---|---|
| | <p>6/13/12 – Photo 1 Unit 1</p> <p>Degraded condition.</p> | <p>Note</p> |

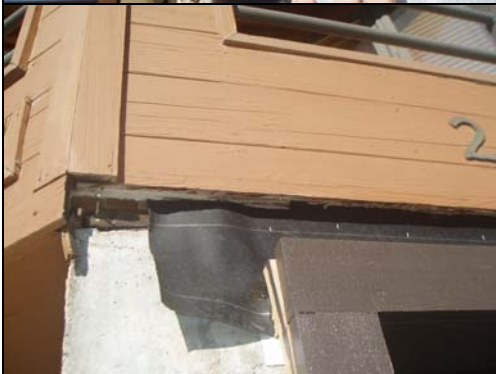
| PHOTO –WORK ITEM | DESCRIPTION | ACTION |
|---|---|---|
| | <p>6/13/12 – Photo 2 Unit 2</p> <p>No signs of degradation.</p> | <p>Note</p> |

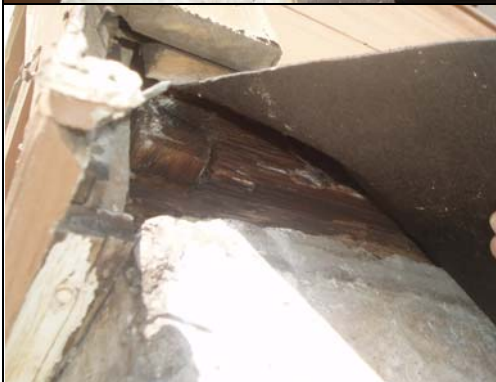
| PHOTO –WORK ITEM | DESCRIPTION | ACTION |
|---|---|---|
| | <p>6/13/12 – Photo 3 Unit 3</p> <p>No signs of degradation.</p> | <p>Note</p> |

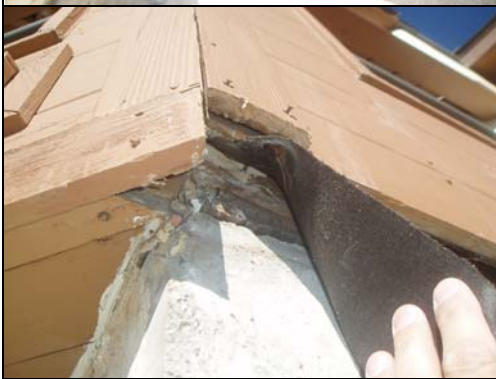
| PHOTO –WORK ITEM | DESCRIPTION | ACTION |
|---|---|---|
| | <p>6/13/12 – Photo 4 Unit 4</p> <p>No signs of degradation.</p> | <p>Note</p> |

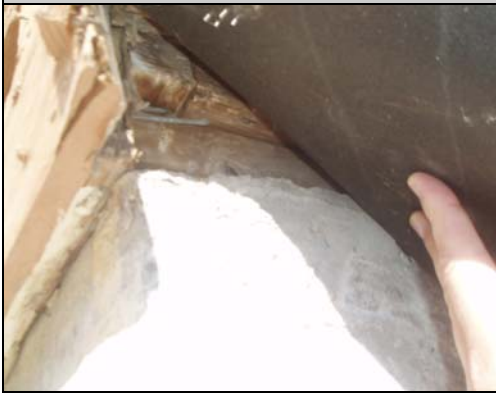
| PHOTO –WORK ITEM | DESCRIPTION | ACTION |
|---|---|---|
| | <p>6/13/12 – Photo 5 Unit 5</p> <p>No signs of degradation.</p> | <p>Note</p> |

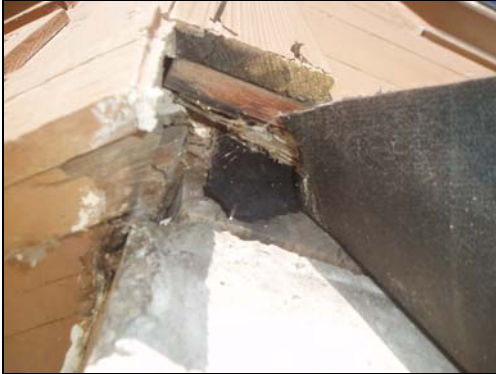
| PHOTO –WORK ITEM | DESCRIPTION | ACTION |
|---|---|---|
| | <p>6/13/12 – Photo 6 Unit 6</p> <p>No signs of degradation.</p> | <p>Note</p> |

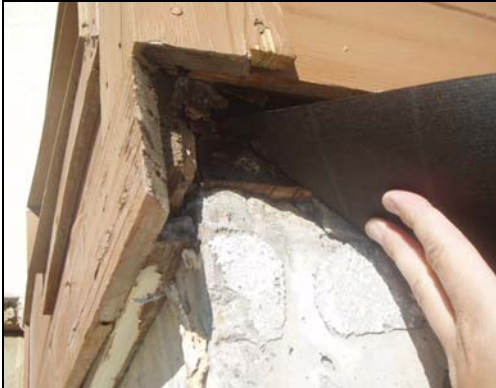
| PHOTO –WORK ITEM | DESCRIPTION | ACTION |
|---|---|---|
| | <p>6/13/12 – Photo 7 Unit 7</p> <p>Degraded condition.</p> | <p>Note</p> |

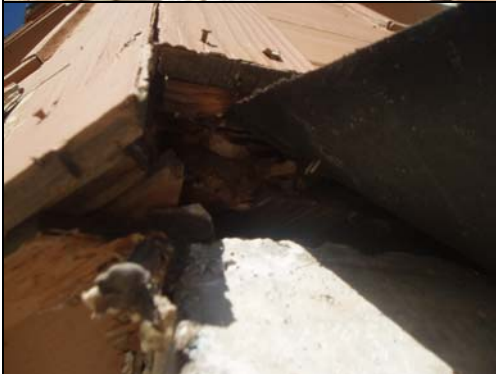
| PHOTO –WORK ITEM | DESCRIPTION | ACTION |
|---|---|---|
| | <p>6/13/12 – Photo 8 Unit 8</p> <p>Degraded condition.</p> <p>Note: Owners have installed a vent at this location that may not be code-compliant.</p> | <p>Note</p> |

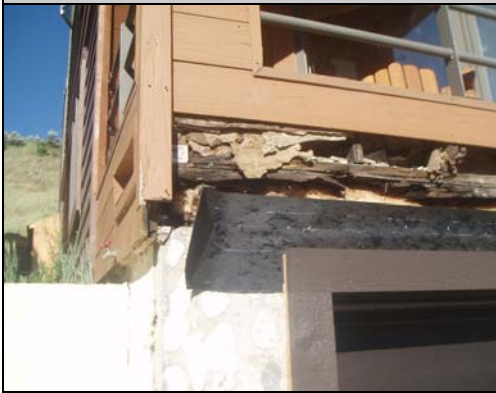
| PHOTO –WORK ITEM | DESCRIPTION | ACTION |
|---|---|---|
| | <p>6/13/12 – Photo 9 Unit 9</p> <p>Degraded condition. Remediation work is scheduled for Phase III.</p> | <p>Note</p> |

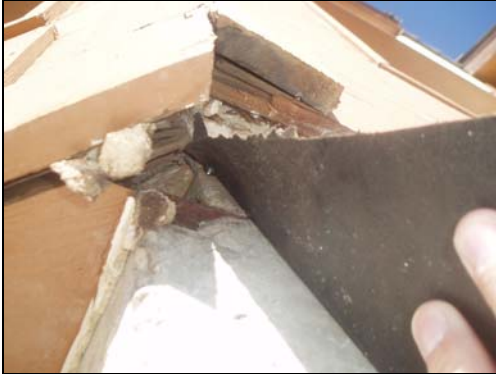
| PHOTO –WORK ITEM | DESCRIPTION | ACTION |
|---|---|---|
| | <p>6/13/12 – Photo 10 Unit 10</p> <p>No signs of degradation.</p> | <p>Note</p> |

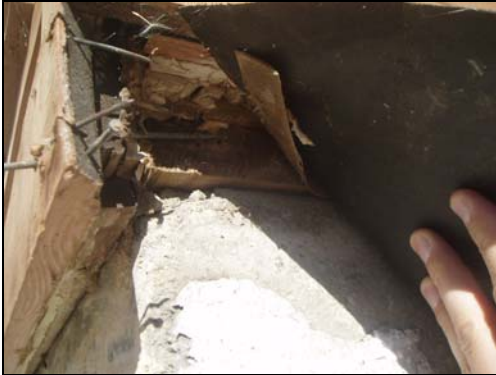
| PHOTO –WORK ITEM | DESCRIPTION | ACTION |
|---|---|---|
| | <p>6/13/12 – Photo 11 Unit 11</p> <p>No signs of degradation.</p> | <p>Note</p> |

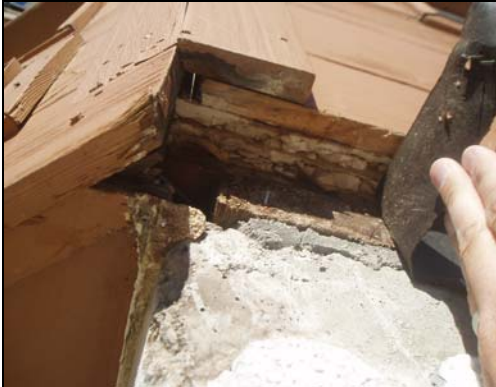
| PHOTO –WORK ITEM | DESCRIPTION | ACTION |
|---|---|---|
| | <p>6/13/12 – Photo 12 Unit 12</p> <p>No signs of degradation.</p> | <p>Note</p> |

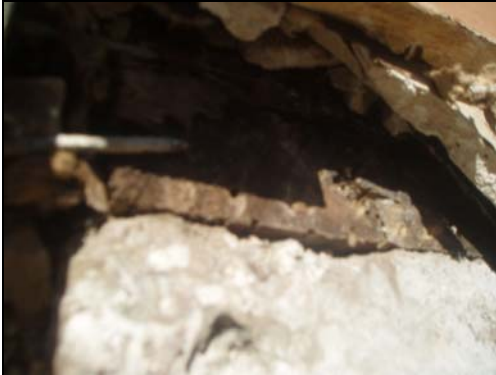
| PHOTO -WORK ITEM | DESCRIPTION | ACTION |
|---|---|---|
| | <p>6/13/12 – Photo 13 Unit 13</p> <p>Degraded condition.</p> | <p>Note</p> |

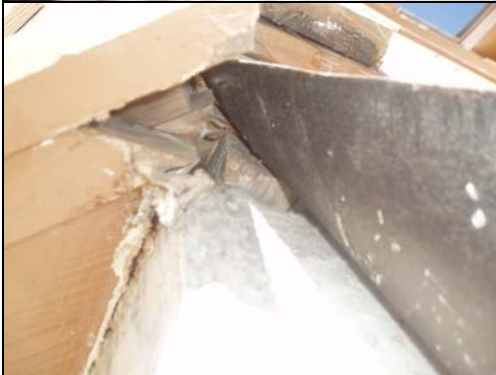
| PHOTO -WORK ITEM | DESCRIPTION | ACTION |
|---|---|---|
| | <p>6/13/12 – Photo 14 Unit 14</p> <p>No signs of degradation.</p> | <p>Note</p> |

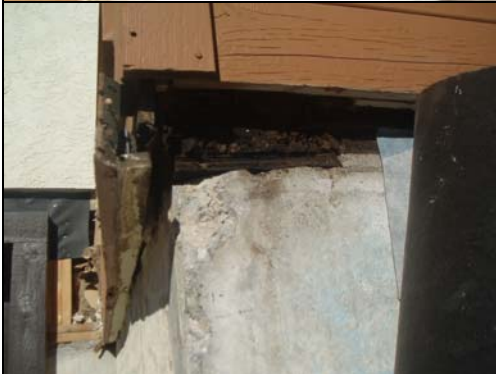
| PHOTO -WORK ITEM | DESCRIPTION | ACTION |
|---|---|---|
| | <p>6/13/12 – Photo 15 Unit 15</p> <p>Degraded condition.</p> | <p>Note</p> |

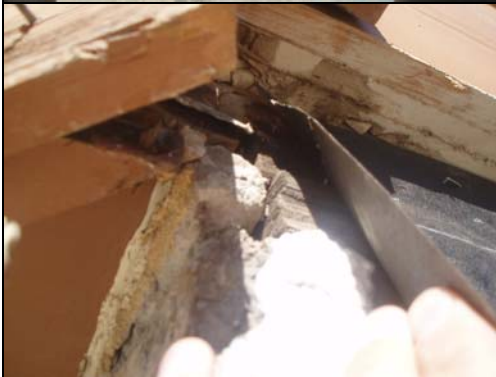
| PHOTO -WORK ITEM | DESCRIPTION | ACTION |
|---|---|---|
| | <p>6/13/12 – Photo 16 Unit 16</p> <p>Degraded condition.</p> | <p>Note</p> |

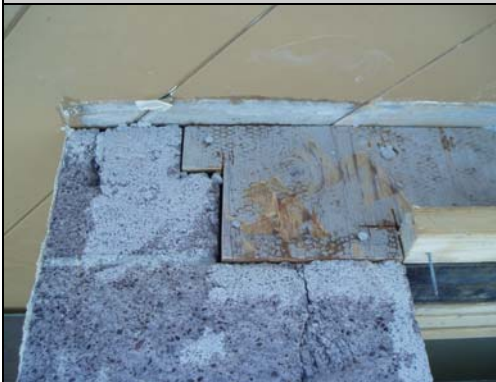
| PHOTO -WORK ITEM | DESCRIPTION | ACTION |
|---|--|---|
| | <p>6/13/12 – Photo 17 Unit 17 Sill Plate</p> <p>No signs of degradation.</p> | <p>Note</p> |

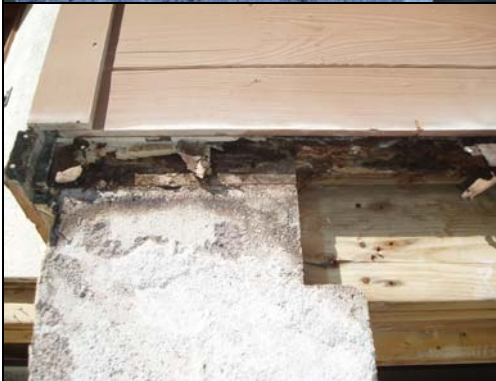
| PHOTO -WORK ITEM | DESCRIPTION | ACTION |
|---|--|---|
| | <p>6/13/12 – Photo 18 Unit 18 Sill Plate</p> <p>Degraded condition.</p> | <p>Note</p> |

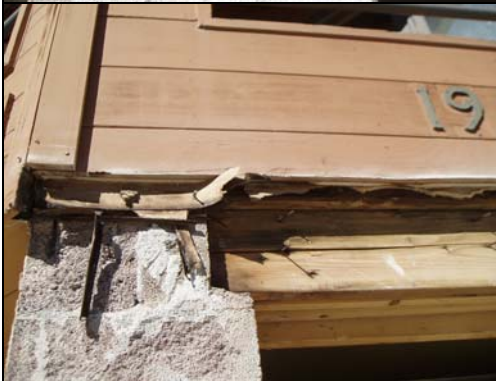
| PHOTO -WORK ITEM | DESCRIPTION | ACTION |
|---|--|---|
| | <p>6/13/12 – Photo 19 Unit 19 Sill Plate</p> <p>No signs of degradation.</p> | <p>Note</p> |

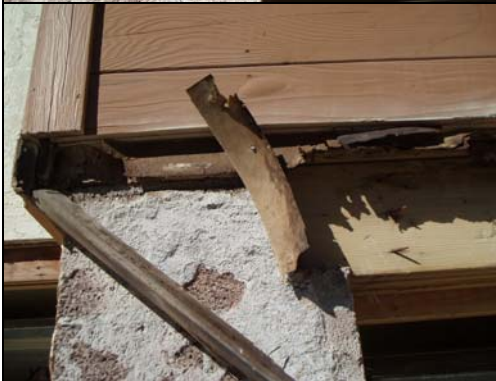
| PHOTO -WORK ITEM | DESCRIPTION | ACTION |
|---|--|---|
| | <p>6/13/12 – Photo 20 Unit 20 Sill Plate</p> <p>Degraded condition.</p> | <p>Note</p> |

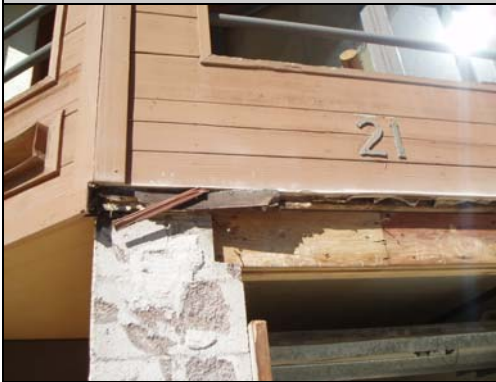
| PHOTO -WORK ITEM | DESCRIPTION | ACTION |
|---|--|---|
| | <p>6/13/12 – Photo 21 Unit 21 Sill Plate</p> <p>Degraded condition.</p> | <p>Note</p> |

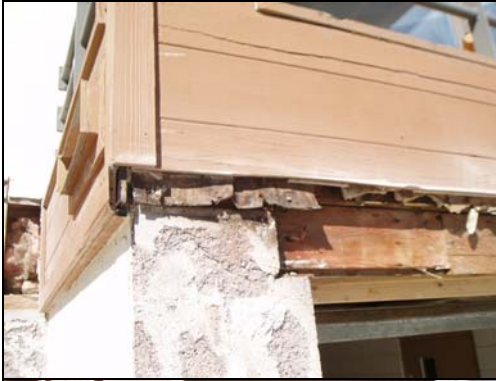
| PHOTO -WORK ITEM | DESCRIPTION | ACTION |
|---|--|---|
| | <p>6/13/12 – Photo 22 Unit 22 Sill Plate</p> <p>Degraded condition.</p> | <p>Note</p> |

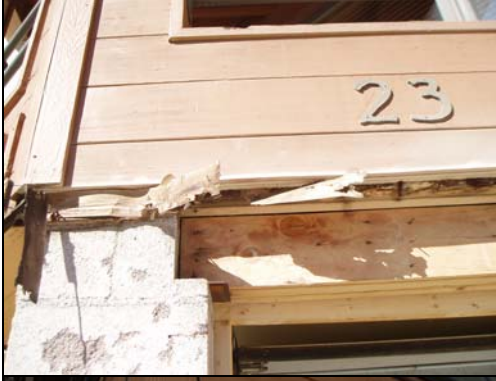
| PHOTO -WORK ITEM | DESCRIPTION | ACTION |
|---|--|---|
| | <p>6/13/12 – Photo 23 Unit 23 Sill Plate</p> <p>No signs of degradation.</p> | <p>Note</p> |

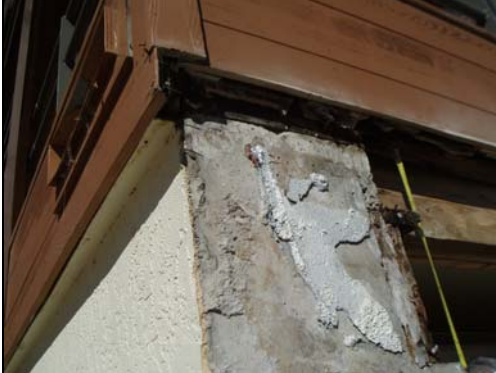
| PHOTO -WORK ITEM | DESCRIPTION | ACTION |
|---|--|---|
| | <p>6/13/12 – Photo 24 Unit 24 Sill Plate</p> <p>Degraded condition.</p> | <p>Note</p> |

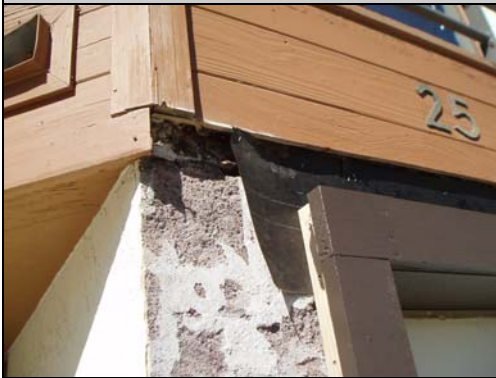
| PHOTO –WORK ITEM | DESCRIPTION | ACTION |
|---|---|---|
| | <p>6/13/12 – Photo 25 Unit 25 Sill Plate</p> <p>Degraded condition.</p> | <p>Note</p> |

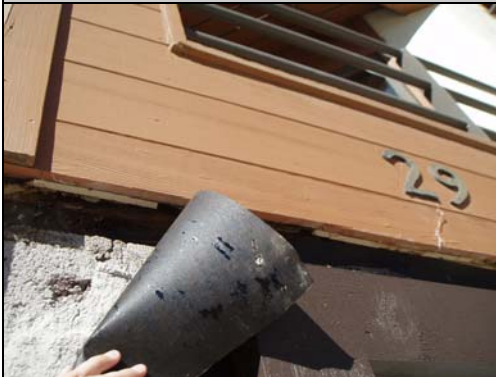
| PHOTO –WORK ITEM | DESCRIPTION | ACTION |
|---|--|---|
| | <p>6/13/12 – Photo 29 Unit 29 Sill Plate</p> <p>Degraded condition.</p> | <p>Note</p> |

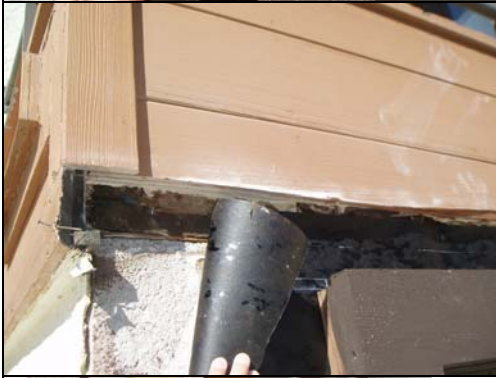
| PHOTO –WORK ITEM | DESCRIPTION | ACTION |
|---|--|---|
| | <p>6/13/12 – Photo 30 Unit 30 Sill Plate</p> <p>No signs of degradation.</p> | <p>Note</p> |

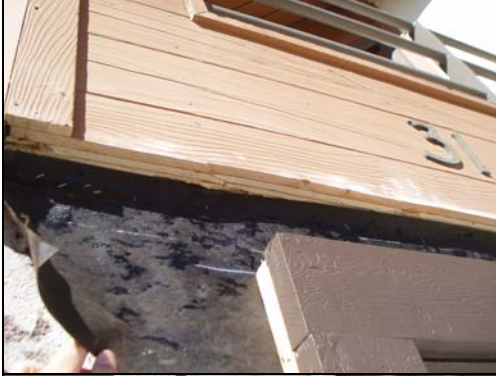
| PHOTO –WORK ITEM | DESCRIPTION | ACTION |
|---|--|---|
| | <p>6/13/12 – Photo 31 Unit 31 Sill Plate</p> <p>No signs of degradation.</p> | <p>Note</p> |

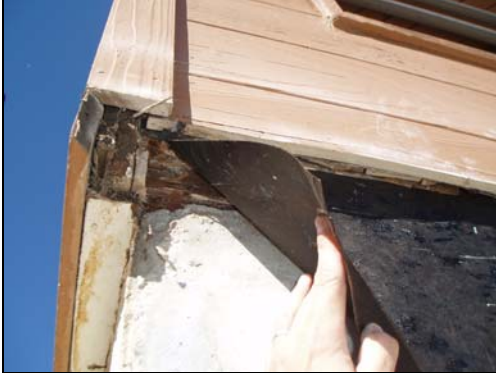
| PHOTO –WORK ITEM | DESCRIPTION | ACTION |
|---|--|---|
| | <p>6/13/12 – Photo 32 Unit 32 Sill Plate</p> <p>No signs of degradation.</p> | <p>Note</p> |

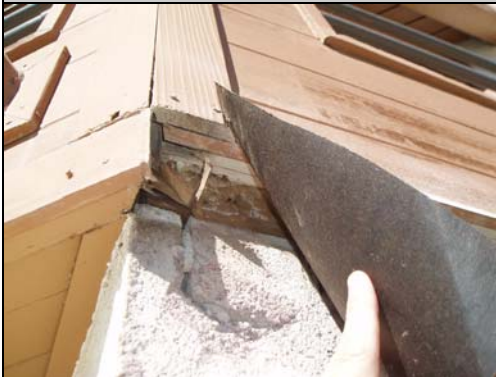
| PHOTO –WORK ITEM | DESCRIPTION | ACTION |
|---|--|---|
| | <p>6/13/12 – Photo 33 Unit 33 Sill Plate</p> <p>No signs of degradation.</p> | <p>Note</p> |

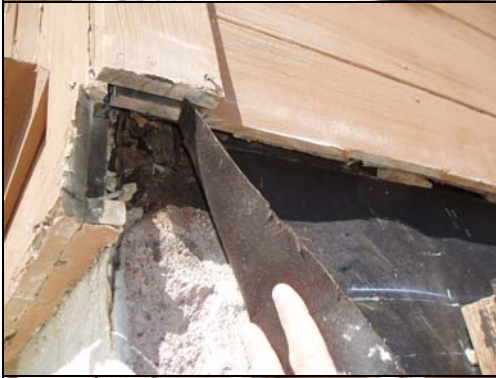
| PHOTO –WORK ITEM | DESCRIPTION | ACTION |
|---|--|---|
| | <p>6/13/12 – Photo 34 Unit 34 Sill Plate</p> <p>Degraded condition.</p> | <p>Note</p> |

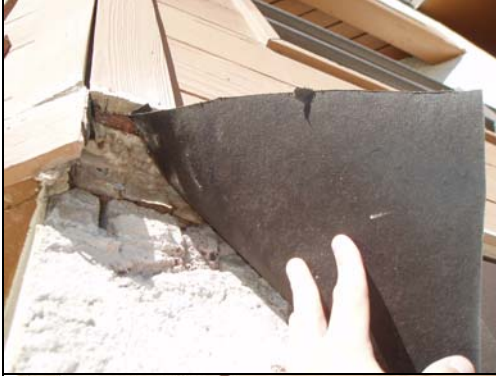
| PHOTO –WORK ITEM | DESCRIPTION | ACTION |
|---|--|---|
| | <p>6/13/12 – Photo 35 Unit 35 Sill Plate</p> <p>No signs of degradation.</p> | <p>Note</p> |

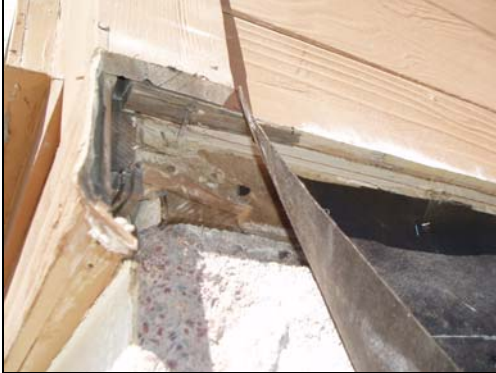
| PHOTO –WORK ITEM | DESCRIPTION | ACTION |
|---|--|---|
| | <p>6/13/12 – Photo 36 Unit 36 Sill Plate</p> <p>No signs of degradation.</p> | <p>Note</p> |

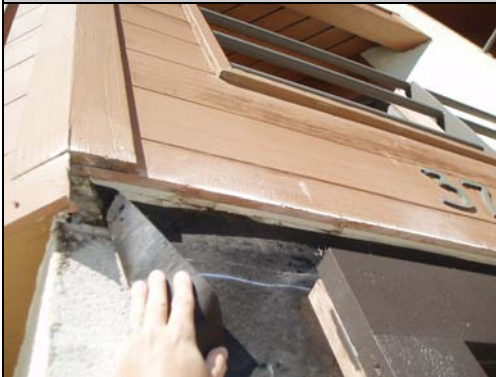
| PHOTO –WORK ITEM | DESCRIPTION | ACTION |
|---|--|---|
| | <p>6/13/12 – Photo 37 Unit 37 Sill Plate</p> <p>Degraded condition.</p> | <p>Note</p> |

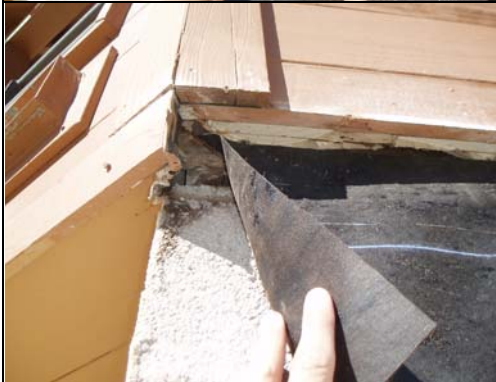
| PHOTO –WORK ITEM | DESCRIPTION | ACTION |
|---|--|---|
| | <p>6/13/12 – Photo 38 Unit 38 Sill Plate</p> <p>Degraded condition.</p> | <p>Note</p> |

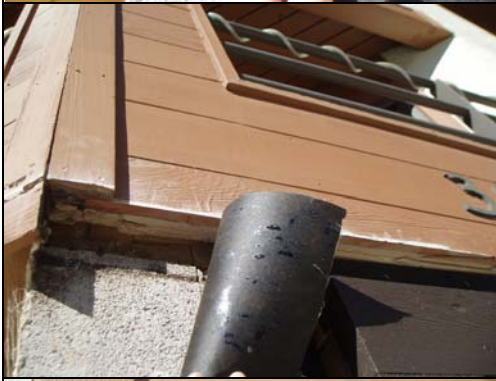
| PHOTO –WORK ITEM | DESCRIPTION | ACTION |
|---|--|---|
| | <p>6/13/12 – Photo 39 Unit 39 Sill Plate</p> <p>No signs of degradation.</p> | <p>Note</p> |

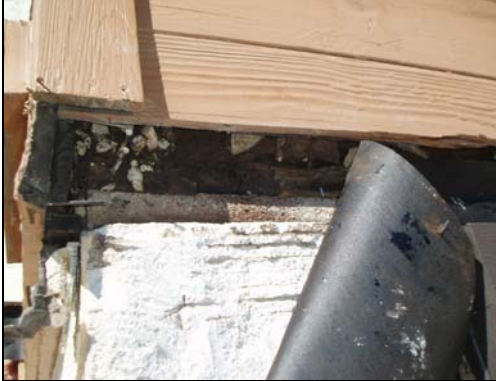
| PHOTO –WORK ITEM | DESCRIPTION | ACTION |
|---|--|---|
| | <p>6/13/12 – Photo 40 Unit 40 Sill Plate</p> <p>Degraded condition.</p> | <p>Note</p> |
