ARCHITECT'S FIELD REPORT

PROJECT	Eagle's Nest Townhouses 11 Morning Glory Way & 31 Marcellina Lane Mt. Crested Butte, CO 81225	DATE	10/16/13
----------------	--	-------------	----------

WORK OBSERVED	
Phase IV Construction – Upper Level Renovations	
TRADES PRESENT	
Holgate Construction Co.

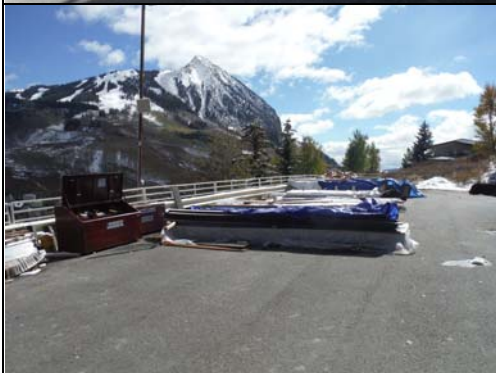
PHOTO –WORK ITEM	DESCRIPTION	ACTION
 	<p>10/16/13 – Photo 1 Building A Work Area Looking South</p> <p>Cutting area is situated between Units 8 & 9.</p>	<p>Note</p>

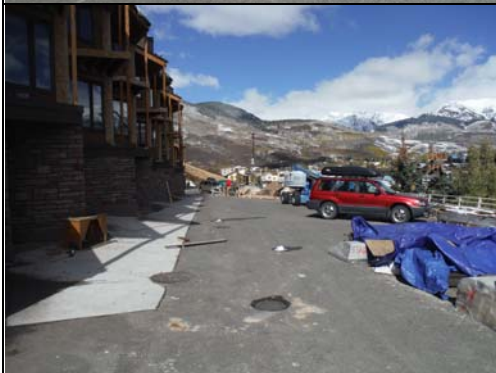
<p>10/16/13 – Photo 2 Upper Parking Area Material Staging</p> <p>Materials are staged in the parking area in front of Units 1 through 4.</p>	<p>Note</p>

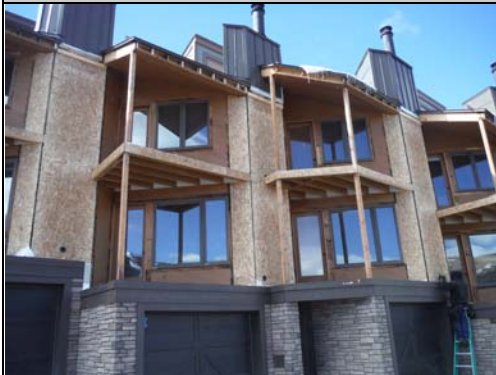
<p>10/16/13 – Photo 3 Upper Level Parking Looking North</p>	<p>Note</p>
 	<p>10/16/13 – Photo 4 Units 1 & 2</p> <p>2nd Floor belly band and scupper installation underway.</p>	<p>Note</p>

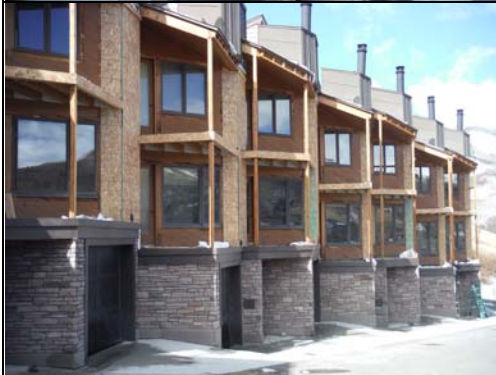
<p>10/16/13 – Photo 5 Units 3 & 4</p> <p>2nd Floor belly band and scupper installation underway.</p>	<p>Note</p>
 	<p>10/16/13 – Photo 6 Units 5 & 6</p> <p>Belly band installation complete. Scupper installation underway.</p>	<p>Note</p>
 	<p>10/16/13 – Photo 7 Units 7 & 8</p> <p>Belly band installation complete. Scupper installation complete.</p>	<p>Note</p>

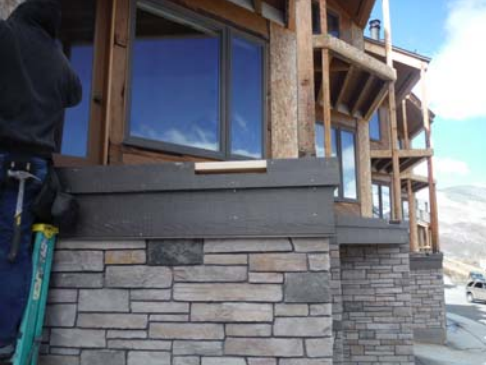
<p>10/16/13 – Photo 10 Unit 5 2nd Floor Deck Scupper</p> <p>Metal scupper installation underway.</p>	<p>Note</p>

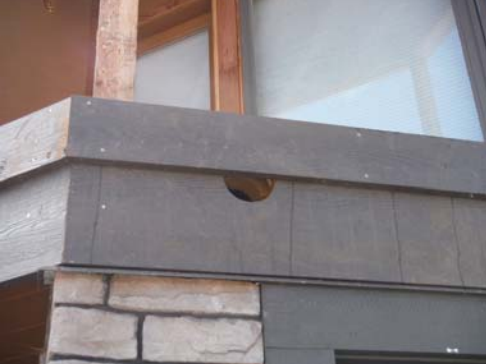
<p>10/16/13 – Photo 11 Unit 8 Dryer Vent Hood</p> <p>New vent hood will be black to match the ENT specification. Hood location will interfere slightly with the address number.</p>	<p>Note</p>

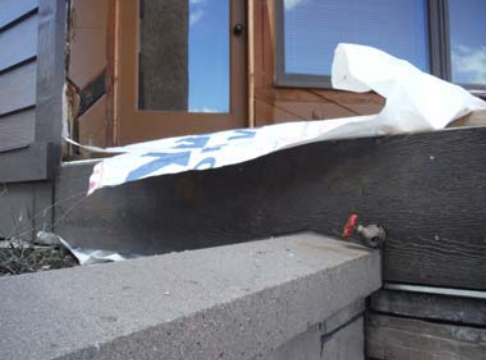
<p>10/16/13 – Photo 12 Unit 9 Hose Bibb</p> <p>Band has been trimmed around the existing hose bibb.</p>	<p>Note</p>
