ARCHITECT'S FIELD REPORT

051

PROJECT	Eagle's Nest Townhouses 11 Morning Glory Way & 31 Marcellina Lane Mt. Crested Butte, CO 81225	DATE	5/24/11
----------------	--	-------------	---------

WORK OBSERVED	
Phase II – Sewer and Asphalt Pre-Construction	
TRADES PRESENT	
Lacy Construction

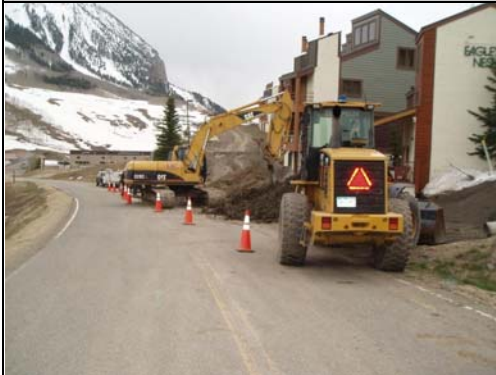
<p>5/23/11 – Photo 1 Morning Glory and Lower Level Entrance</p> <p>Lacy Construction is potholing to locate the Lower Level Sewer Line.</p>	<p>Note</p>

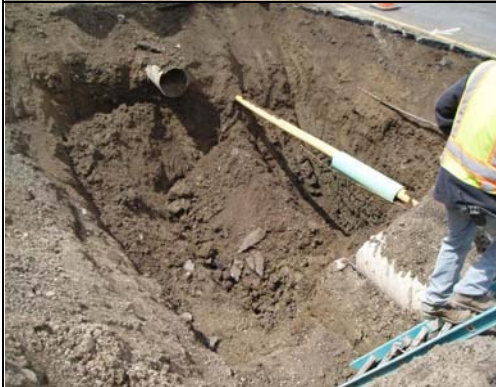
<p>5/23/11 – Photo 2 Morning Glory and Lower Level Entrance</p> <p>Pothole is approximately 12' deep. Town of Mt. Crested Butte Sanitation Dept was on-site for observation and coordination.</p>	<p>Note</p>

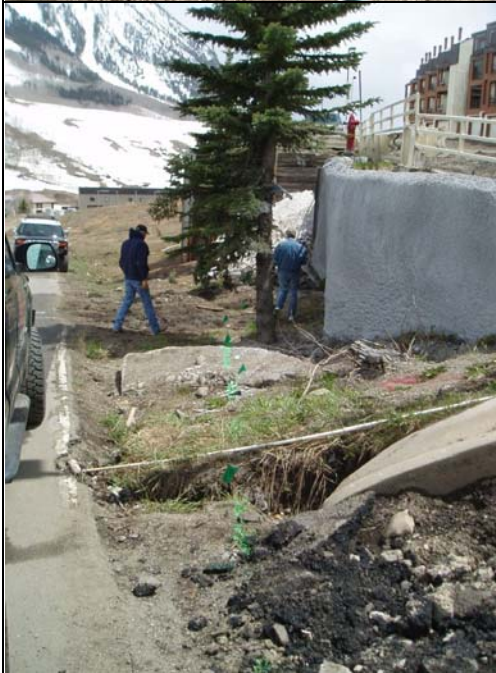
<p>5/23/11 – Photo 3 Lower Level Site</p> <p>Green paint marks locate for sewer and drain line.</p>	<p>Note</p>

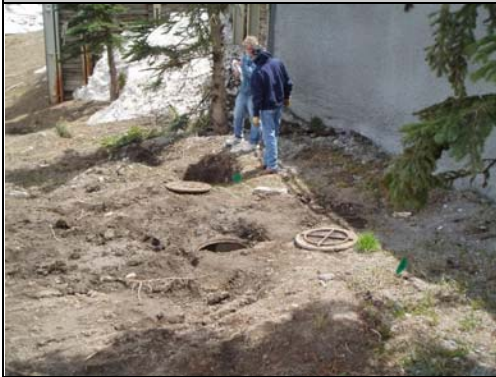
<p>5/23/11 – Photo 4 Lower Level Site</p> <p>Lacy was able to locate and excavate two unknown manholes.</p>	<p>Note</p>

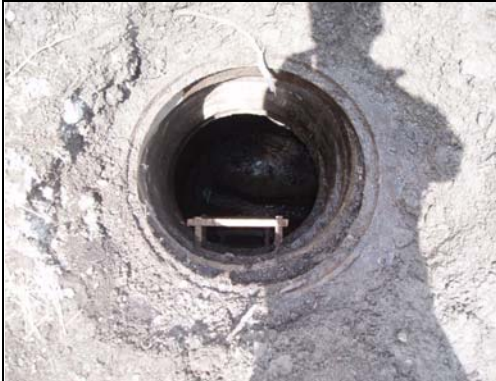
<p>5/23/11 – Photo 5 Lower Level Site</p> <p>Manhole #1 is the town sewer line.</p>	<p>Note</p>

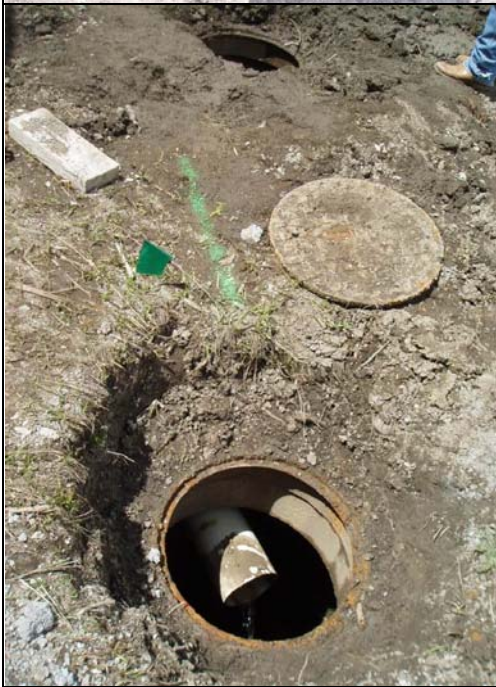
<p>5/23/11 – Photo 6 Lower Level Site Looking North</p> <p>Manhole #2 is an existing drywell apparently serving Eagle’s Nest. A 10” PVC line continues uphill to the driveway entrance.</p> <p>Once the location of the line is determined, the new underground drainage system could be tied into this drywell eliminating the need to install a new one.</p>	<p>Note</p>

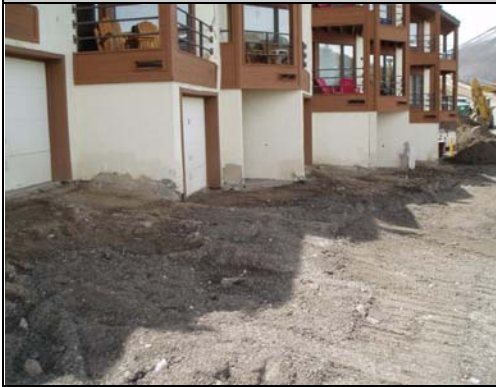
<p>5/23/11 – Photo 10 Lower Level Units 21 to 17</p> <p>Note stucco damage to lower portions of walls. This occurred in conjunction with the removal of the concrete aprons below.</p>	<p>Note</p>

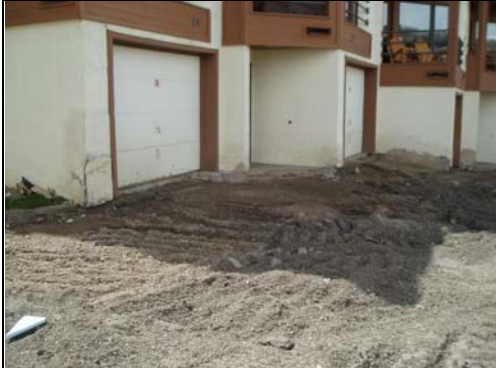
<p>5/23/11 – Photo 11 Lower Level Units 22 to 24</p> <p>Note stucco damage to lower portions of walls.</p>	<p>Note</p>

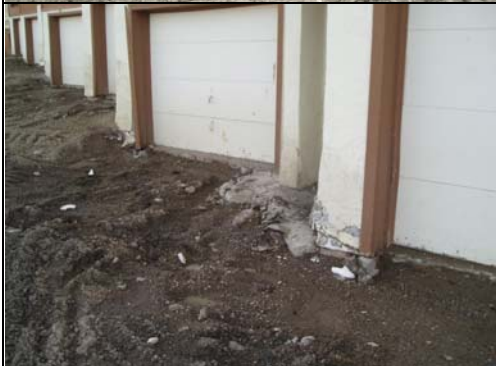
<p>5/23/11 – Photo 12 Lower Level Units 25 through 28</p> <p>Note stucco damage to lower portions of walls.</p>	<p>Note</p>

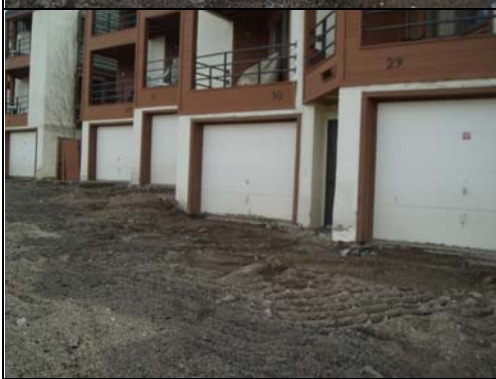
<p>5/23/11 – Photo 13 Lower Level Units 29 through 33</p> <p>Note stucco damage to lower portions of walls. Assessment of damages should be performed after installation of new concrete aprons as additional stucco removal may be necessary.</p>	<p>Note</p>

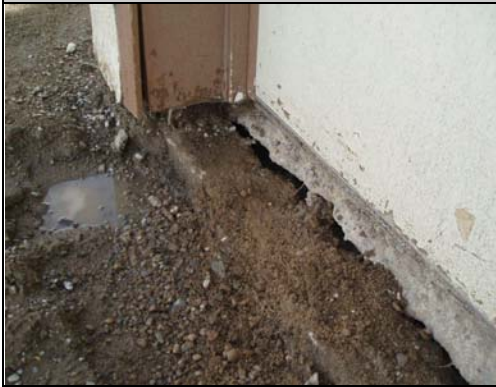
<p>5/23/11 – Photo 14 Example Garage Footing Unit 29</p> <p>Note the top of the garage footing is visible however concrete has been removed to the garage door threshold. Settling under the slab is visible. Edge will be cleaned and an expansion joint installed prior to pouring new concrete.</p>	<p>Note</p>

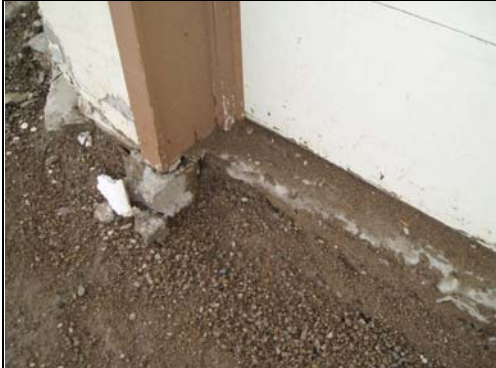
<p>5/23/11 – Photo 15 Example Garage Footing Unit 30</p> <p>Edge of garage slab is intact. There is no apparent consistency in garage slab and slab-to-apron construction.</p>	<p>Note</p>

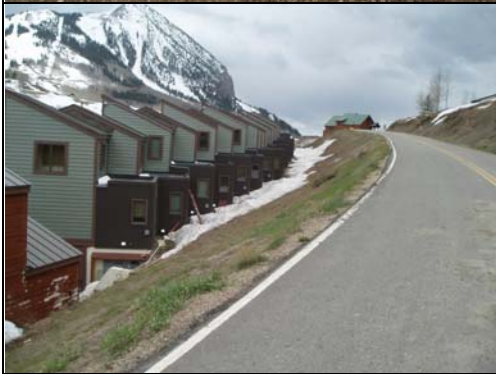
<p>5/23/11 – Photo 16 Lower Level Units</p> <p>Snowpack is receding.</p>	<p>Note</p>

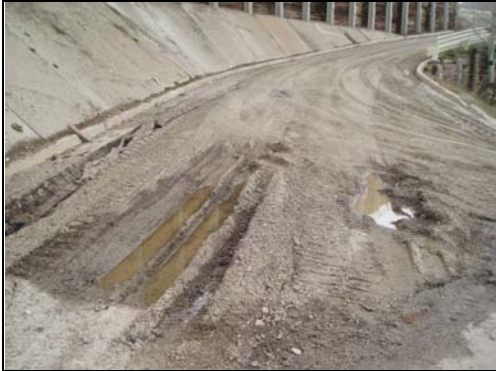
<p>5/23/11 – Photo 17 Upper Level Driveway Entrance</p> <p>Exposed area has collected an unusual amount of standing water. Bill recommends minor sub-surface drainage to the road-side swale.</p>	<p>Note</p>

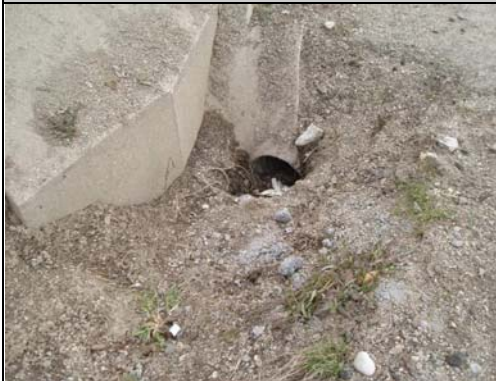
<p>5/23/11 – Photo 18 Upper Level Driveway Entrance</p> <p>Uphill portion of the culvert under the driveway needs to be cleared of sediment.</p>	<p>Note</p>

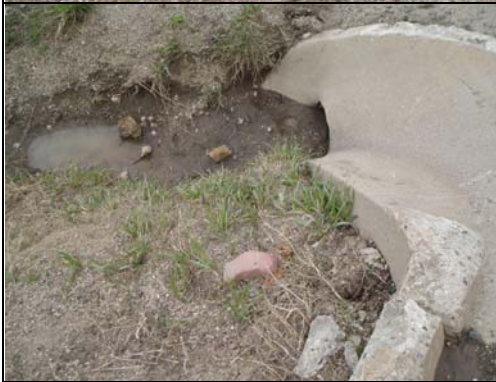
<p>5/23/11 – Photo 19 Upper Level Driveway Entrance</p> <p>Down-stream section of culvert needs attention.</p>	<p>Note</p>

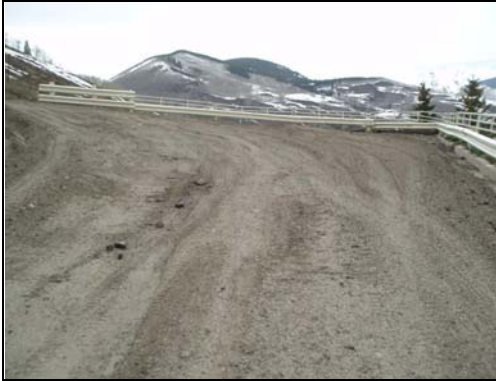
<p>5/23/11 – Photo 20 Turn at Upper Level Drive</p> <p>Asphalt has been pulverized.</p>	<p>Note</p>

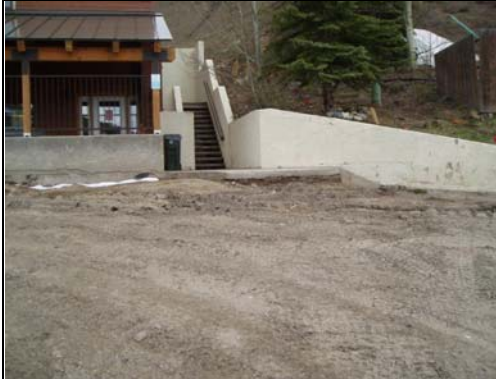
<p>5/23/11 – Photo 21 Upper Level Service Unit</p> <p>Asphalt has been pulverized.</p>	<p>Note</p>

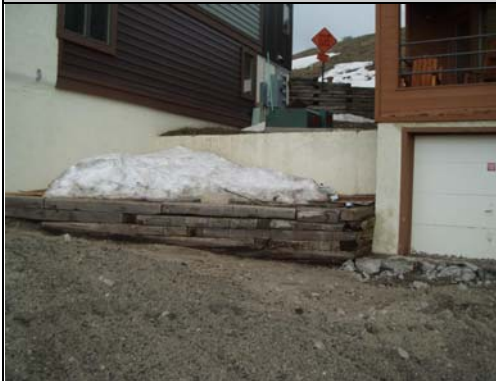
<p>5/23/11 – Photo 26 Between Units 8 & 9</p> <p>Timber retaining wall is in poor condition prior to site construction work. Additional photos were taken of this wall to document its condition.</p>	<p>Note</p>

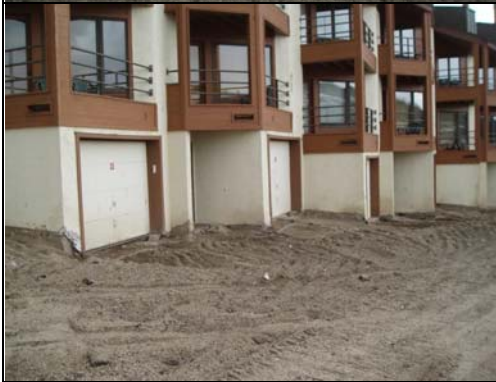
<p>5/23/11 – Photo 27 Units 5 through 8</p> <p>Minor stucco damage to lower portions of walls.</p>	<p>Note</p>

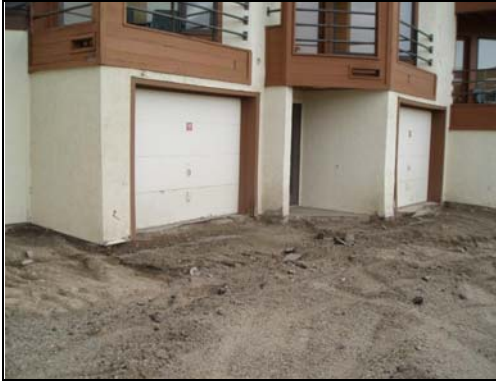
<p>5/23/11 – Photo 28 Units 1 & 2</p> <p>Stucco is in relatively good condition.</p>	<p>Note</p>

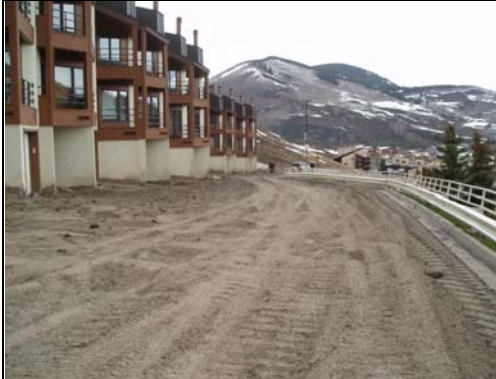
<p>5/23/11 – Photo 29 Upper Level Drive Looking North</p> <p>Asphalt has been pulverized.</p>	<p>Note</p>
