**ARCHITECT'S FIELD REPORT**

**060**

<b>PROJECT</b>	<b>Eagle's Nest Townhouses</b> 11 Morning Glory Way & 31 Marcellina Lane Mt. Crested Butte, CO 81225	<b>DATE</b>	9/01/11
----------------	--	-------------	---------

<b>WORK OBSERVED</b>	
Phase II – Garage Apron Photos from Owner Punch List Items	
<b>TRADES PRESENT</b>	
None

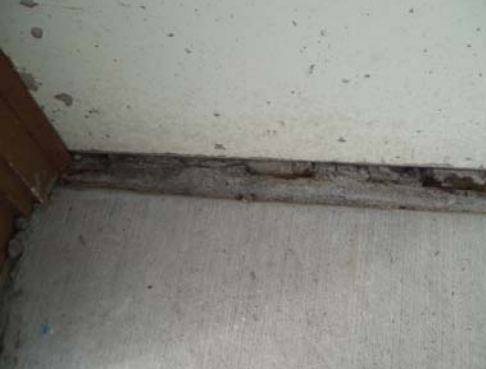
<p>9/01/11 – Photo 2 Unit 2 South Threshold</p> <p>Note Steel Threshold Bar and chipped concrete. Demolition was held to the exterior of the existing steel bar; condition could be existing.</p>	<p>Note</p>

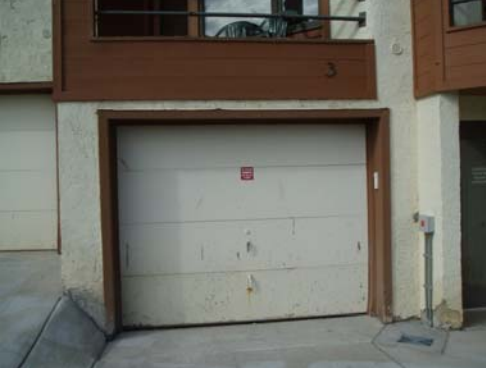
<p>9/01/11 – Photo 3 Unit 3</p>	<p>Note</p>
 	<p>9/01/11 – Photo 4 Unit 3 South Threshold</p> <p>Note Steel Threshold Bar and chipped concrete. Demolition was held to the exterior of the existing steel bar; condition could be existing.</p>	<p>Note</p>

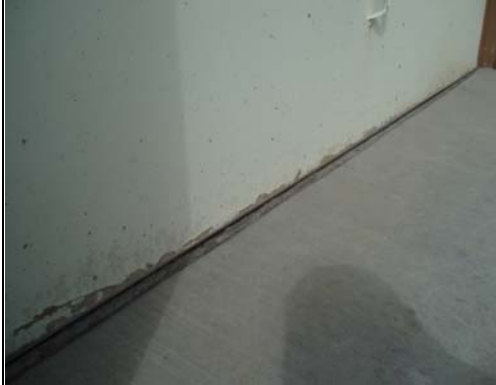
<p>9/01/11 – Photo 7 Unit 4</p> <p>Threshold</p> <p>Further investigation required. Did not document interior conditions. Exterior appeared in good shape. Concrete poured to existing Steel Threshold Bar.</p>	<p>Note</p>

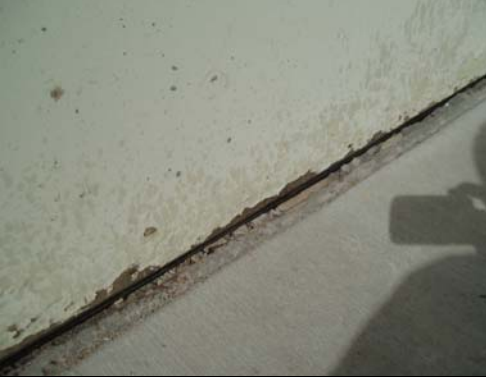
<p>9/01/11 – Photo 9 Unit 6 Threshold</p> <p>Further investigation required. Did not document interior conditions. Exterior appeared in good shape. Concrete poured to existing Steel Threshold Bar.</p>	<p>Note</p>

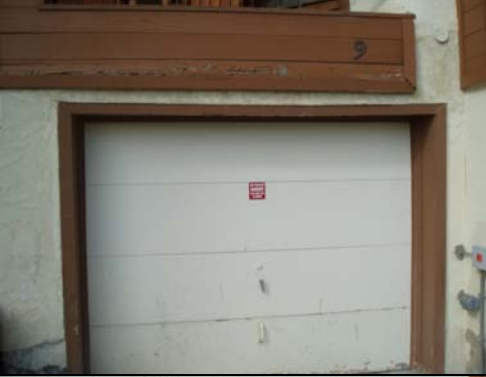
<p>9/01/11 – Photo 10 Unit 9</p> <p>“Holes in South Wall” were not documented. Further clarification required.</p>	<p>CBL ENT</p>

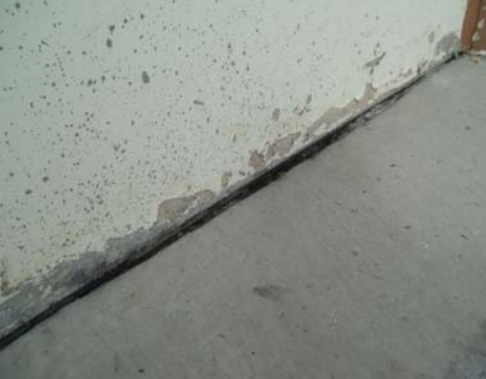
<p>9/01/11 – Photo 11 Unit 9 Threshold</p> <p>Concrete poured to existing Steel Threshold Bar.</p>	<p>Note</p>

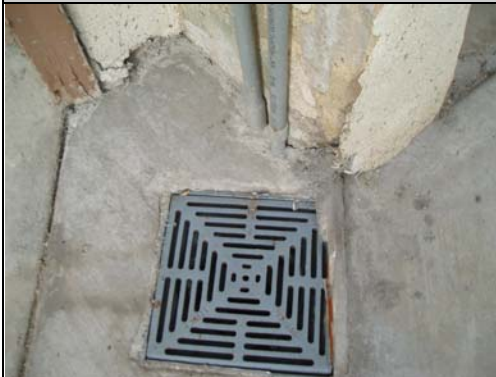
<p>9/01/11 – Photo 12 Unit 9 Area Drain</p> <p>Concrete still evident at top right-hand corner of operable area drain grate.</p>	<p>Note</p>

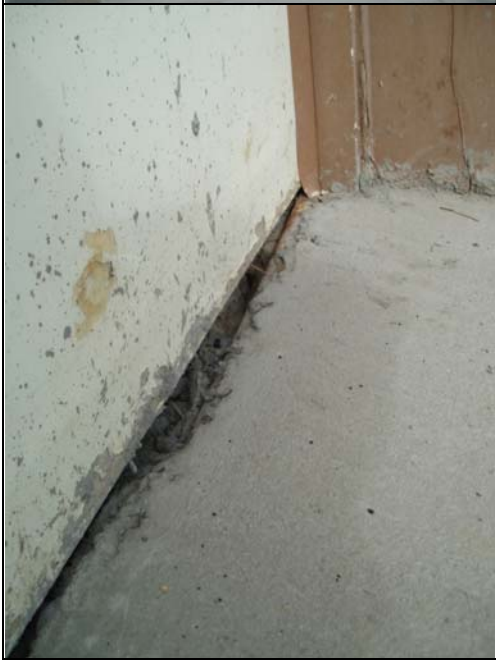
<p>9/01/11 – Photo 14 Unit 13</p> <p>North Threshold</p> <p>Concrete at north threshold was poured against existing Steel Threshold Bar. Bar appears to have been damaged during demolition.</p>	<p>Note</p>

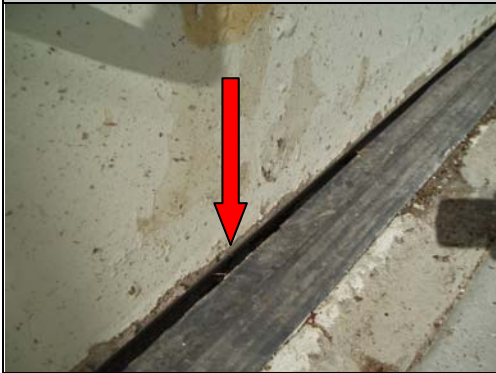
<p>9/01/11 – Photo 31 Unit 28 Existing Threshold; New concrete stops in lower right-hand corner.</p> <p>Note existing vinyl garage door threshold is not located under the garage door. Any water flowing on the garage door face will likely enter the garage.</p>	<p>Note</p>

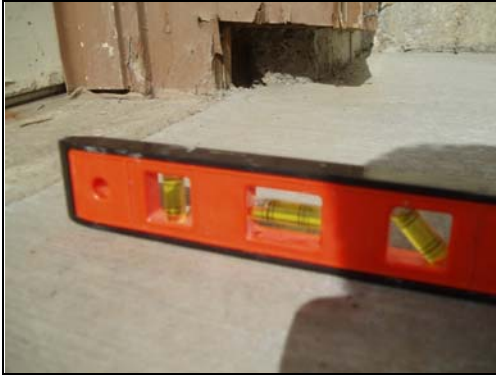
<p>9/01/11 – Photo 34 Unit 29 North Threshold Inside Valley Pan Slope: CORRECT</p>	<p>Note</p>

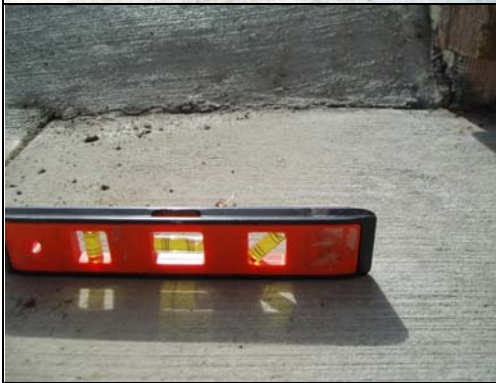
<p>9/01/11 – Photo 40 Unit 30 South Threshold Outside Valley Pan Slope: CORRECT</p>	<p>Note</p>

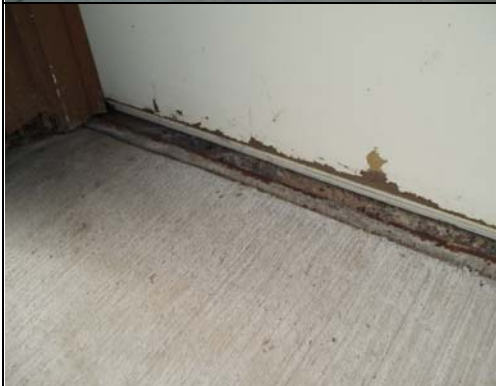
<p>9/01/11 – Photo 43 Unit 32</p> <p>South Threshold</p> <p>Concrete poured to existing Steel Threshold Bar.</p>	<p>Note</p>
 	<p>9/01/11 – Photo 44 Unit 32</p> <p>South Threshold Detail</p> <p>Concrete on interior of Steel Threshold Bar is approximately ¼" lower. Further investigation required.</p>	<p>Note</p>

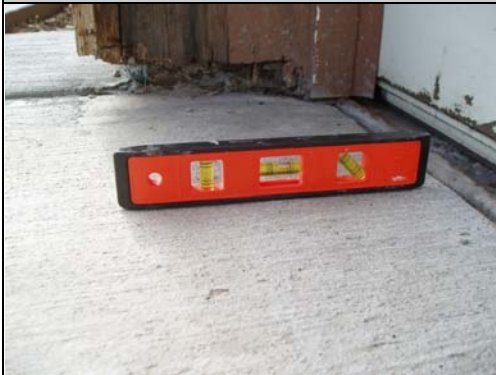
<p>9/01/11 – Photo 45 Unit 32 South Threshold Inside Valley Pan Slope: CORRECT</p>	<p>Note</p>

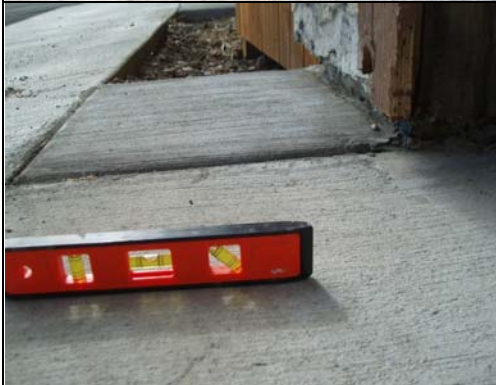
<p>9/01/11 – Photo 46 Unit 32 South Threshold Outside Valley Pan Slope: CORRECT</p>	<p>Note</p>

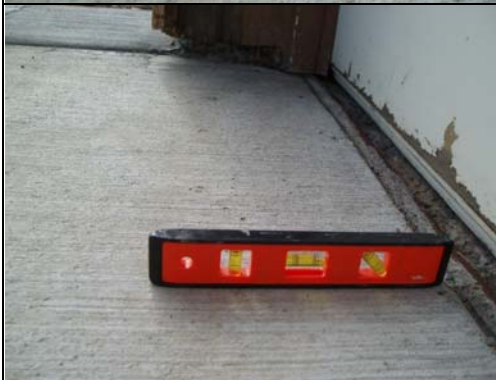
<p>9/01/11 – Photo 47 Unit 32 South Threshold (2' North of Photo 45) Inside Valley Pan Slope: CORRECT</p>	<p>Note</p>

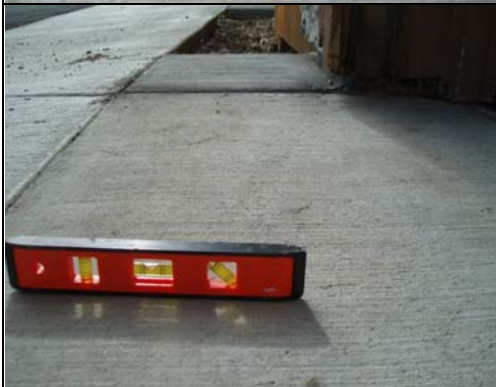
<p>9/01/11 – Photo 48 Unit 32 South Threshold (2' North of Photo 45) Outside Valley Pan Slope: CORRECT</p>	<p>Note</p>

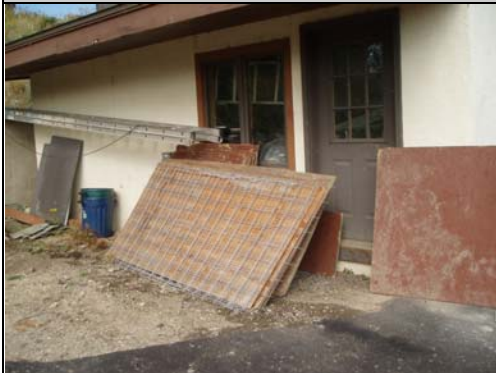
<p>9/01/11 – Photo 63 Upper Level Maintenance Shed</p> <p>Wire mesh remains.</p>	<p>LC</p>

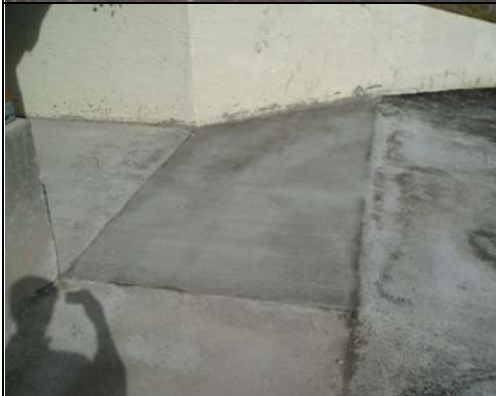
<p>9/01/11 – Photo 64 Upper Level Caretaker Sidewalk</p> <p>Section of sidewalk has been removed and replaced.</p>	<p>Note</p>

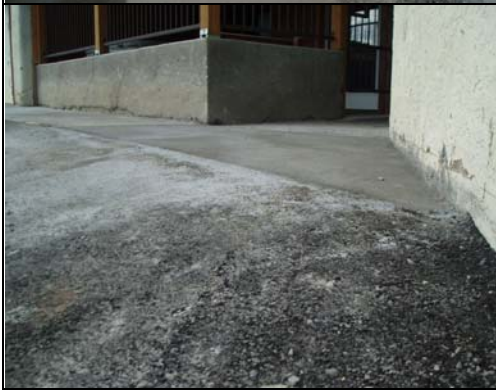
<p>9/01/11 – Photo 65 Upper Level Caretaker Sidewalk</p> <p>Section of sidewalk has been removed and replaced. Note pitch to north retaining wall.</p>	<p>Note</p>
