ARCHITECT'S FIELD REPORT

PROJECT	Eagle's Nest Townhouses 11 Morning Glory Way & 31 Marcellina Lane Mt. Crested Butte, CO 81225	DATE	6/19/13
----------------	--	-------------	---------

CONDITIONS			
DATE	6/19/13	TIME	10:30 am
WEATHER	Clear, Sunny, Hot	TEMP	60 deg

WORK OBSERVED	
Phase IV Construction	
TRADES PRESENT	
Holgate Construction Co.

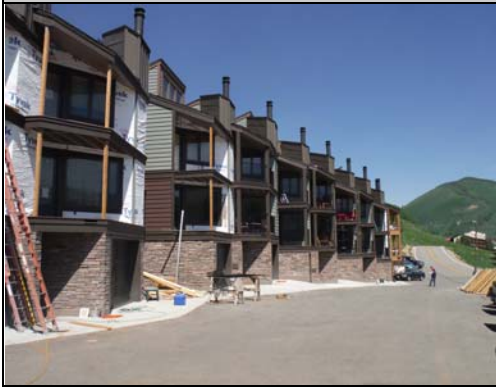
<p>6/19/13 – Photo 1 Building C Looking North</p> <p>Siding, Guardrail and Light Fixture installation underway. Units 20, 21, 22, and 23 are substantially complete.</p>	<p>Note</p>

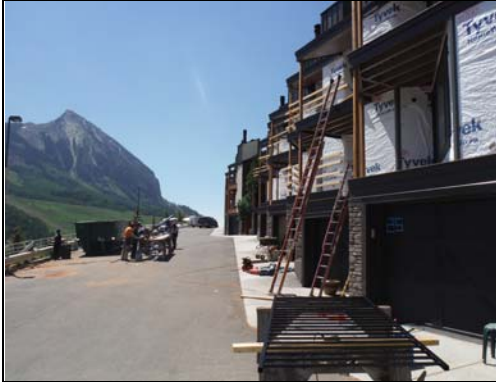
<p>6/19/13 – Photo 2 Building D Looking South</p> <p>Cutting and work area have been moved to the front of Building D.</p>	<p>Note</p>

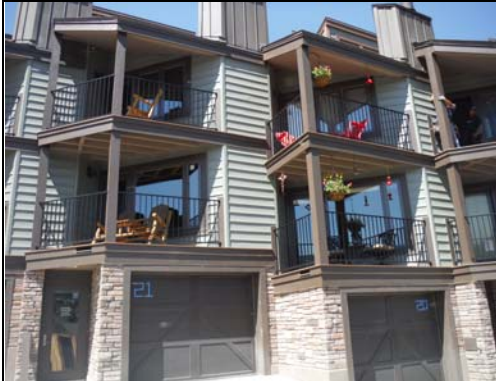
<p>6/19/13 – Photo 3 Units 20 & 21</p> <p>Installed siding, 3rd floor deck, guardrails, and light fixtures on Units 20 & 21.</p>	<p>Note</p>

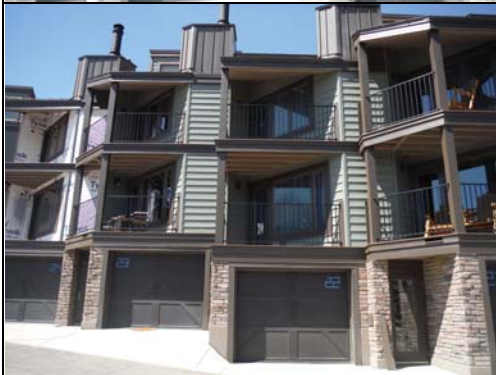
<p>6/19/13 – Photo 4 Units 22 & 23</p> <p>Installed siding, 3rd floor deck and guardrails on Units 22 & 23.</p>	<p>Note</p>

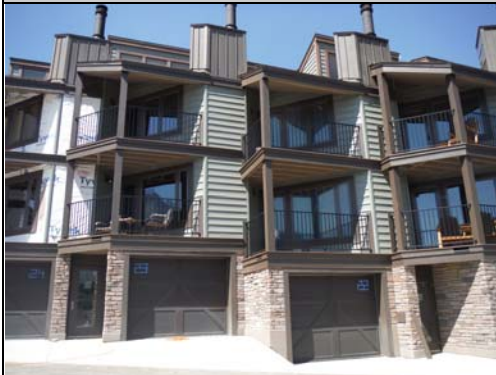
<p>6/19/13 – Photo 5 Units 22 & 23</p> <p>Alternate angle to see north facing guardrails.</p>	<p>Note</p>
 	<p>6/19/13 – Photo 6 3rd Floor Deck Unit 19</p> <p>Bottom bracket installation underway.</p>	<p>Note</p>

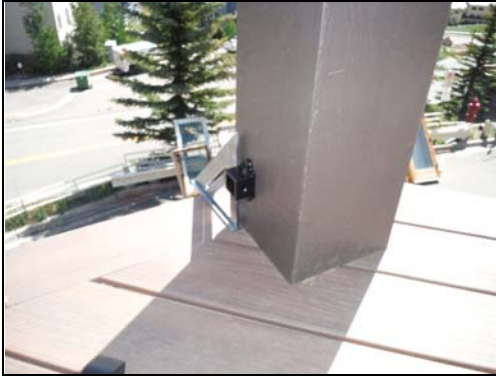
<p>6/19/13 – Photo 7 Guardrail Bracket on Wood Column</p>	<p>Note</p>
 	<p>6/19/13 – Photo 8 Unit 19 – 3rd Floor Deck</p> <p>Fiberon decking has been installed in the same manner as the 2nd floor.</p>	<p>Note</p>

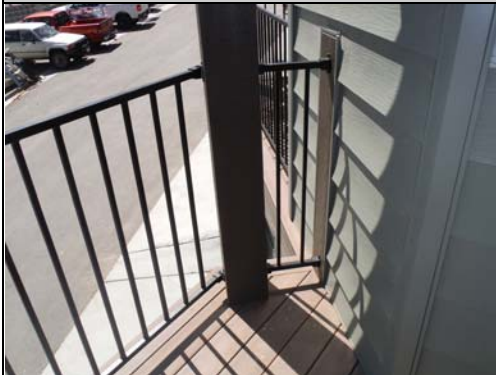
<p>6/19/13 – Photo 9 Unit 19 2nd Floor Guardrail</p> <p>Installed guardrails.</p>	<p>Note</p>

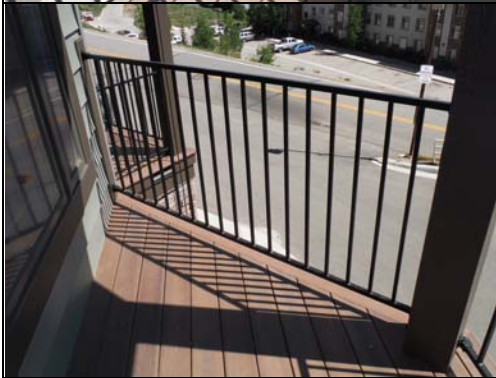
<p>6/19/13 – Photo 10 Unit 19 2nd Floor Guardrail</p> <p>Installed guardrails.</p>	<p>Note</p>

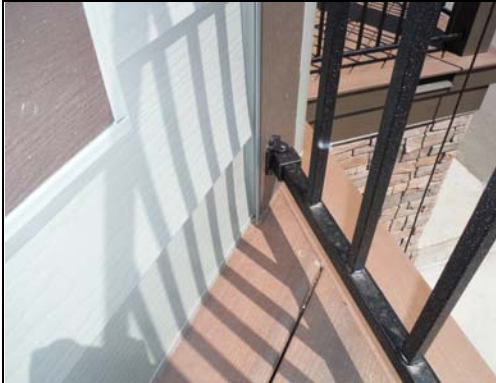
<p>6/19/13 – Photo 11 Unit 19 Guardrail Bottom Bracket</p> <p>Installed bottom bracket for the guardrail.</p>	<p>Note</p>

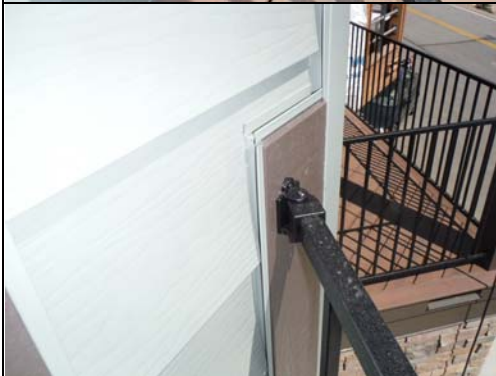
<p>6/19/13 – Photo 12 Unit 19 Guardrail Top Bracket</p> <p>Installed top bracket for the guardrail.</p>	<p>Note</p>

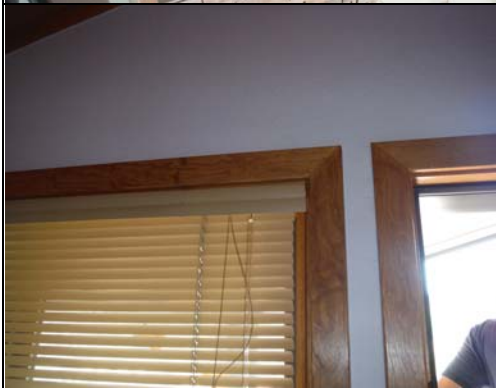
<p>6/19/13 – Photo 15 Interior Trim, 3rd Floor Unit 19</p> <p>New interior trim matches the existing wooding trim.</p>	<p>Note</p>

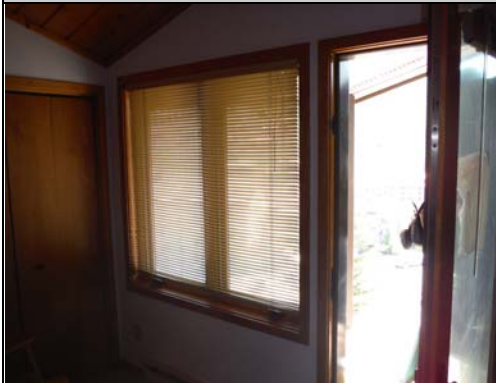
<p>6/19/13 – Photo 16 Interior Trim, 3rd Floor Unit 19</p> <p>Note: Blinds have been re-installed by Holgate Construction.</p>	<p>Note</p>

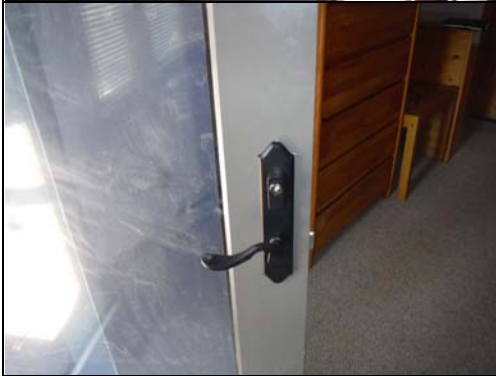
<p>6/19/13 – Photo 17 Door Hardware, Detail</p> <p>Door hardware on the initial shipment as keys.</p>	<p>Note</p>

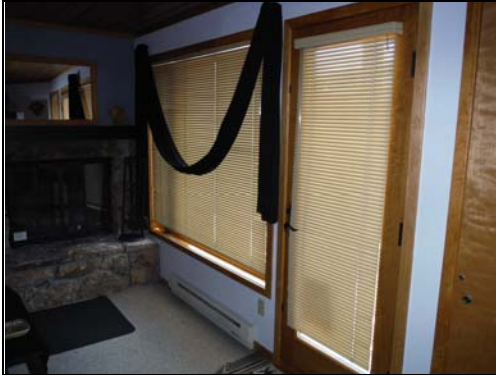
<p>6/19/13 – Photo 18 Interior Trim, 2nd Floor Unit 19</p> <p>Completed interior trim. Blinds have been re-installed.</p>	<p>Note</p>

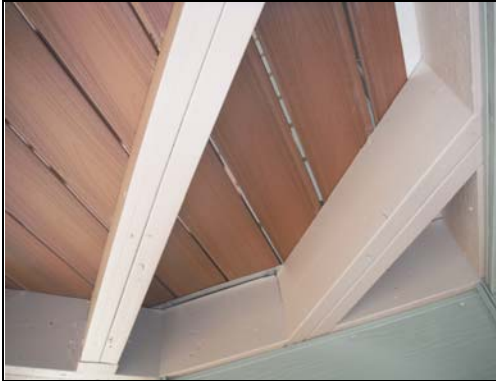
<p>6/19/13 – Photo 19 Looking Up at 3rd Floor Deck</p> <p>Fiberon decking from underneath.</p>	<p>Note</p>

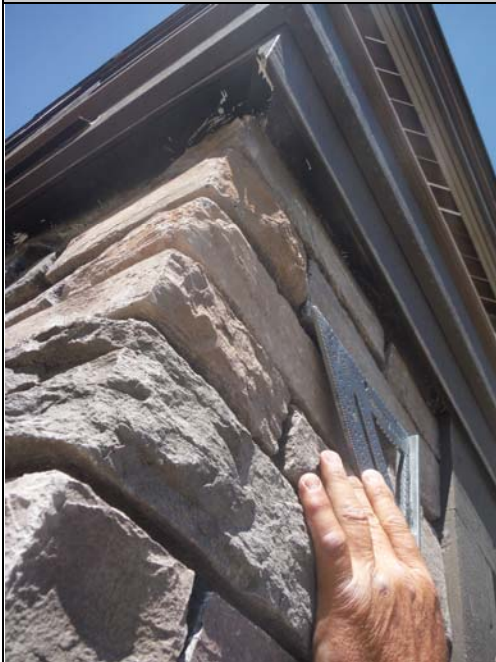
<p>6/19/13 – Photo 20 Unit 24, Example Address Sign Location</p> <p>Sign placement and materials were discussed.</p>	<p>Note</p>

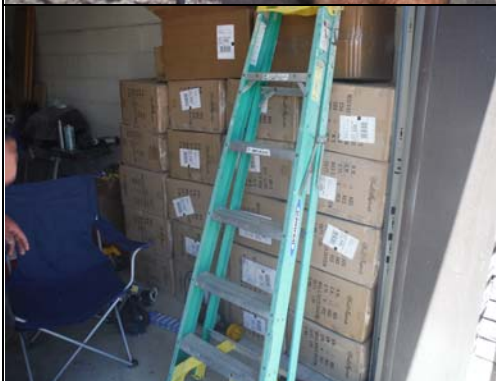
<p>6/19/13 – Photo 21 Light Fixtures</p> <p>Light fixtures have arrived and are stored on site at Unit 26 garage.</p>	<p>Note</p>

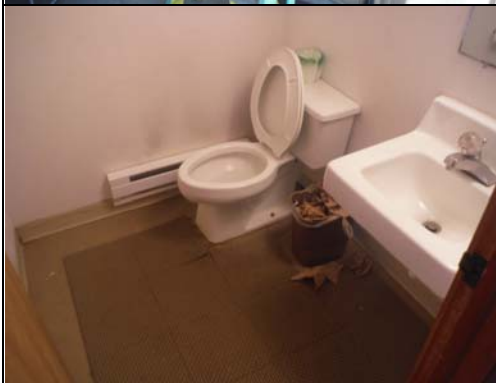
<p>6/19/13 – Photo 22 Lower Level Hot Tub Restroom</p> <p>Restroom is clean but not especially tidy.</p>	<p>Note</p>

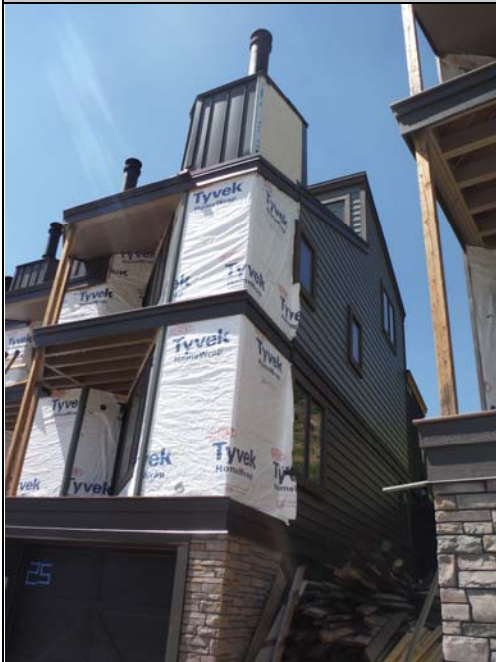
<p>6/19/13 – Photo 23 Unit 25 Chimney End</p> <p>Fascia and belly bands have been extended around the chimney on Unit 25.</p>	<p>Note</p>

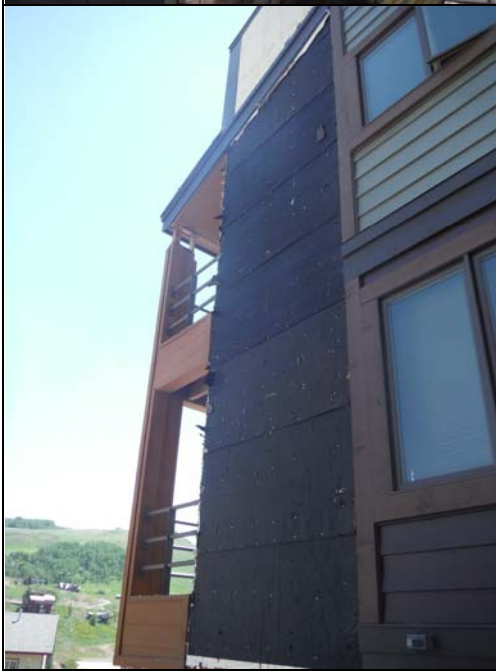
<p>6/19/13 – Photo 24 Unit 17, North Elevation Chimney</p> <p>Stucco face was demolished before the planned construction schedule. This was done to best accommodate space available in the dumpster. MH is aware that this work has disturbed the tenants currently in residence.</p>	<p>Note</p>
