# ARCHITECT'S FIELD REPORT

107

<b>PROJECT</b>	<b>Eagle's Nest Townhouses</b>	<b>DATE</b>	5/22/13
	11 Morning Glory Way & 31 Marcellina Lane	<b>REV</b>	5/23/13
	Mt. Crested Butte, CO 81225

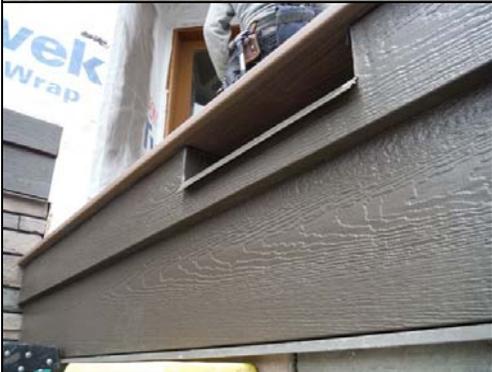
<p>5/21/13 – Photo 2 Unit 20, 2<sup>nd</sup> Floor Deck Detail</p> <p>Fiberon “Tudor Brown” deck edge board has been installed.</p>	<p>Note</p>

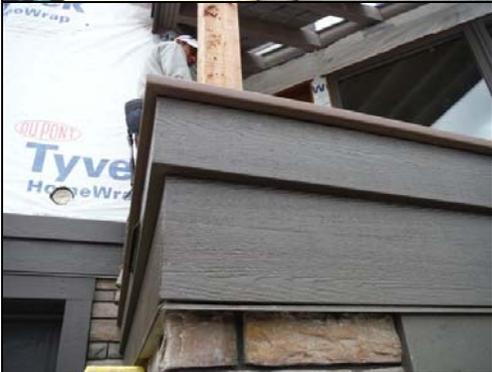
<p>5/21/13 – Photo 3 Unit 20, 2<sup>nd</sup> Floor Deck Detail</p> <p>View of leading edge of deck board.</p>	<p>Note</p>

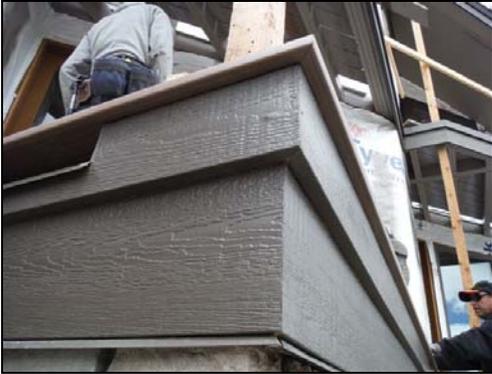
<p>5/21/13 – Photo 4 Unit 20, 2<sup>nd</sup> Floor Deck Detail</p> <p>View #2 of the deck corner.</p>	<p>Note</p>

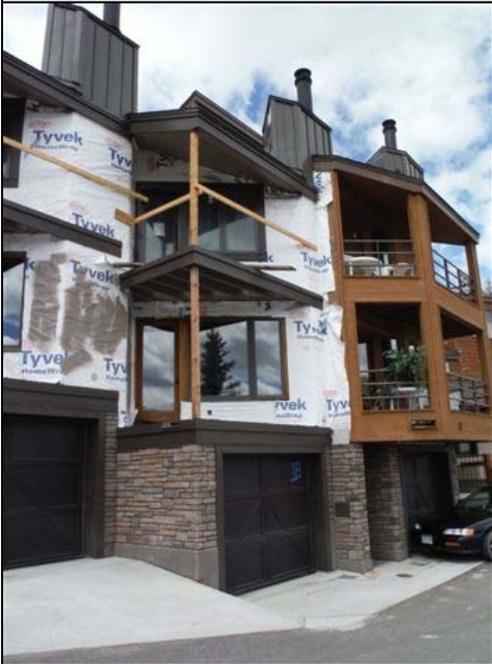
<p>5/21/13 – Photo 5 Unit 18</p> <p>Building C: Fascia Boards, Soffit Paint, Soffit Vent, 3<sup>rd</sup> Floor Belly Band, Deck Joist Paint, 2<sup>nd</sup> Floor EPDM, Scupper Drain, 2<sup>nd</sup> Floor Belly Band complete.</p> <p>Awaiting 2<sup>nd</sup> Floor Deck Boards, 2<sup>nd</sup> Floor Doors and Windows, Window Trim, Siding and Railings.</p>	<p>Note</p>

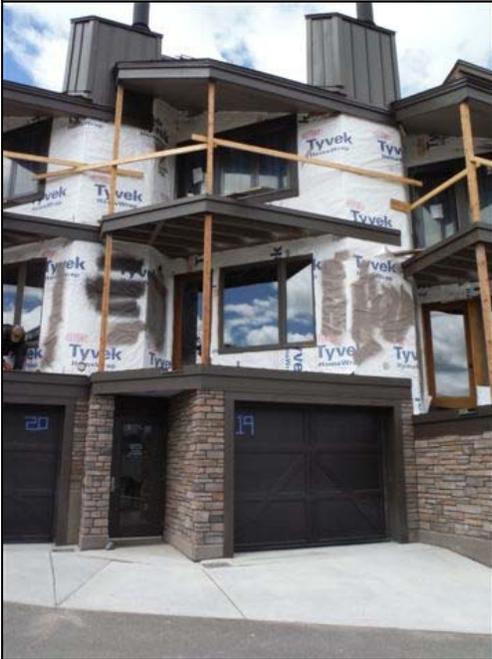
<p>5/21/13 – Photo 6 Unit 19</p> <p>Note fascia and belly bands are complete.</p>	<p>Note</p>

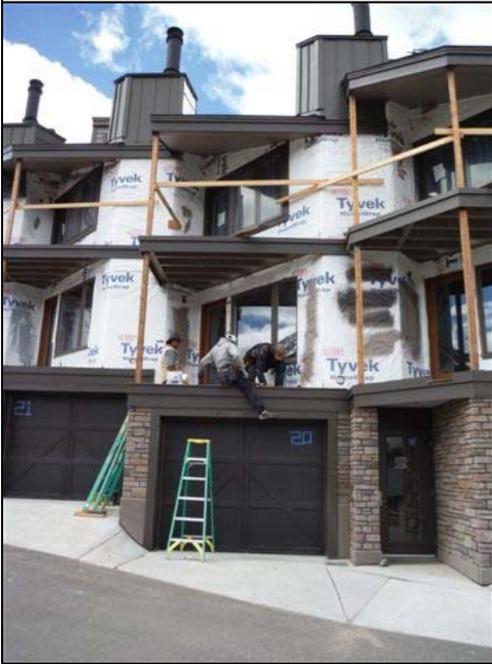
<p>5/21/13 – Photo 7 Unit 20</p> <p>Deck installation underway.</p>	<p>Note</p>

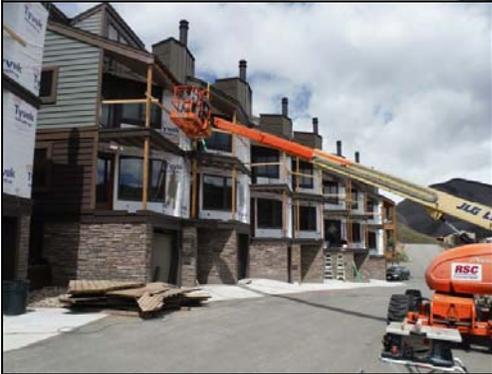
<p>5/21/13 – Photo 9 Unit 24</p> <p>Fascia replacement underway.</p>	<p>Note</p>

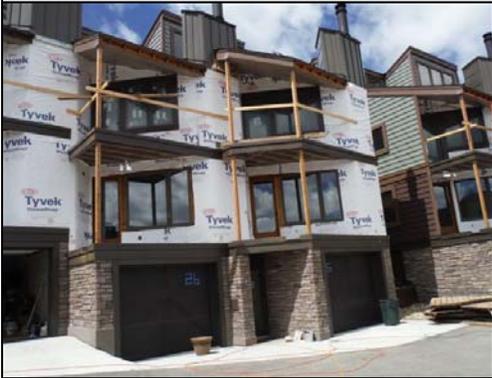
<p>5/21/13 – Photo 10 Units 25 &amp; 26</p> <p>Upper level fascia boards have been removed. All chimney flue paint is complete on Buildings C &amp; D.</p>	<p>Note</p>

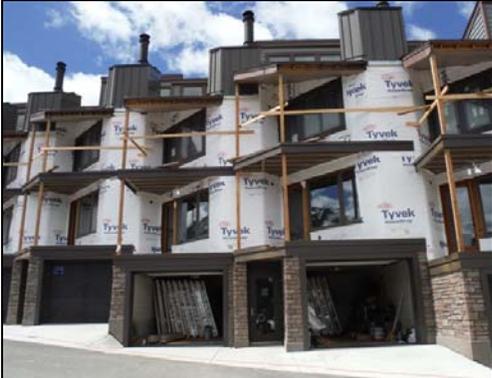
<p>5/21/13 – Photo 11 Units 26 &amp; 27</p> <p>Materials are still stored in the garages.</p>	<p>Note</p>

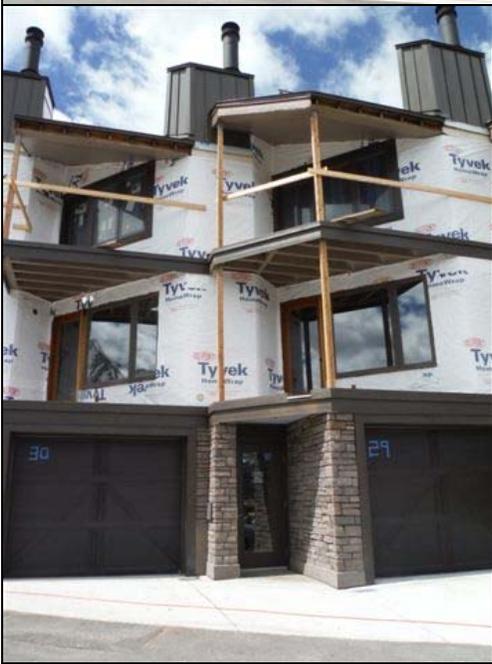
<p>5/21/13 – Photo 12 Units 29 &amp; 30</p> <p>Building D: Soffit Paint, Soffit Vents, 3<sup>rd</sup> Floor Belly Band, Deck Joist Paint, 2<sup>nd</sup> Floor EPDM, Scupper Drain, 2<sup>nd</sup> Floor Belly Band complete.</p>	<p>Note</p>

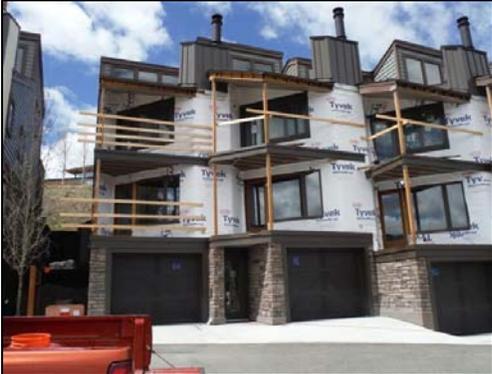
<p>5/21/13 – Photo 13 Units 31 &amp; 32</p> <p>Note additional temporary guardrails were installed at Unit 32.</p>	<p>Note</p>

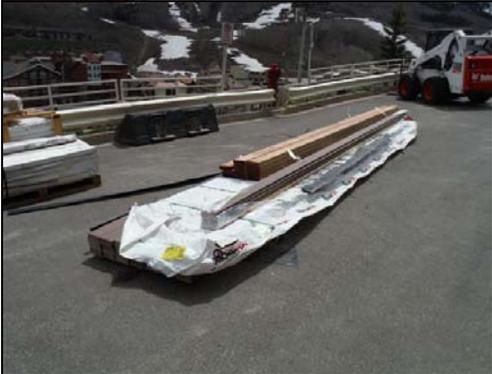
<p>5/21/13 – Photo 14 Fiberon Decking</p> <p>Boards for the initial mock-up are on site.</p>	<p>Note</p>

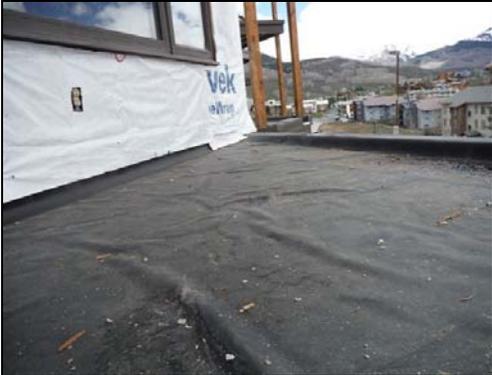
<p>5/21/13 – Photo 16 Unit 31 Deck Detail</p> <p>EPDM Membrane is in place. Membrane is installed as a single piece without intermittent seams.</p>	<p>Note</p>

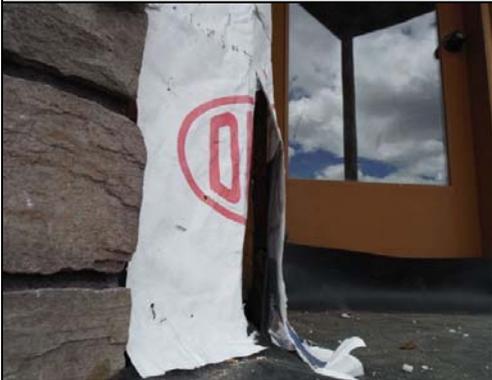
<p>5/21/13 – Photo 17 Unit 32</p> <p>Detail of EPDM Membrane extending up wall approximately 8” per the drawings.</p>	<p>Note</p>

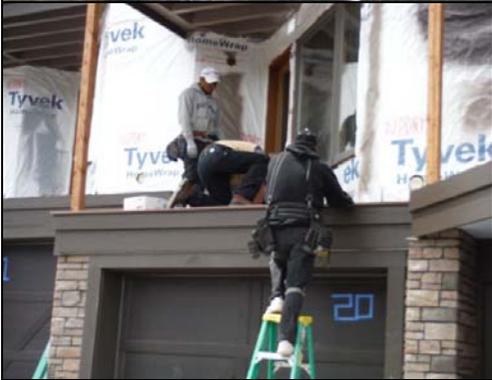
<p>5/21/13 – Photo 18 Unit 20</p> <p>Fiberon Deck installation underway.</p> <p>Photos of the completed deck will come from MH.</p>	<p>Note</p>

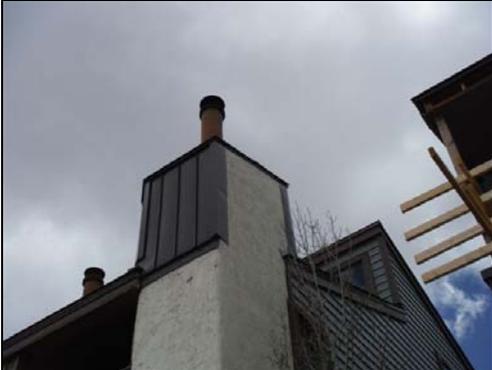
<p>5/21/13 – Photo 19 Unit 33, North Upper Chimney</p> <p>Area to receive new standing seam metal siding is above the fascia.</p>	<p>Note</p>

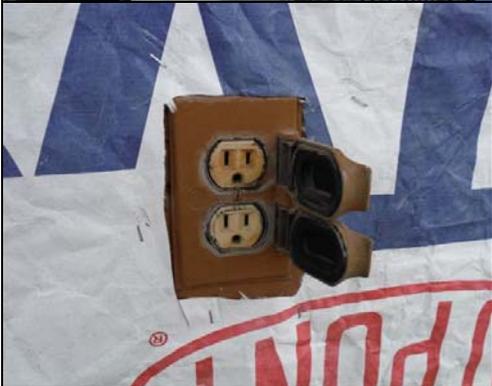
<p>5/21/13 – Photo 20 Unit 30, Exterior Electrical Outlet</p> <p>Existing receptacle is not GFCI protected.</p>	<p>Note</p>

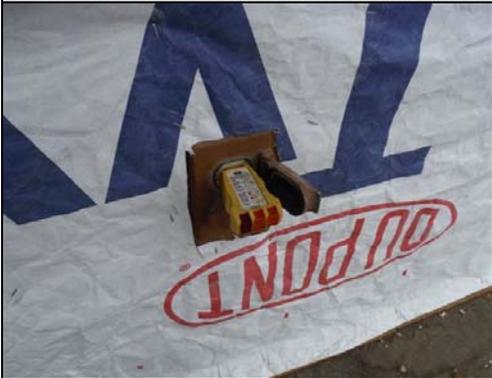
<p>5/21/13 – Photo 21 Unit 30, Exterior Electrical Outlet</p> <p>Voltmeter in place to test circuit location. It was determined that the exterior outlet is on the Living Room</p>	<p>Note</p>

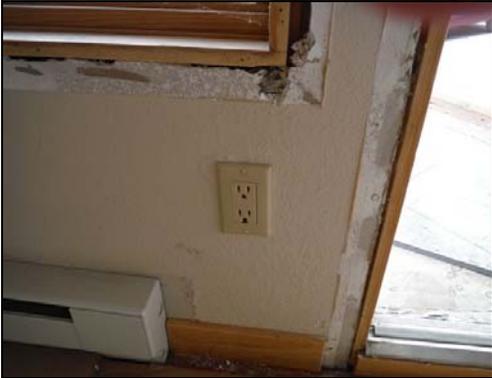
<p>5/21/13 – Photo 22 Unit 30, Interior Outlet Location</p> <p>Likely the last receptacle on the outlet circuit.</p>	<p>Note</p>

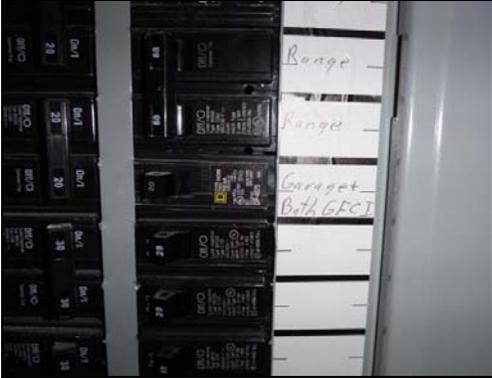
<p>5/21/13 – Photo 23 Unit 26 Break Panel</p> <p>The Living Room outlet circuit is not GFCI protected. The only circuit that is GFCI protected is the Garage/Bath circuit.</p>	<p>Note</p>

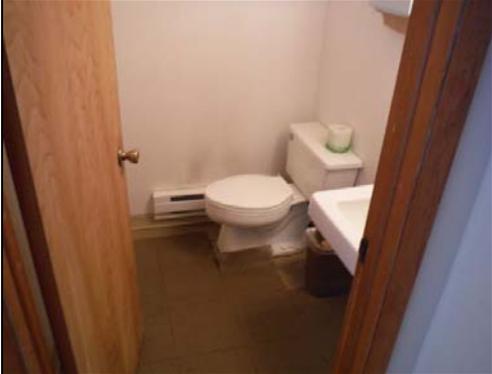
<p>5/21/13 – Photo 24 Lower Level Hot Tub Restroom</p> <p>Restroom is clean and in good order.</p>	<p>Note</p>

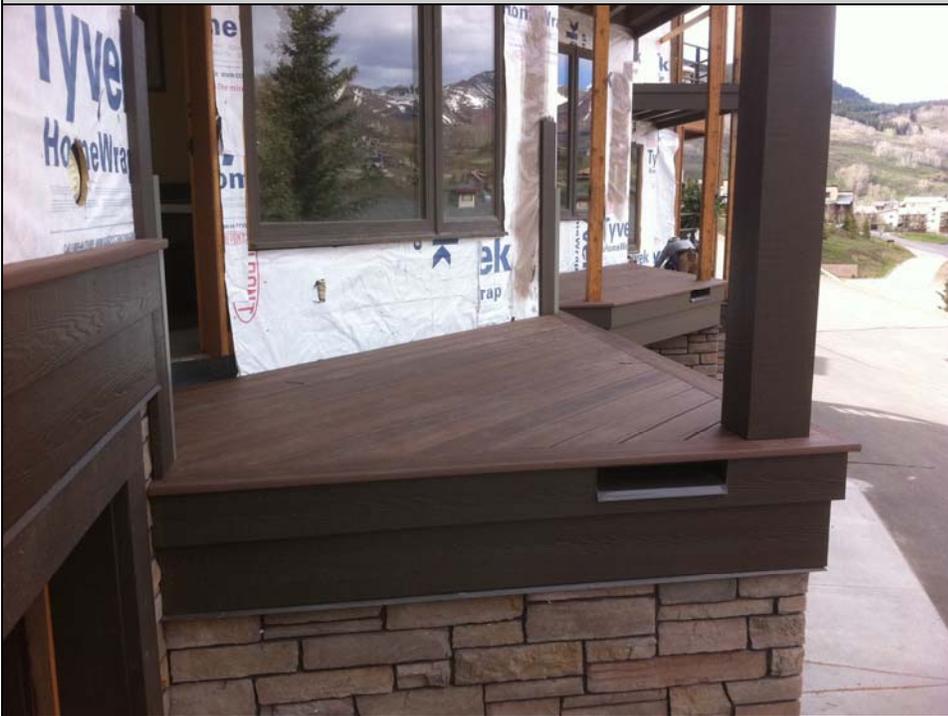
5/22/13 – Photo 25 – Completed Mock-Up Deck Installation  
Photo by Mick Holgate

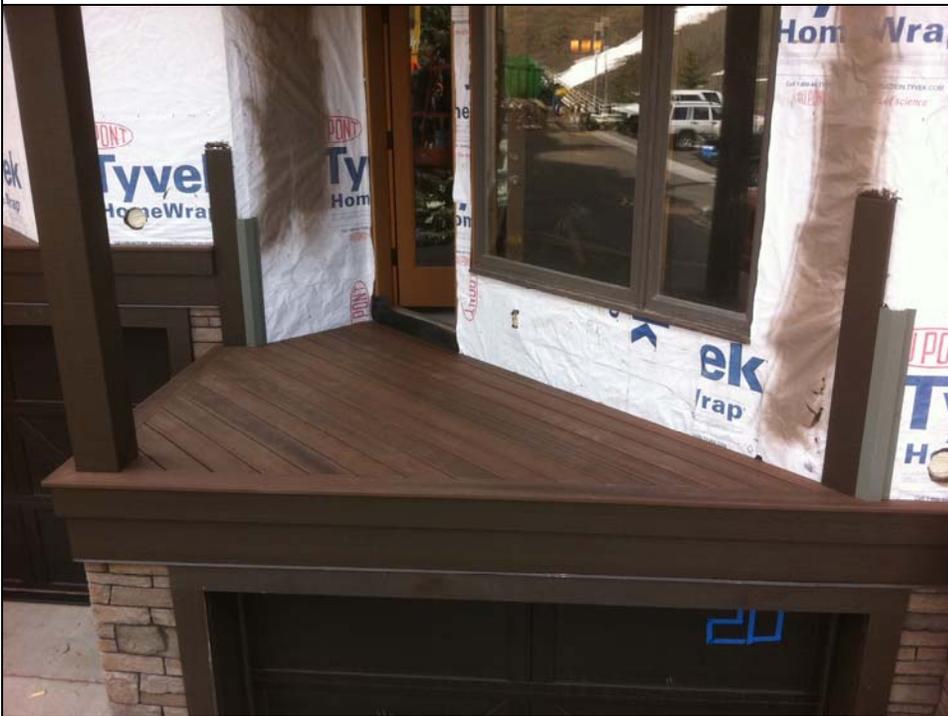
5/22/13 – Photo 26 – Completed Mock-Up Deck Installation  
Photo by Mick Holgate

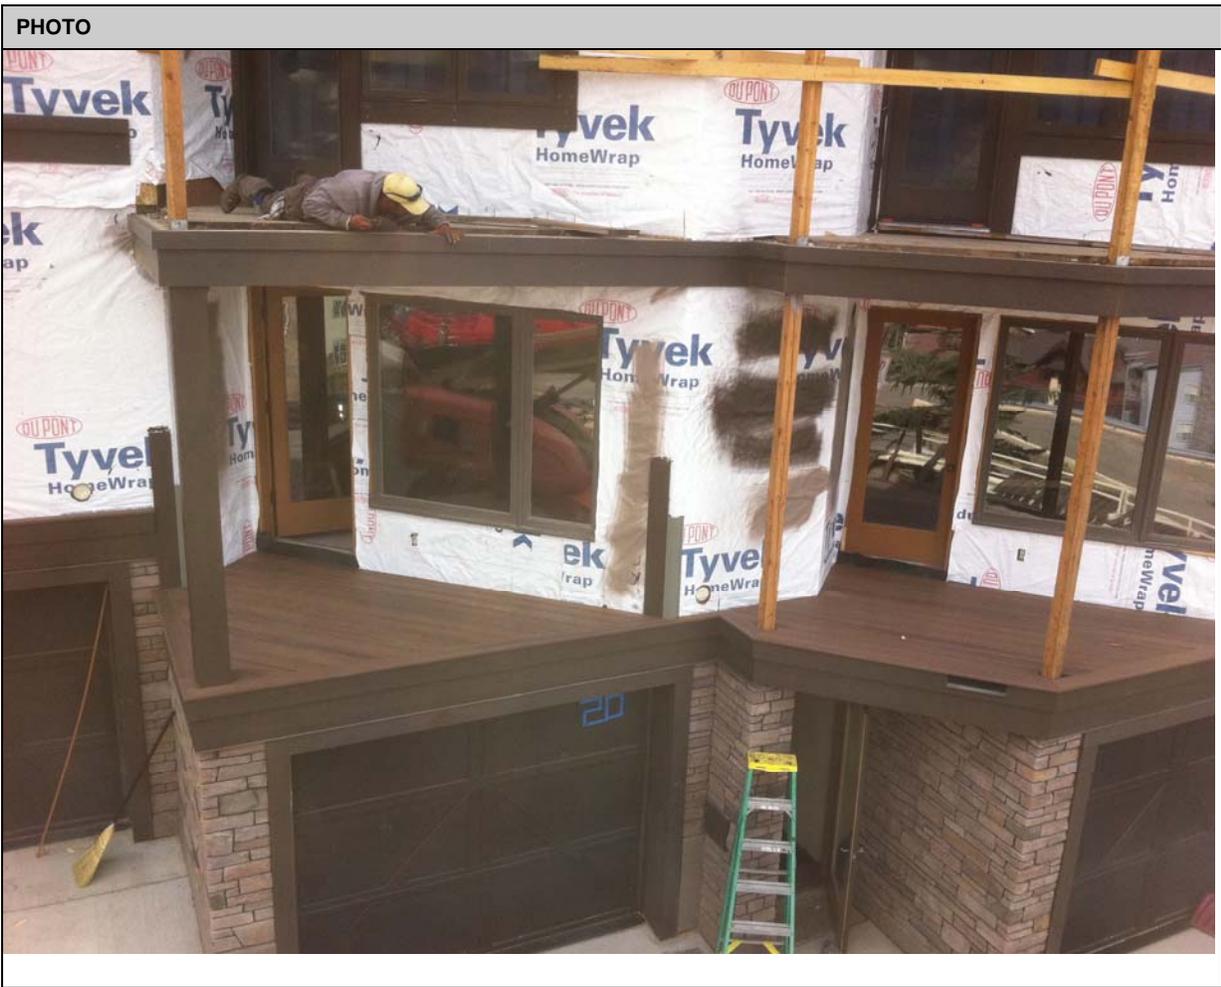
5/22/13 – Photo 27 – Completed Mock-Up Deck Installation  
Photo by Mick Holgate
