ARCHITECT'S FIELD REPORT

125

PROJECT	Eagle's Nest Townhouses 11 Morning Glory Way & 31 Marcellina Lane Mt. Crested Butte, CO 81225	DATE	10/2/13
---------	--	------	---------

WORK OBSERVED	
Phase IV Construction – Upper Level Renovations	
TRADES PRESENT	
Holgate Construction Co.

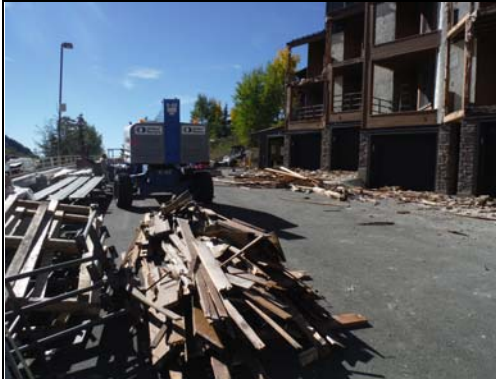
<p>10/2/13 – Photo 1 Upper Level Looking South</p> <p>Extensive demolition is underway. South parking lot is temporarily inaccessible.</p>	Note

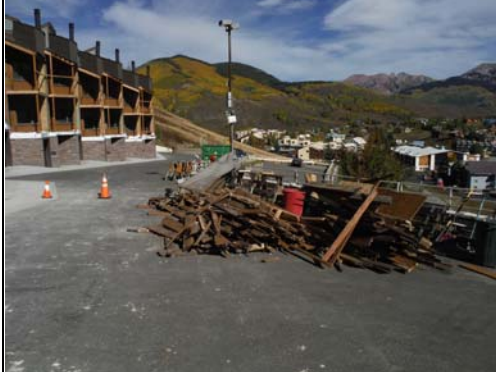
<p>10/2/13 – Photo 2 Upper Level Work Area Looking North</p> <p>Demolition debris is being sorted in the parking lot. Traffic is blocked from Unit 8 to the Maintenance Shed.</p>	Note

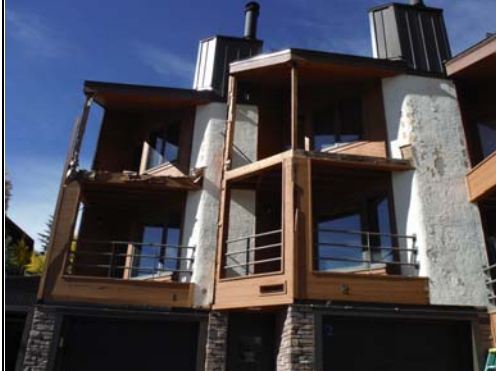
<p>10/2/13 – Photo 3 Units 1 & 2</p> <p>Demolition underway. Deck edge conditions are not yet exposed.</p>	Note

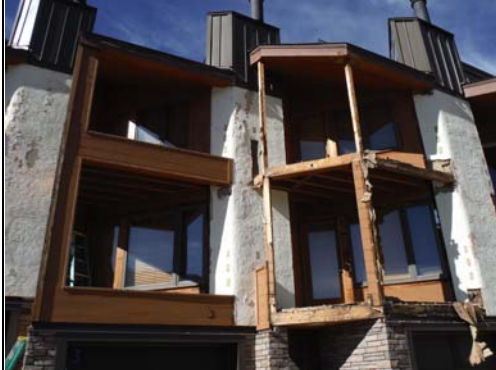
<p>10/2/13 – Photo 4 Units 3 & 4</p> <p>Demolition underway.</p>	Note

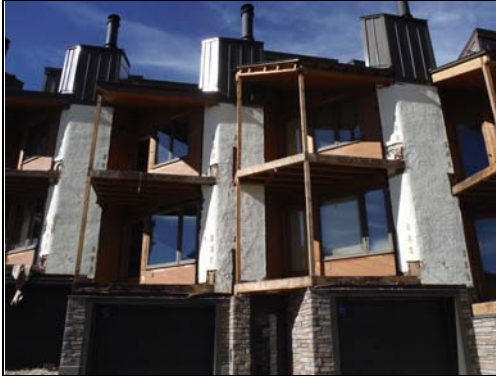
<p>10/2/13 – Photo 5 Units 5 & 6</p> <p>Demolition underway.</p>	Note

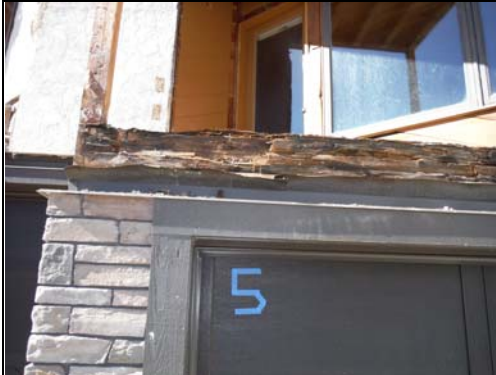
<p>10/2/13 – Photo 6 Unit 5 Deck Detail</p> <p>Advanced degradation of the 2nd floor deck rim boards.</p>	Note

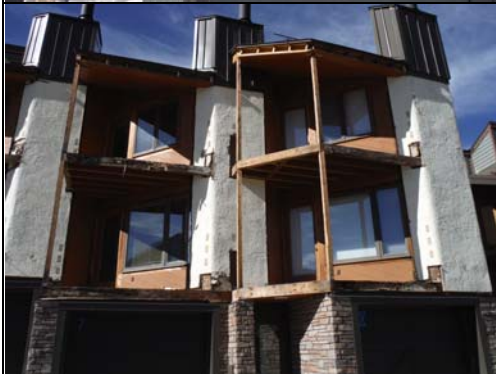
<p>10/2/13 – Photo 7 Units 7 & 8</p> <p>Demolition underway.</p>	Note

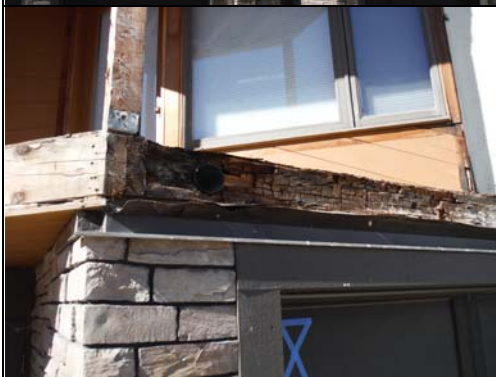
<p>10/2/13 – Photo 8 Unit 8 Detail</p> <p>Advanced degradation of the 2nd floor deck rim boards. Mick will reinstall the existing dryer vent hood.</p>	Note

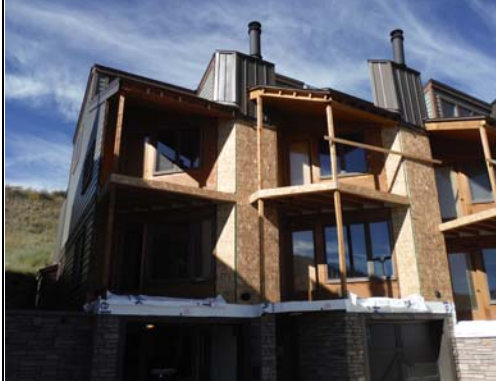
<p>10/2/13 – Photo 9 Units 9 & 10</p> <p>Completed repairs. Fascia boards have been removed. Tyvek is temporarily protecting the 2nd floor deck.</p>	Note

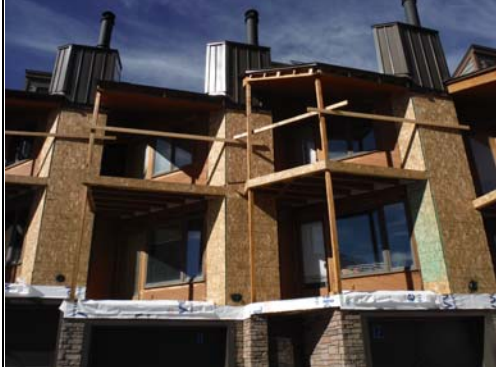
<p>10/2/13 – Photo 10 Units 11 & 12</p> <p>Completed repairs. Awaiting fascia boards and exterior paint</p>	Note

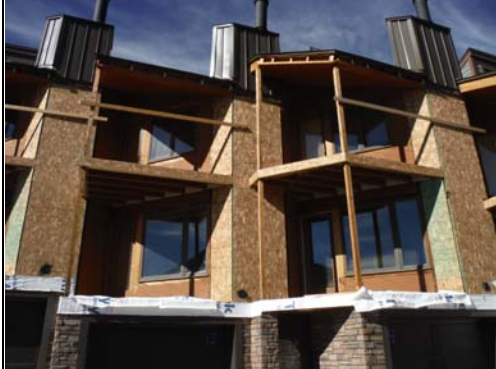
<p>10/2/13 – Photo 11 Units 13 & 14</p> <p>Completed repairs.</p>	Note

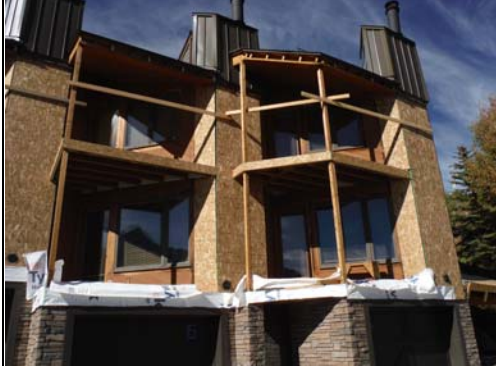
<p>10/2/13 – Photo 12 Units 15 & 16</p> <p>Completed repairs.</p>	Note

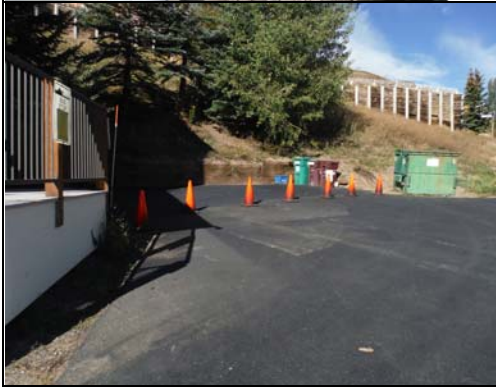
PHOTO –WORK ITEM	DESCRIPTION	ACTION
 	<p>10/2/13 – Photo 13 Unit 16 Looking South</p> <p>Completed repairs.</p>	Note
