## ARCHITECT'S FIELD REPORT

PROJECT	<b>Eagle's Nest Townhouses</b> 11 Morning Glory Way & 31 Marcellina Lane Mt. Crested Butte, CO 81225	DATE	5/14/2015
		REV

WORK OBSERVED	
Phase V – Manger's Units Renovations	
TRADES PRESENT	
Holgate Construction

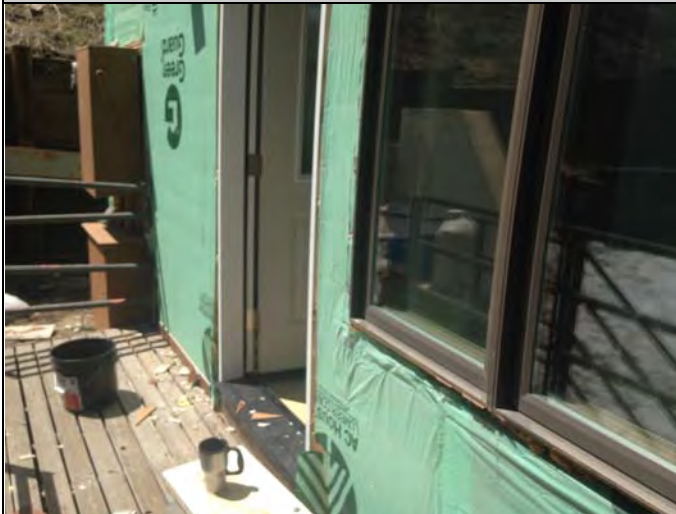
<p>4/28/15 – Photo 25 Lower Level Caretaker Unit</p> <p>Manager's Unit Deck. Detail of new entry door.</p>	Note
 	<p>4/28/15 – Photo 26 Lower Level Caretaker Unit</p> <p>South Elevation of the Manager's Unit. Electrical panels to the right will be painted ENT Brown.</p>	Note

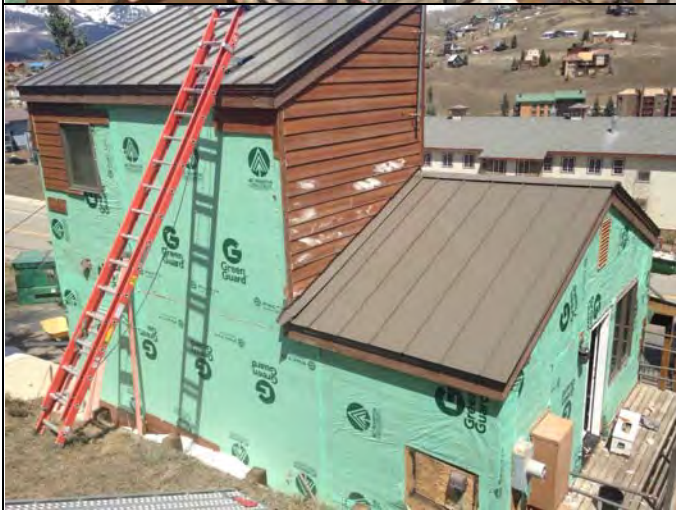
<p>4/28/15 – Photo 27 Lower Level Caretaker Unit</p> <p>West Elevation. View of the siding demolition underway.</p>	Note
