**ARCHITECT'S FIELD REPORT**

<b>PROJECT</b>	<b>Eagle's Nest Townhouses</b> 11 Morning Glory Way & 31 Marcellina Lane Mt. Crested Butte, CO 81225	<b>DATE</b>	4/15/13
----------------	--	-------------	---------

<b>WORK OBSERVED</b>	
Phase IV Construction	
<b>TRADES PRESENT</b>	
Holgate Construction Co.

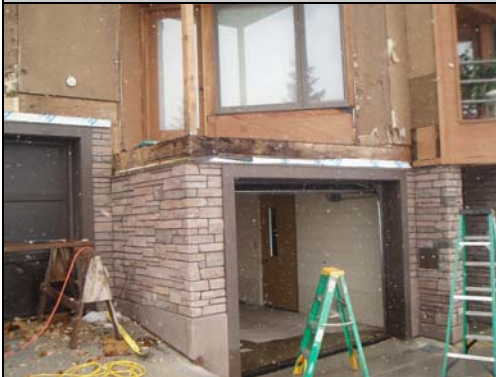
<p>4/15/13 – Photo 1 Unit 18, 2<sup>nd</sup> Floor Deck Demolition Complete</p> <p>Degraded joists noted.</p>	<p>Note</p>
 	<p>4/15/13 – Photo 2 Unit 18, 3<sup>rd</sup> Floor Deck Demolition Complete</p> <p>Joists appear intact.</p>	<p>Note</p>
 	<p>4/15/13 – Photo 3 Unit 19, 2<sup>nd</sup> Floor Deck Demolition Complete</p> <p>Minor degradation around outside column noted.</p>	<p>Note</p>
 	<p>4/15/13 – Photo 4 Unit 19, 3<sup>rd</sup> Floor Deck Demolition Complete</p> <p>All 3 outside joists were degraded. Joists have been removed.</p>	<p>Note</p>

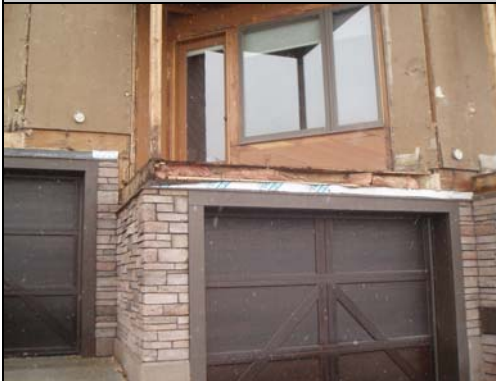
<p>4/15/13 – Photo 9 Unit 22, 2<sup>nd</sup> Floor Deck Demolition Complete</p> <p>Joists and sill are completely degraded. Joists have been removed. (Insulation in joists bays visible.)</p>	<p>Note</p>

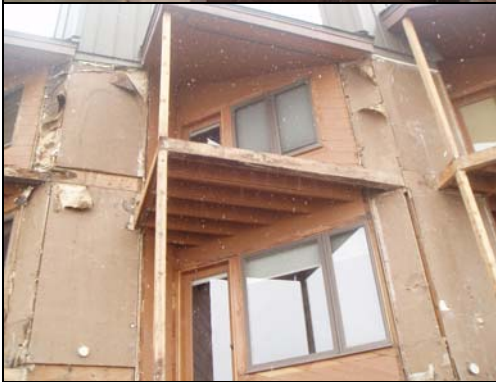
<p>4/15/13 – Photo 10 Unit 22, 3<sup>rd</sup> Floor Deck Demolition Complete</p> <p>Joists appear intact.</p>	<p>Note</p>

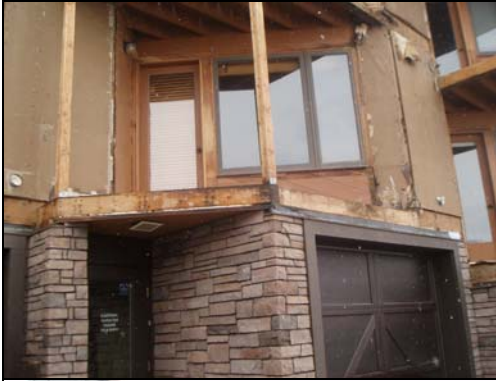
<p>4/15/13 – Photo 11 Unit 23, 2<sup>nd</sup> Floor Deck Demolition Complete</p> <p>Minor degradation of joists and sill at outside column.</p>	<p>Note</p>

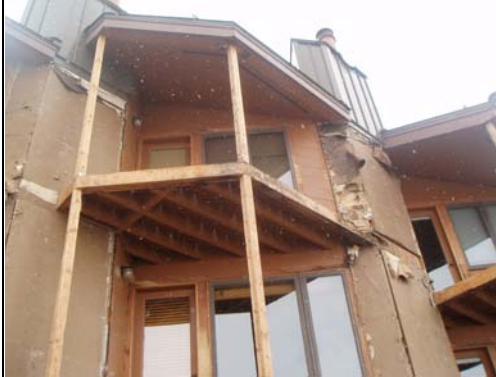
<p>4/15/13 – Photo 12 Unit 23, 3<sup>rd</sup> Floor Deck Demolition Complete</p> <p>Joists appear intact.</p>	<p>Note</p>

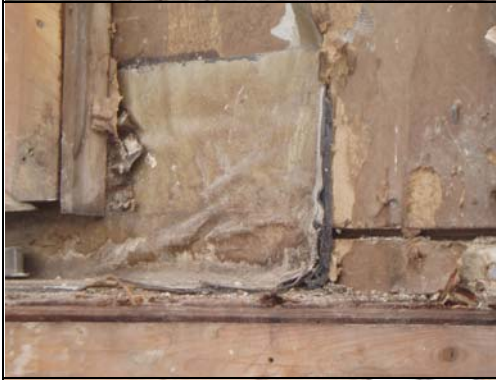
<p>4/15/13 – Photo 18 Unit 18, Example 2<sup>nd</sup> Floor Deck</p> <p>Detail of deck membrane flashing.</p>	<p>Note</p>

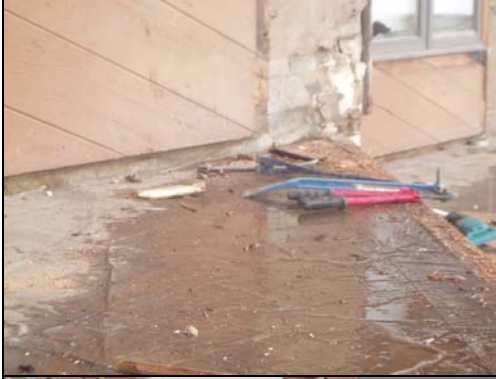
<p>4/15/13 – Photo 19 Unit 18, Example 2<sup>nd</sup> Floor Deck</p> <p>Looking north on the deck.</p>	<p>Note</p>
 	<p>4/15/13 – Photo 20 Unit 18, Example 2<sup>nd</sup> Floor Deck</p> <p>Flashing at door threshold.</p>	<p>Note</p>

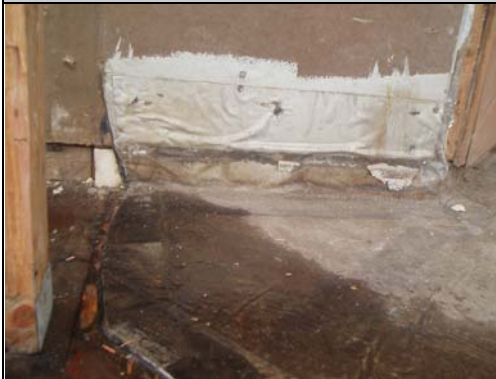
<p>4/15/13 – Photo 21 Unit 18, Example 2<sup>nd</sup> Floor Deck</p> <p>Detail of flashing against west wall.</p>	<p>Note</p>

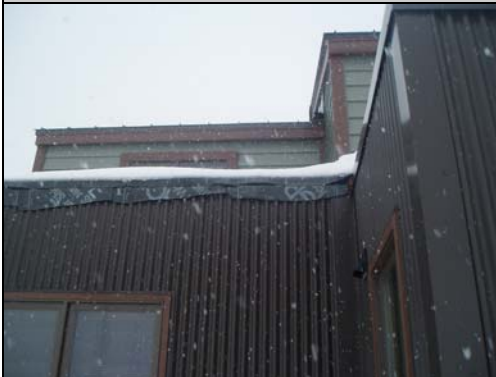
<p>4/15/13 – Photo 33 Unit 25 Roof, West Side</p> <p>Roof is still under construction.</p>	<p>Note</p>

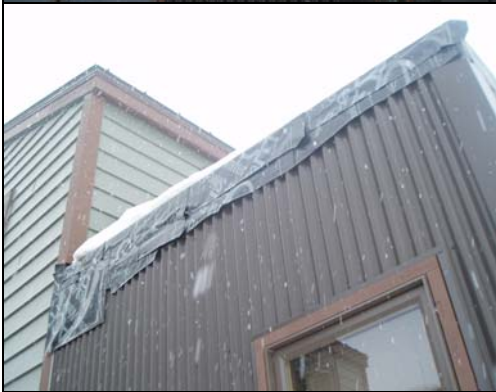
<p>4/15/13 – Photo 34 Unit 25 Roof, North Side</p> <p>Roof is still under construction. Ice and Watershield membrane is protecting roof.</p>	<p>Note</p>

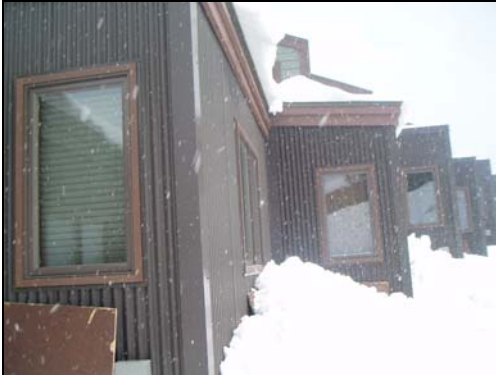
<p>4/15/13 – Photo 35 Site Photo at Units 17 &amp; 18</p> <p>Rear sloped roofs have created additional snow slide along back of the units.</p>	<p>Note</p>

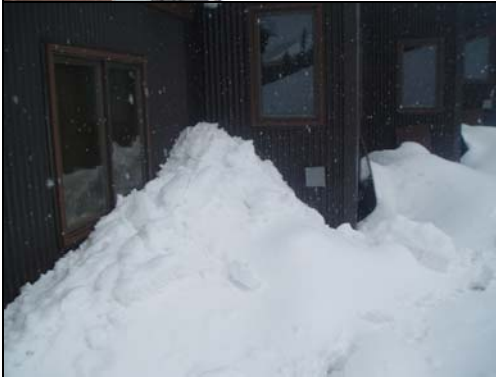
<p>4/15/13 – Photo 36 Detail of Snow Slide Condition</p> <p>Recent snow has piled to the height of the 3<sup>rd</sup> Floor windows.</p>	<p>Note</p>
