ARCHITECT'S FIELD REPORT

PROJECT	Eagle's Nest Townhouses 11 Morning Glory Way & 31 Marcellina Lane Mt. Crested Butte, CO 81225	DATE	11/19/14
----------------	--	-------------	----------

WORK OBSERVED	
Radon Mitigation Substantial Completion, Odd Units	
TRADES PRESENT	
None

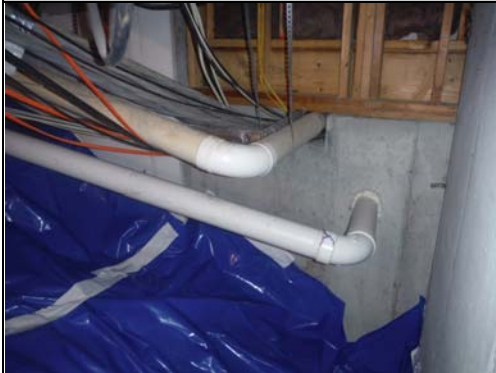
<p>11/19/14 – Photo 1 Unit 10 Crawlspace</p> <p>North wall pipe penetration and vapor retarder.</p>	<p>Note</p>

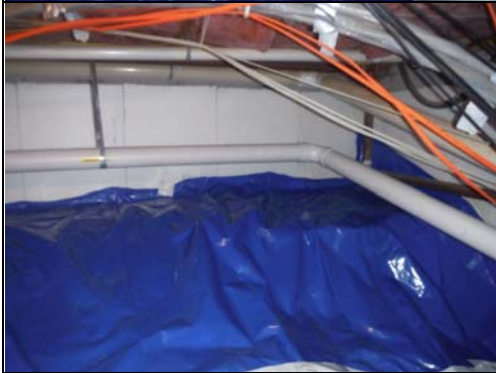
<p>11/19/14 – Photo 2 Unit 10 Crawlspace</p> <p>West wall vapor retarder.</p>	<p>Note</p>

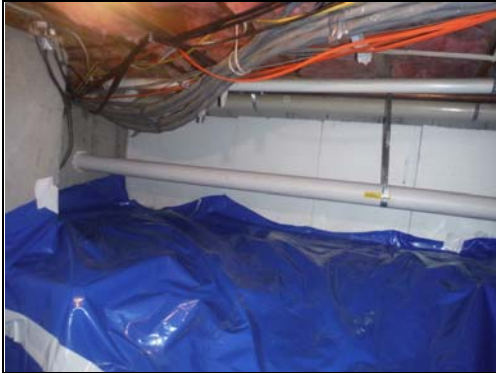
<p>11/19/14 – Photo 3 Unit 10 Crawlspace</p> <p>Southwest corner vapor retarder.</p>	<p>Note</p>

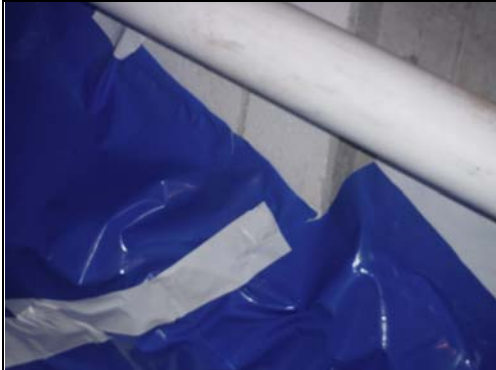
<p>11/19/14 – Photo 4 Unit 10 Crawlspace</p> <p>Detail of vapor retarder at foam insulation.</p>	<p>Note</p>

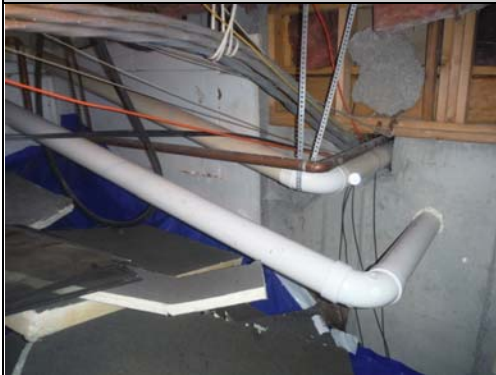
<p>11/19/14 – Photo 5 Unit 12 Crawlspace</p> <p>North wall pipe penetration and vapor retarder.</p> <p>Note: Insulation debris was existing.</p>	<p>Note</p>

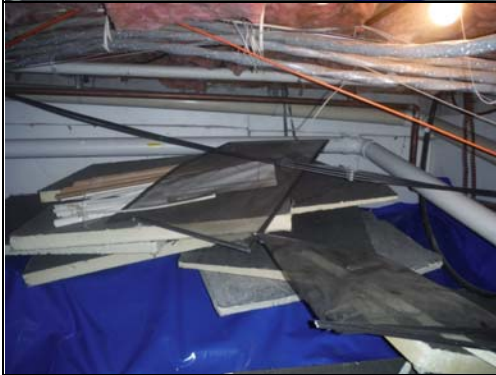
<p>11/19/14 – Photo 6 Unit 12 Crawlspace</p> <p>West wall condition.</p>	<p>Note</p>

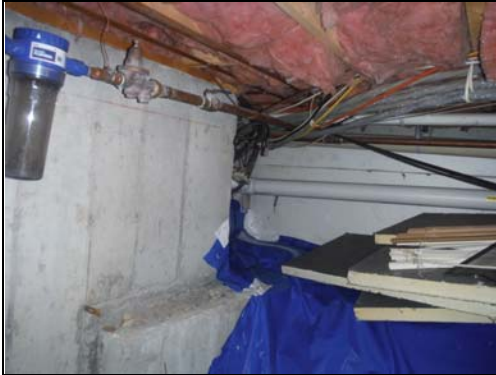
<p>11/19/14 – Photo 7 Unit 12 Crawlspace</p> <p>Southwest corner vapor retarder.</p>	<p>Note</p>

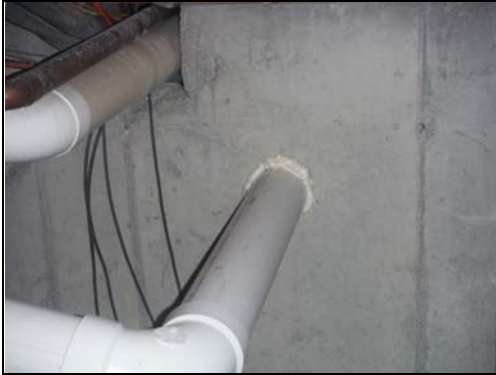
<p>11/19/14 – Photo 8 Unit 12 Crawlspace</p> <p>Pipe penetration at north wall.</p>	<p>Note</p>

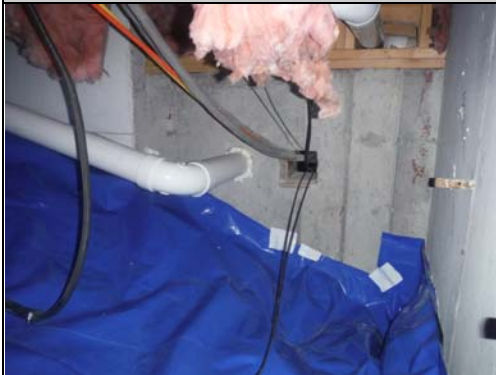
<p>11/19/14 – Photo 9 Unit 14 Crawlspace</p> <p>North wall pipe penetration and vapor retarder.</p>	<p>Note</p>

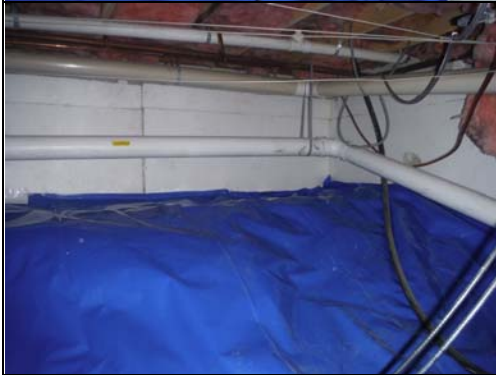
<p>11/19/14 – Photo 10 Unit 14 Crawlspace</p> <p>West wall vapor retarder.</p>	<p>Note</p>

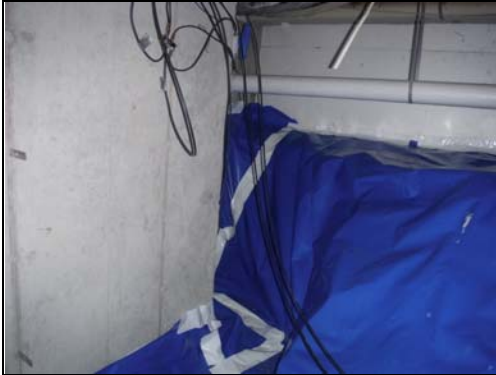
<p>11/19/14 – Photo 11 Unit 14 Crawlspace</p> <p>Southwest wall vapor retarder.</p>	<p>Note</p>

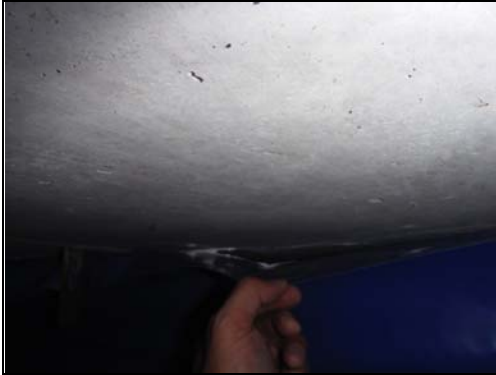
<p>11/19/14 – Photo 12 Unit 14 Crawlspace</p> <p>Caulk joint is not continuous at the east wall connection.</p>	<p>Note</p>

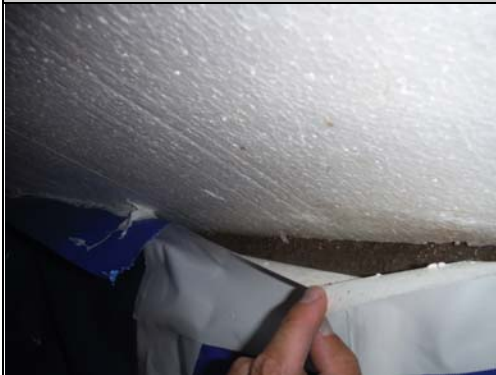
<p>11/19/14 – Photo 13 Unit 14 Crawlspace</p> <p>Vapor retarder is not sealed to the back, west wall.</p>	<p>Note</p>

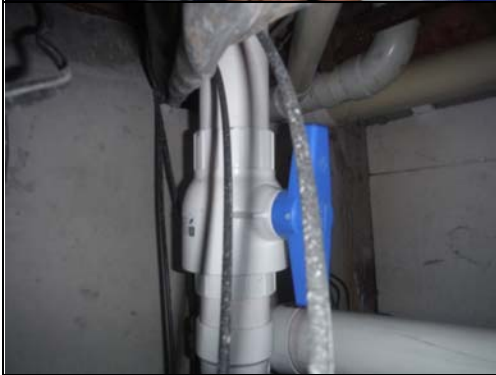
<p>11/19/14 – Photo 14 Unit 14 Crawlspace</p> <p>Detail of balancing valve.</p>	<p>Note</p>

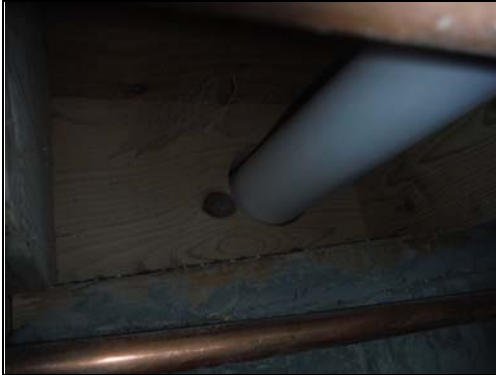
<p>11/19/14 – Photo 15 Unit 14 Crawlspace</p> <p>Detail of pipe penetration at the water heater closet.</p>	<p>Note</p>

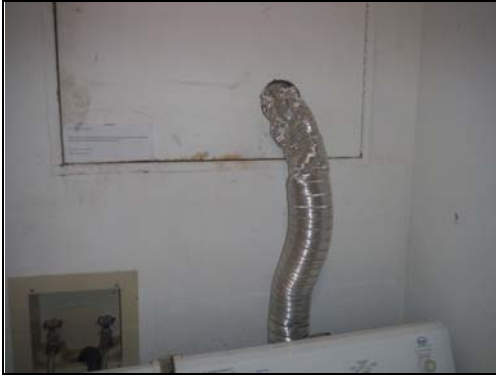
<p>11/19/14 – Photo 16 Unit 16 Laundry Room</p> <p>Unrelated to this project: Dryer vent is directed to the crawlspace. This ventilation and disruption of the 1-hour fire barrier is not advised.</p>	<p>Note</p>

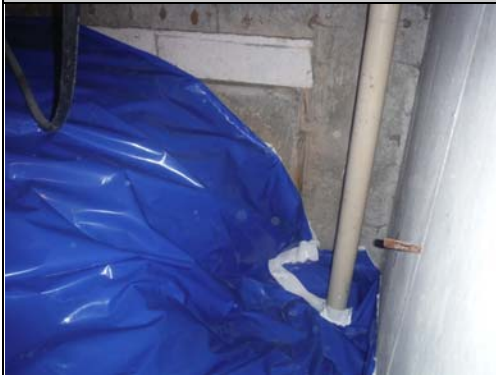
<p>11/19/14 – Photo 17 Unit 16 Crawlspace</p> <p>North wall condensate drain and vapor retarder.</p>	<p>Note</p>

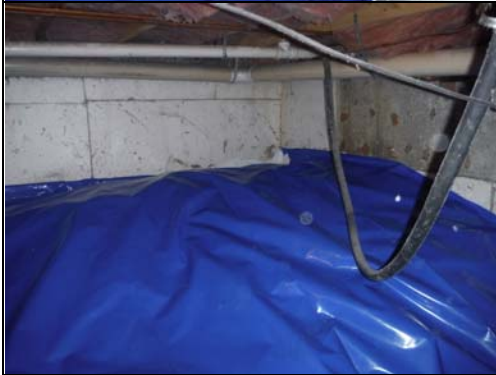
<p>11/19/14 – Photo 18 Unit 16 Crawlspace</p> <p>Northwest wall vapor retarder.</p>	<p>Note</p>

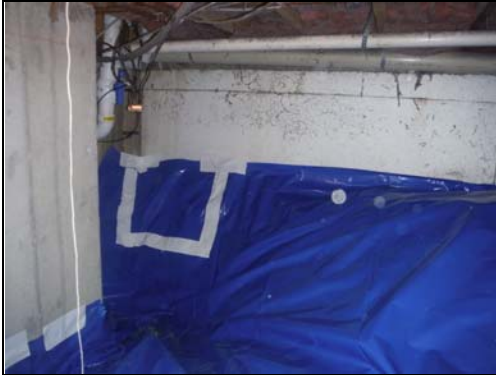
<p>11/19/14 – Photo 19 Unit 16 Crawlspace</p> <p>Southwest wall vapor retarder.</p>	<p>Note</p>

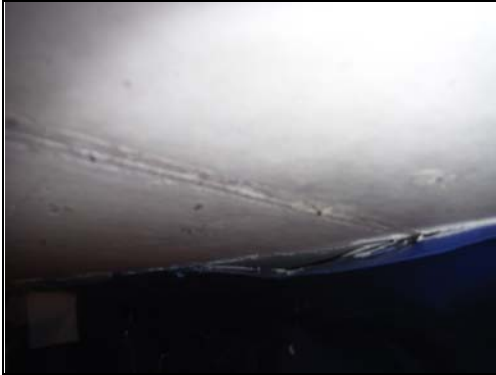
<p>11/19/14 – Photo 20 Unit 16 Crawlspace</p> <p>Vapor retarder is not fully adhered to the foundation wall.</p>	<p>Note</p>

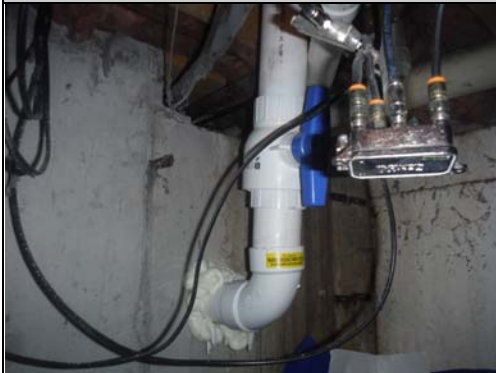
<p>11/19/14 – Photo 21 Unit 16 Crawlspace</p> <p>Detail of balancing valve.</p>	<p>Note</p>

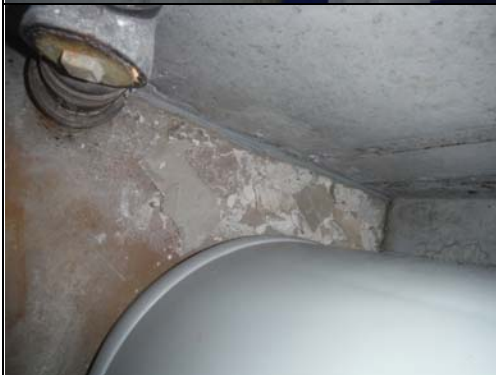
<p>11/19/14 – Photo 22 Unit 15 Water Heater Closet</p> <p>Drywall debris remains behind the hot water heater.</p>	<p>Note</p>

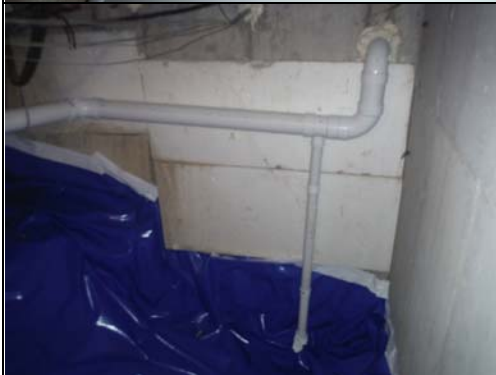
<p>11/19/14 – Photo 23 Unit 17 Crawlspace</p> <p>North wall condensate drain and vapor retarder.</p>	<p>Note</p>

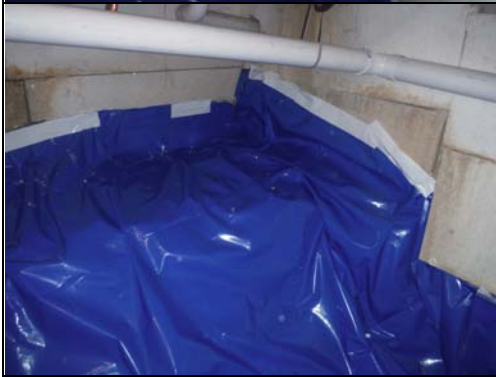
<p>11/19/14 – Photo 24 Unit 17 Crawlspace</p> <p>Northwest wall vapor retarder.</p>	<p>Note</p>

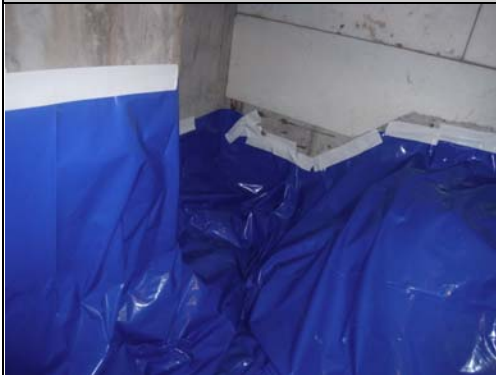
<p>11/19/14 – Photo 25 Unit 17 Crawl space</p> <p>Southwest wall vapor retarder.</p>	<p>Note</p>

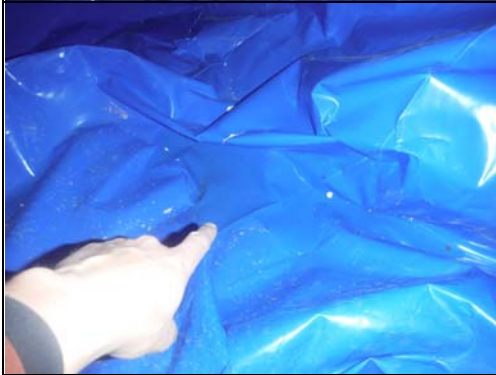
<p>11/19/14 – Photo 26 Unit 17 Crawl space</p> <p>Note: Standing water on top of the vapor retarder.</p>	<p>Note</p>

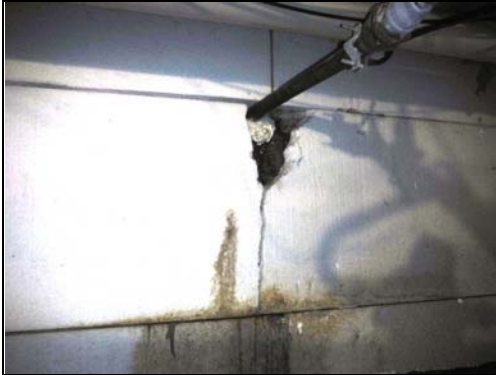
<p>11/19/14 – Photo 27 Unit 17 Crawl space</p> <p>Likely source of the water infiltration. There is running water from the pipe penetration in the back foundation wall.</p>	<p>Note</p>

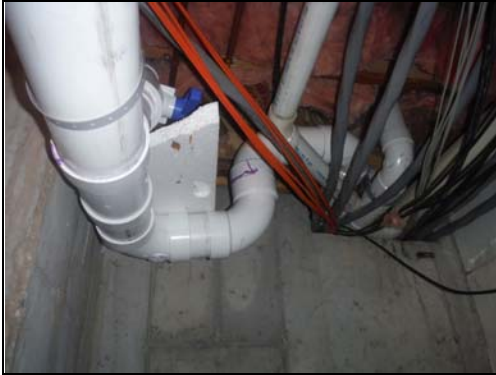
<p>11/19/14 – Photo 28 Unit 17 Crawl space</p> <p>Detail of mixing valve and pipe penetration at south foundation wall.</p>	<p>Note</p>

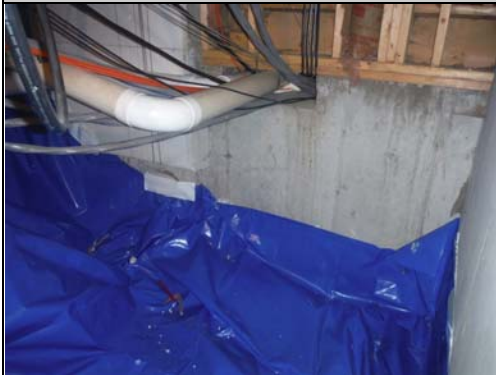
<p>11/19/14 – Photo 29 Unit 19 Crawlspace</p> <p>North wall pipe penetration and vapor retarder.</p>	<p>Note</p>

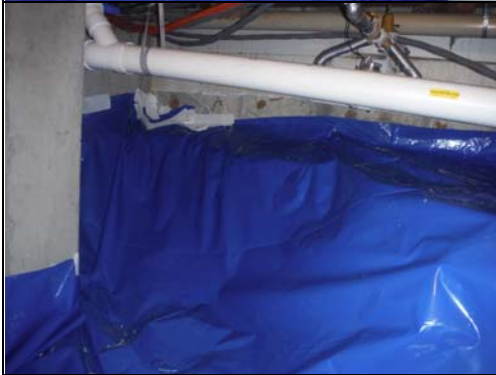
<p>11/19/14 – Photo 30 Unit 19 Crawlspace</p> <p>West wall vapor retarder.</p>	<p>Note</p>

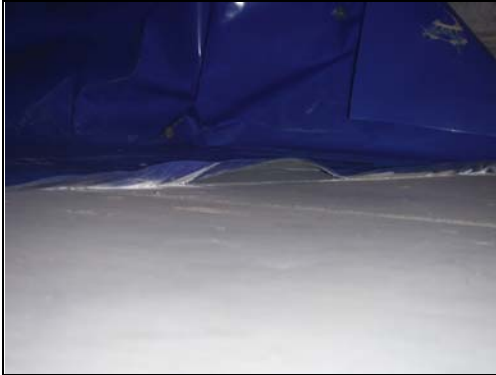
<p>11/19/14 – Photo 31 Unit 19 Crawlspace</p> <p>Vapor retarder is not fully adhered to the foundation wall.</p>	<p>Note</p>

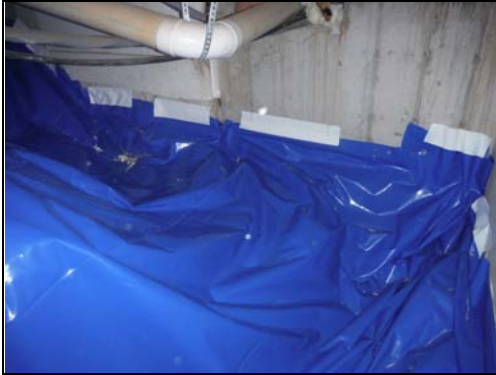
<p>11/19/14 – Photo 32 Unit 21 Crawlspace</p> <p>North wall pipe penetration and vapor retarder.</p>	<p>Note</p>

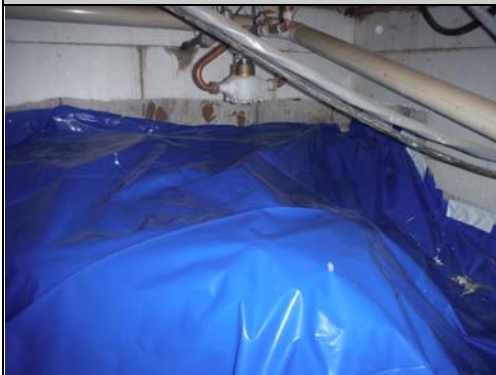
<p>11/19/14 – Photo 33 Unit 21 Crawlspace</p> <p>West wall vapor retarder.</p>	<p>Note</p>

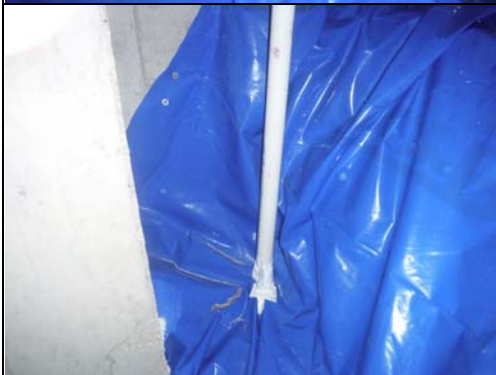
<p>11/19/14 – Photo 34 Unit 21 Crawlspace</p> <p>Detail of the condensate drain at the vapor retarder.</p>	<p>Note</p>

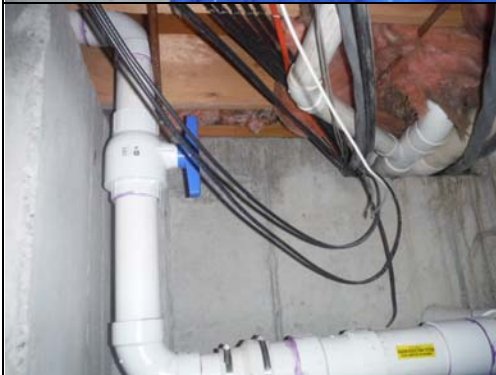
<p>11/19/14 – Photo 35 Unit 21 Crawlspace</p> <p>Detail of balancing valve.</p>	<p>Note</p>

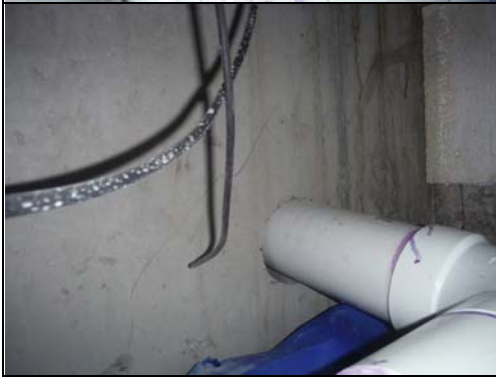
<p>11/19/14 – Photo 36 Unit 21 Crawlspace</p> <p>Pipe penetration is sealed on the opposite side. Reference Field Report 148, Photo 68.</p>	<p>Note</p>

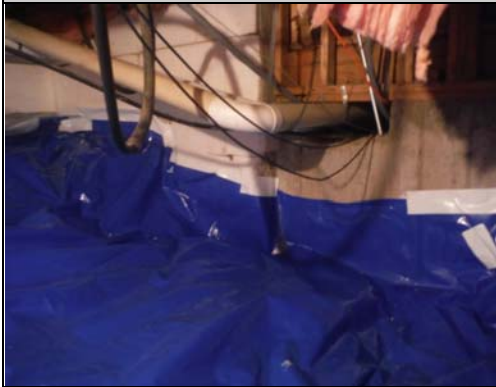
<p>11/19/14 – Photo 37 Unit 23 Crawlspace</p> <p>North wall pipe penetration and vapor retarder.</p>	<p>Note</p>

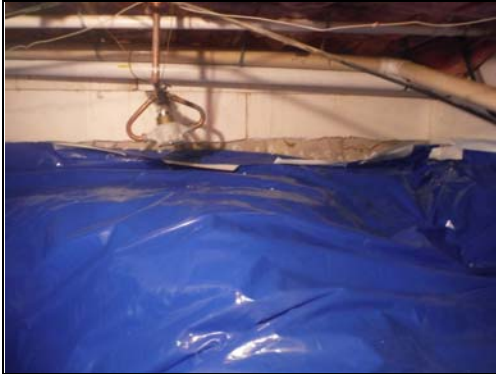
<p>11/19/14 – Photo 38 Unit 23 Crawlspace</p> <p>West wall vapor retarder.</p>	<p>Note</p>
 	<p>11/19/14 – Photo 39 Unit 23 Crawlspace</p> <p>Vapor retarded is not adhered to the back wall.</p>	<p>Note</p>

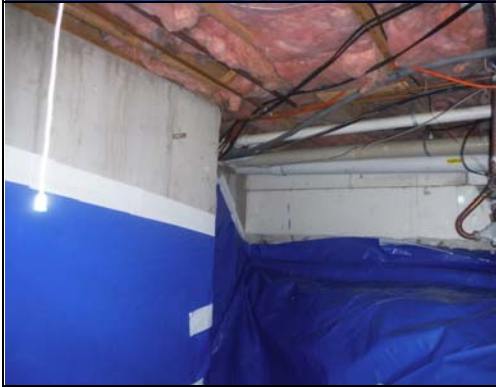
<p>11/19/14 – Photo 40 Unit 23 Crawlspace</p> <p>Southwest wall vapor retarder.</p>	<p>Note</p>

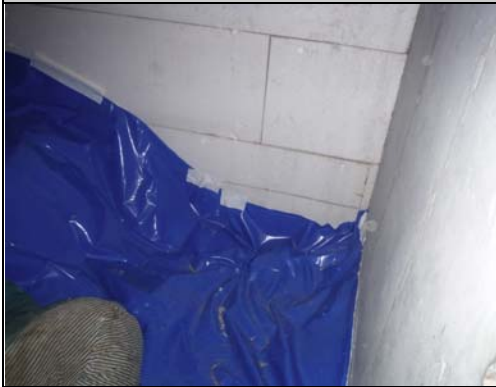
<p>11/19/14 – Photo 41 Unit 25 Crawlspace</p> <p>Northwest wall vapor retarder.</p>	<p>Note</p>

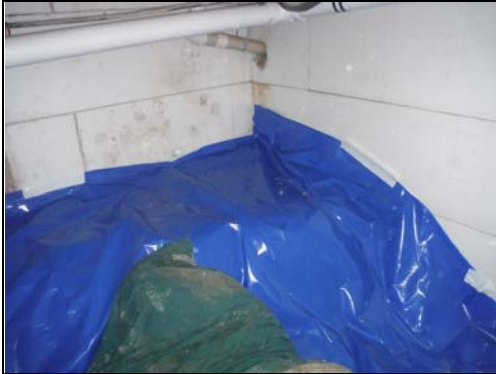
<p>11/19/14 – Photo 42 Unit 25 Crawlspace</p> <p>Northwest wall vapor retarder.</p>	<p>Note</p>

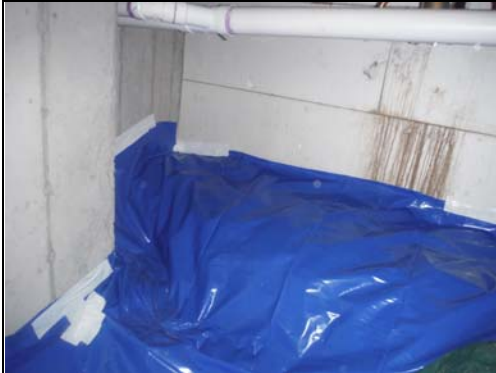
<p>11/19/14 – Photo 43 Unit 25 Crawlspace</p> <p>Southwest wall vapor retarder.</p>	<p>Note</p>

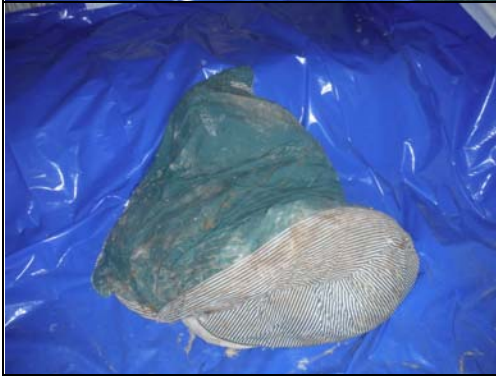
<p>11/19/14 – Photo 44 Unit 25 Crawlspace</p> <p>What appears to be a futon mattress.</p>	<p>Note</p>

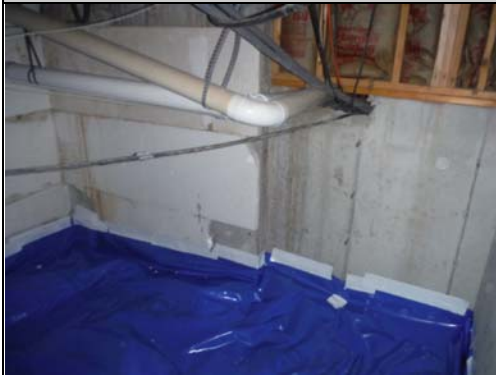
<p>11/19/14 – Photo 45 Unit 27 Crawlspace</p> <p>North wall pipe penetration and vapor retarder.</p>	<p>Note</p>

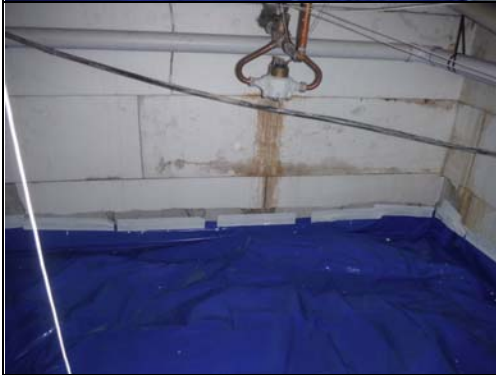
<p>11/19/14 – Photo 46 Unit 27 Crawlspace</p> <p>West wall vapor retarder.</p>	<p>Note</p>

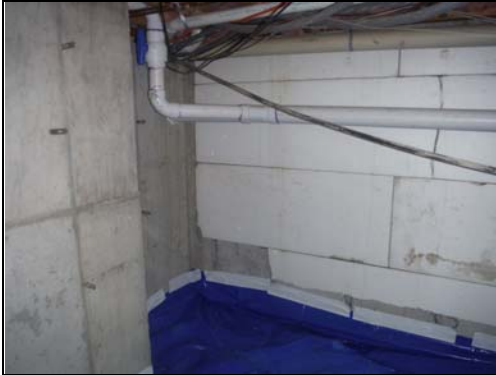
<p>11/19/14 – Photo 47 Unit 27 Crawlspace</p> <p>Southwest wall vapor retarder.</p> <p>Note: Radon pipes are not labeled in this area.</p>	<p>Note</p>

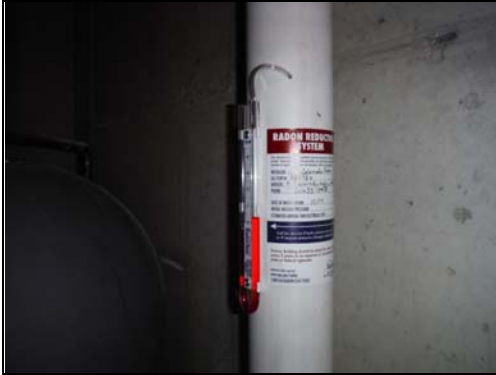
<p>11/19/14 – Photo 48 Unit 28 Water Heater Closet</p> <p>A manometer has been installed on the sub-slab vent stack.</p>	<p>Note</p>

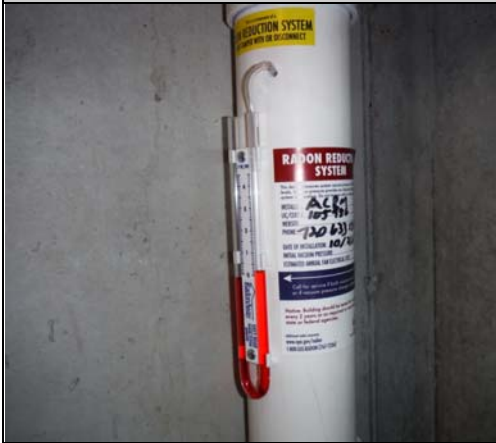
<p>11/19/14 – Photo 49 Unit 30 Water Heater Closet</p> <p>A manometer has been installed on the sub-slab vent stack.</p>	<p>Note</p>

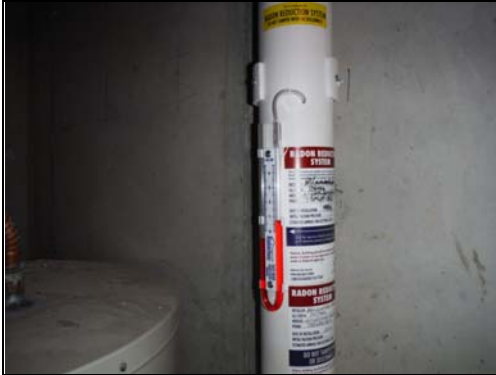
<p>11/19/14 – Photo 50 Unit 32 Water Heater Closet</p> <p>A manometer has been installed on the sub-slab vent stack.</p>	<p>Note</p>

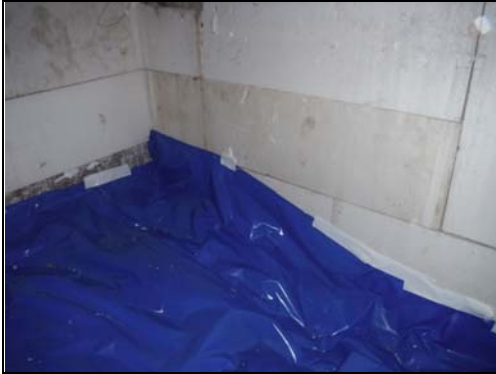
<p>11/19/14 – Photo 51 Unit 33 Crawlspace</p> <p>Northwest wall vapor retarder.</p>	<p>Note</p>

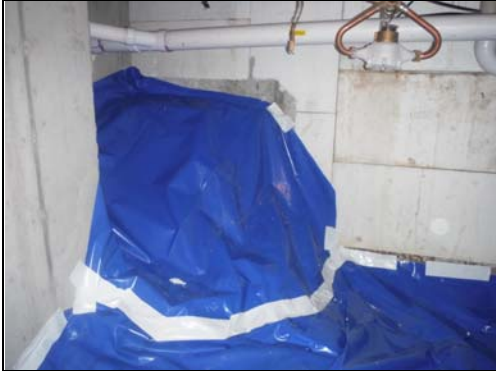
<p>11/19/14 – Photo 52 Unit 33 Crawlspace</p> <p>Southwest wall vapor retarder.</p>	<p>Note</p>

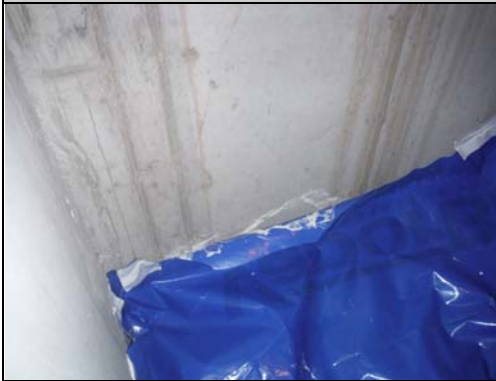
<p>11/19/14 – Photo 53 Unit 33 Crawlspace</p> <p>Vapor retarder is not adhered to the foundation wall.</p>	<p>Note</p>

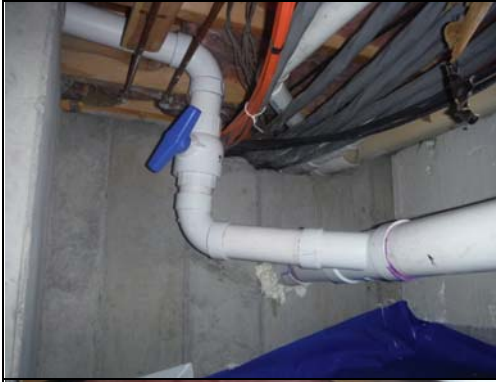
<p>11/19/14 – Photo 54 Unit 33 Crawlspace</p> <p>Detail of the mixing valve.</p>	<p>Note</p>

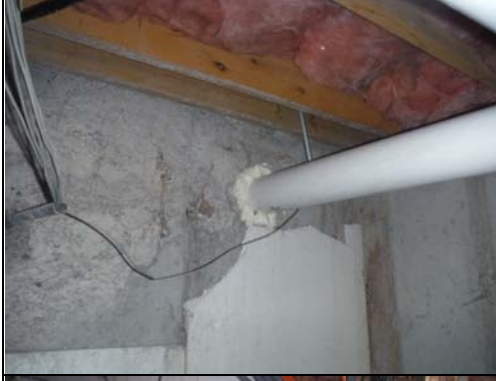
<p>11/19/14 – Photo 55 Unit 33 Crawlspace</p> <p>North wall pipe penetration.</p>	<p>Note</p>

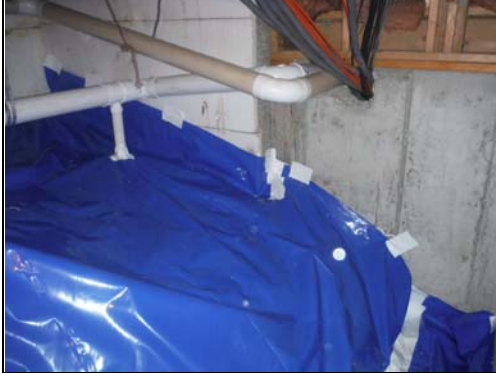
<p>11/19/14 – Photo 56 Unit 35 Crawlspace</p> <p>North wall pipe penetration and vapor retarder.</p>	<p>Note</p>

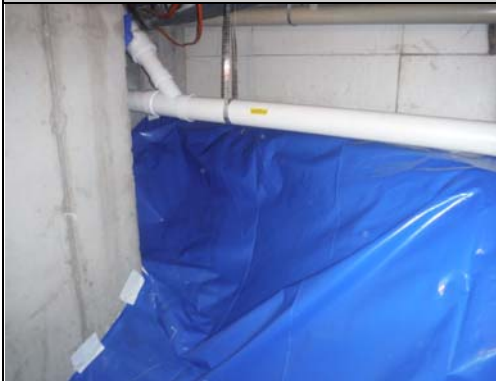
<p>11/19/14 – Photo 57 Unit 35 Crawlspace</p> <p>Southwest wall vapor retarder.</p>	<p>Note</p>

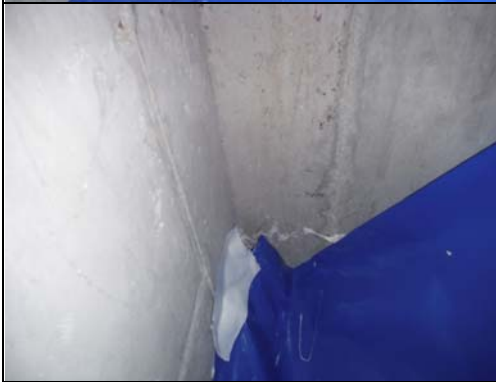
<p>11/19/14 – Photo 58 Unit 35 Crawlspace</p> <p>Vapor retarder is not adhered to the wall in this location.</p>	<p>Note</p>

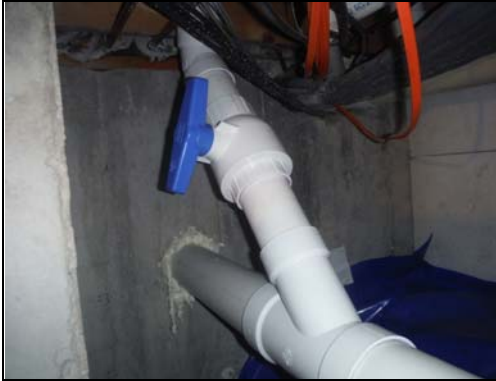
<p>11/19/14 – Photo 59 Unit 35 Crawlspace</p> <p>Detail of balancing valve.</p>	<p>Note</p>

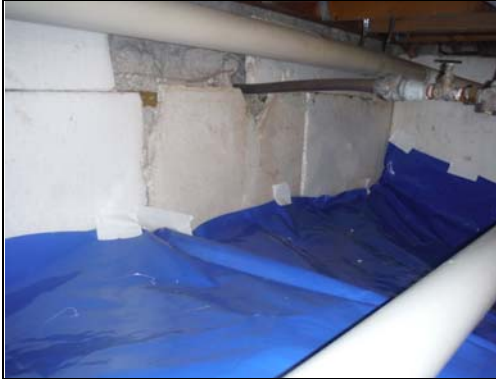
<p>11/19/14 – Photo 60 Unit 35 Crawlspace</p> <p>Looking north along the west wall line.</p>	<p>Note</p>

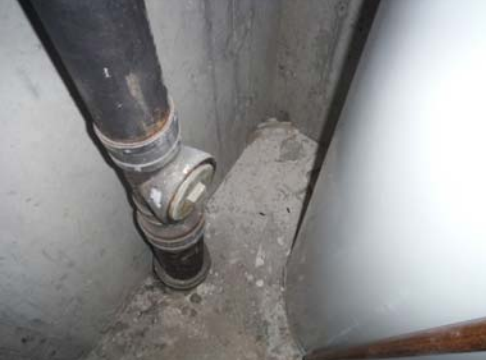
<p>11/19/14 – Photo 61 Unit 36 Water Heater Closet</p> <p>Drywall debris remains behind the water heater.</p>	<p>Note</p>

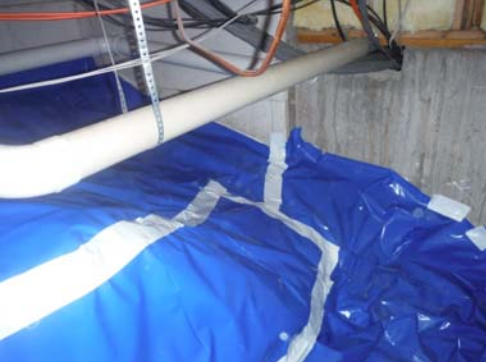
<p>11/19/14 – Photo 62 Unit 37 Crawlspace</p> <p>North wall pipe penetration and vapor retarder.</p>	<p>Note</p>

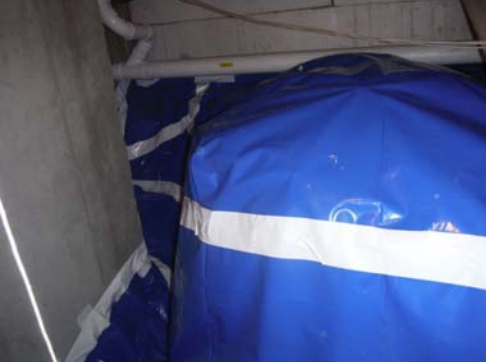
<p>11/19/14 – Photo 63 Unit 37 Crawlspace</p> <p>Southwest wall vapor retarder.</p>	<p>Note</p>

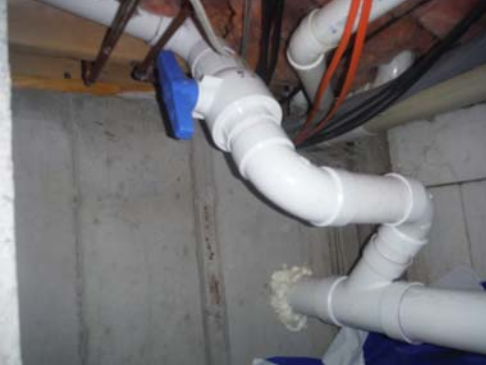
<p>11/19/14 – Photo 64 Unit 37 Crawlspace</p> <p>Detail of balancing valve.</p>	<p>Note</p>

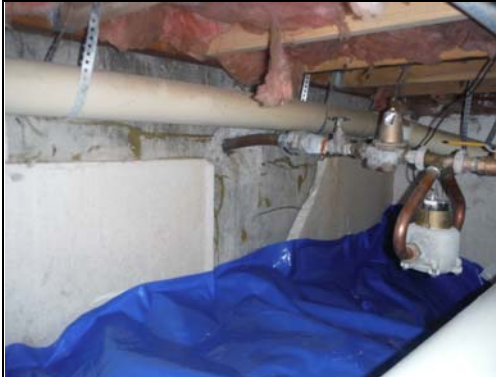
<p>11/19/14 – Photo 69 Unit 39 Crawlspace</p> <p>Looking north along the back, west wall.</p>	<p>Note</p>

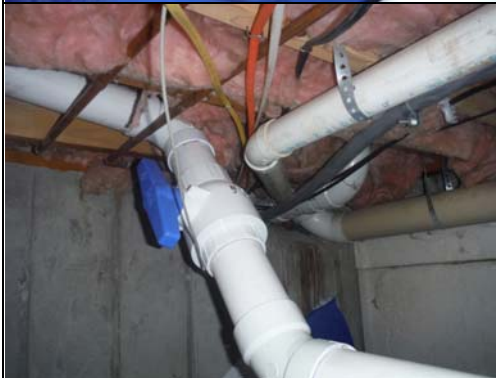
<p>11/19/14 – Photo 70 Unit 39 Crawlspace</p> <p>Detail of balancing valve.</p>	<p>Note</p>

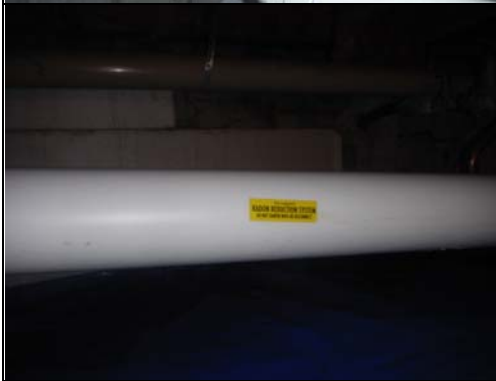
<p>11/19/14 – Photo 71 Radon Pipe Label</p> <p>Example detail of radon pipe label used throughout the project.</p>	<p>Note</p>
