ARCHITECT'S FIELD REPORT

073

PROJECT	Eagle's Nest Townhouses 11 Morning Glory Way & 31 Marcellina Lane Mt. Crested Butte, CO 81225	DATE	5/23/12
----------------	--	-------------	---------

WORK OBSERVED	
Phase III Construction Repairs, Trim & Installed Garage Doors	
TRADES PRESENT	
Holgate Construction

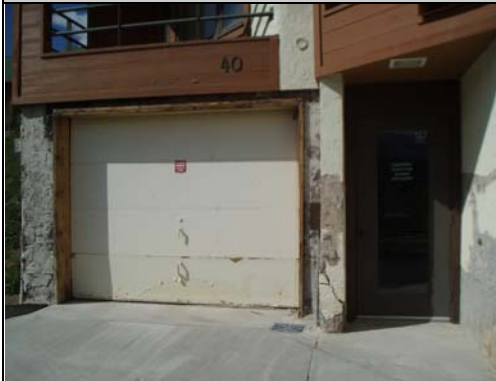
<p>5/23/12 – Photo 1 Lower Level Units</p> <p>Entrance door trim has been installed on the Lower Level Units. (Paint Color #1)</p>	<p>Note</p>

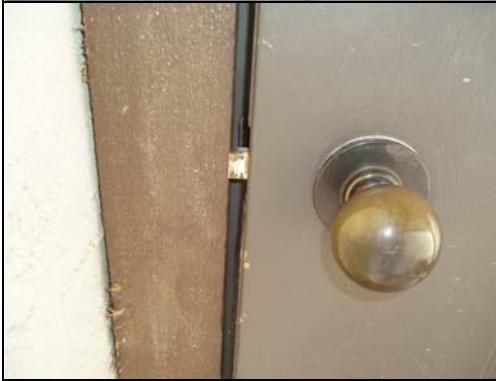
<p>5/23/12 – Photo 2 Typical Door Trim</p> <p>Note possible wear point between door latch and new wood door trim. As doors are on closers, we could see some damage where the latch hits the trim. Only likely solution would be a blank strike plate with the new door hardware.</p>	<p>BWA</p>

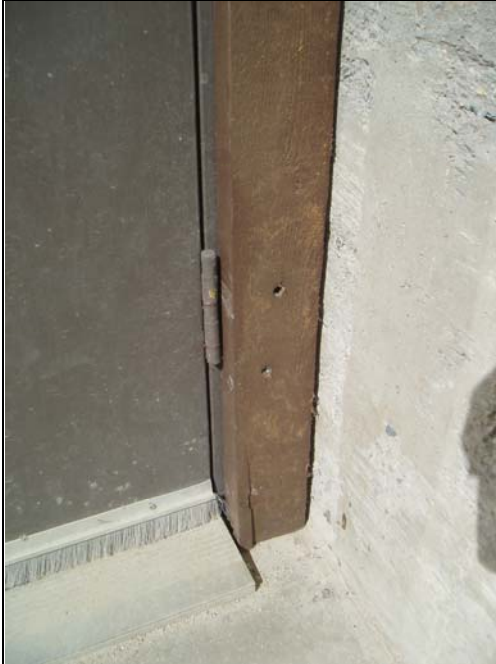
<p>5/23/12 – Photo 3 Unit 20 Entry</p> <p>Split door trim noted.</p>	<p>MCH</p>

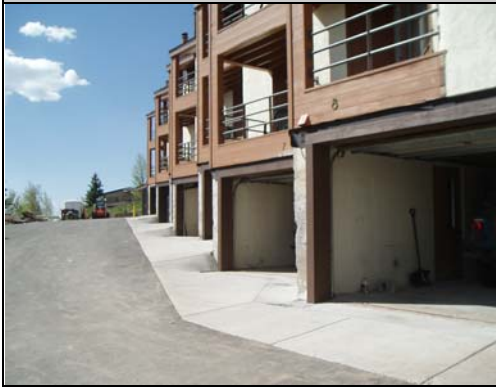
<p>5/23/12 – Photo 4 Upper Level Units, Building “A”</p> <p>Door Trim is in place and garage doors are installed. Work is underway updating the paint color from Paint #1 (Sable) to Paint #2 (Eagle’s Nest Brown).</p>	<p>Note</p>

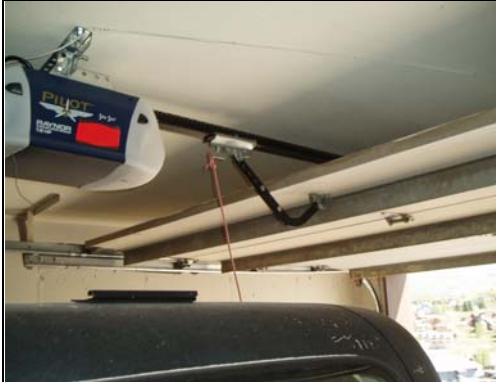
<p>5/23/12 – Photo 5 Typical Garage Door</p> <p>Garage door openers have been reinstalled.</p>	<p>Note</p>

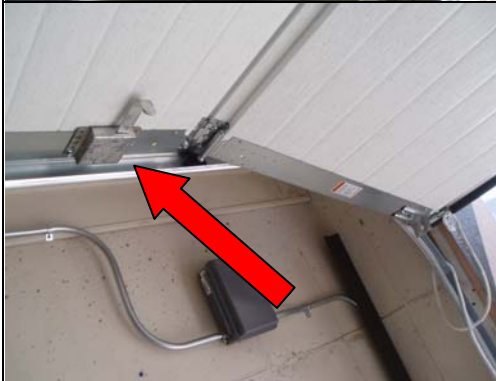
<p>5/23/12 – Photo 6 Typical Garage Door</p> <p>On units without garage door openers, a cane latch has been installed.</p>	<p>Note</p>

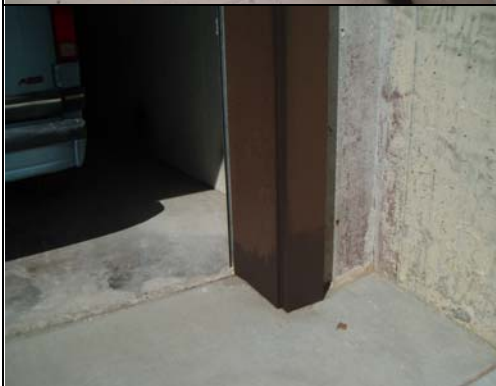
<p>5/23/12 – Photo 7 Typical Garage Door Trim</p> <p>Paint color is being updated. Note new ENB on the lower portion of the garage door trim.</p>	<p>Note</p>

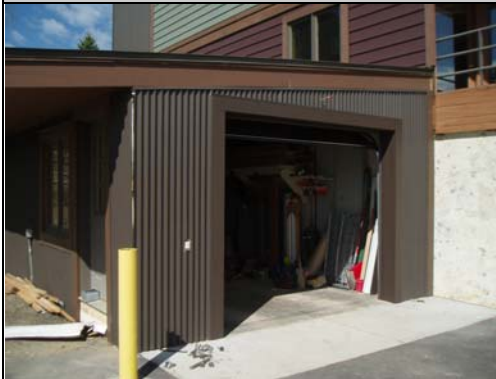
<p>5/23/12 – Photo 12 Upper Level Maintenance Shed</p> <p>Garage door is in place. Awaiting final trim pieces.</p>	<p>Note</p>

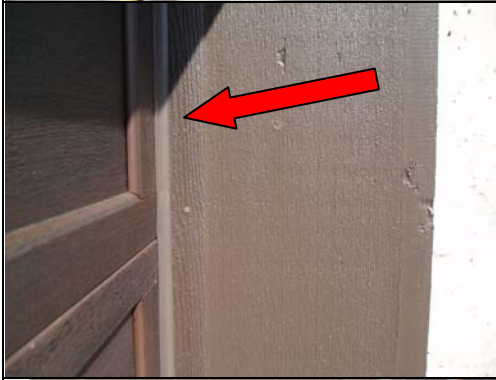
<p>5/23/12 – Photo 13 Unit 1 Garage Door Trim Detail</p> <p>North Jamb – Note color comparison between painted wood jamb and prefinished weather-stripping.</p> <p>Red arrow points to the weather-stripping.</p>	<p>Note</p>

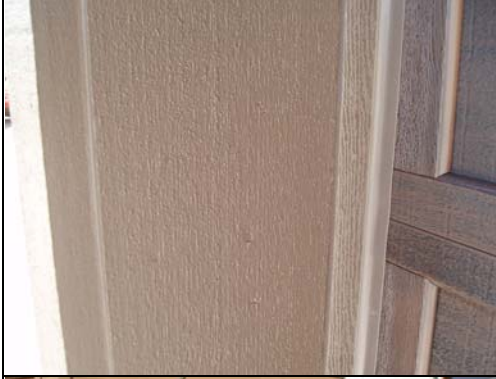
<p>5/23/12 – Photo 14 Unit 1 Garage Door Trim Detail</p> <p>South Jamb in different light for color comparison.</p>	<p>Note</p>

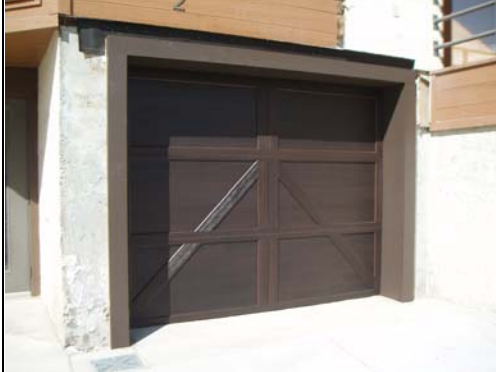
<p>5/23/12 – Photo 15 Unit 2</p> <p>Completed trim and garage door.</p>	<p>Note</p>

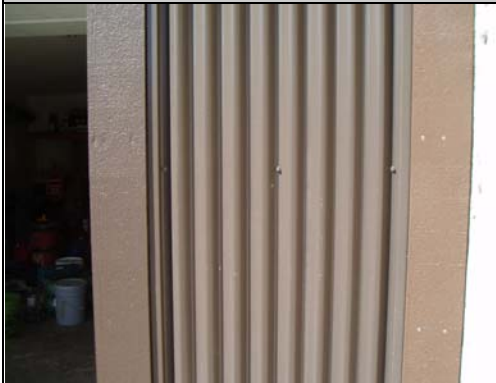
<p>5/23/12 – Photo 16 Upper Level Maintenance Shed</p> <p>Comparison between the two paint colors. ENB matches the burnished slate siding.</p>	<p>Note</p>

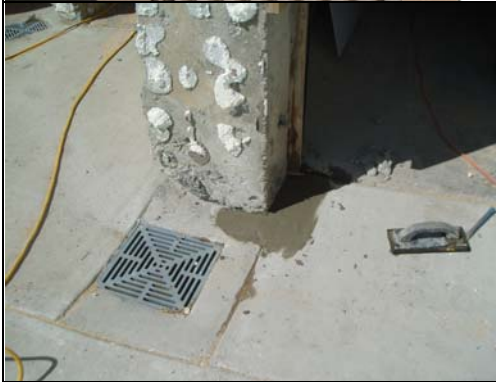
<p>5/23/12 – Photo 17 Unit 12</p> <p>Concrete repairs underway at jamb bases.</p>	<p>Note</p>

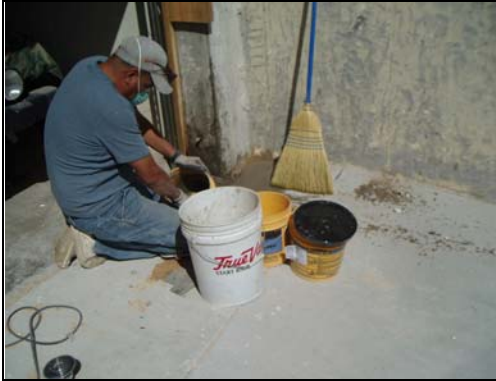
<p>5/23/12 – Photo 18 Unit 12</p> <p>Concrete repairs underway at jamb bases.</p>	<p>Note</p>

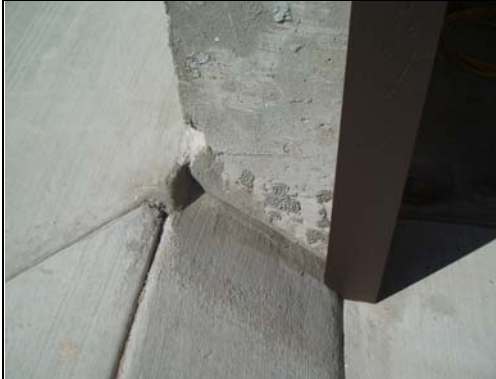
<p>5/23/12 – Photo 19 Unit 7</p> <p>Completed concrete repairs.</p>	<p>Note</p>

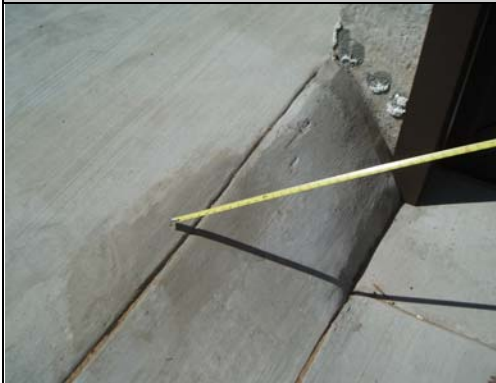
<p>5/23/12 – Photo 20 Unit 5</p> <p>Additional concrete repairs performed by Holgate Construction with remaining concrete patch. (Not in contract.)</p>	<p>Note</p>

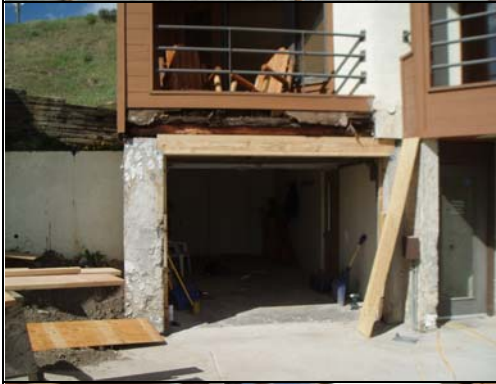
<p>5/23/12 – Photo 21 Unit 9</p> <p>Garage door header has been replaced.</p>	<p>Note</p>

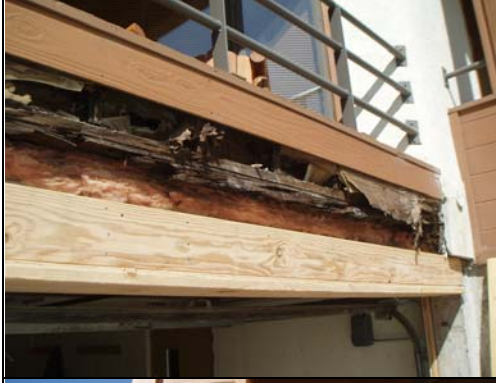
<p>5/23/12 – Photo 22 Unit 9</p> <p>Garage door header has been replaced. This will provide a structural base to begin the rest of the repairs.</p>	<p>Note</p>

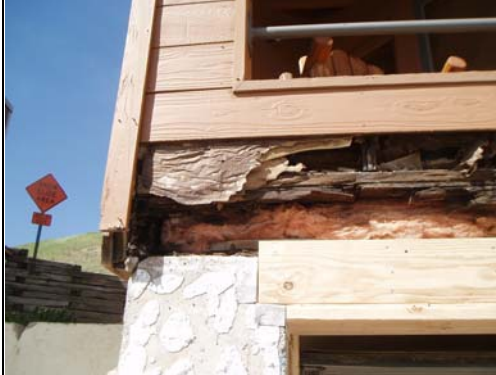
<p>5/23/12 – Photo 23 Unit 9</p> <p>Note degraded condition of deck and knee wall members. Batt insulation for the garage ceiling is visible now that the degraded deck member has been removed.</p>	<p>Note</p>
