ARCHITECT'S FIELD REPORT

056

PROJECT	Eagle's Nest Townhouses 11 Morning Glory Way & 31 Marcellina Lane Mt. Crested Butte, CO 81225	DATE	6/29/11
----------------	--	-------------	---------

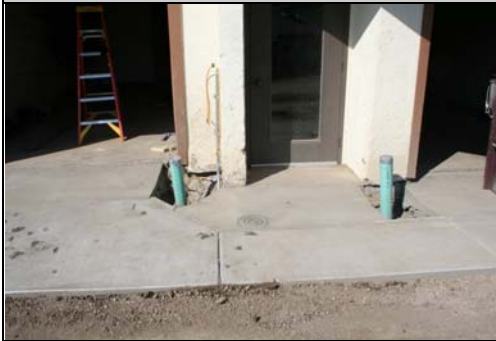
<p>6/29/11 – Photo 21 Lower Level Detail of Units 17 and 18</p> <p>Area drains have yet to be installed.</p>	<p>Note</p>

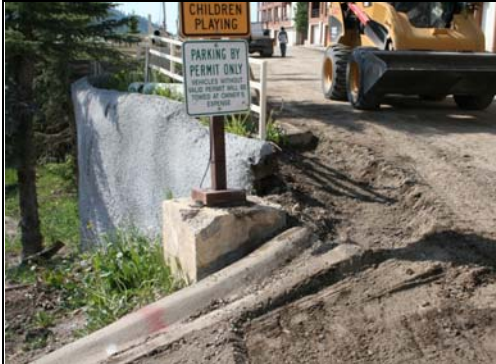
<p>6/29/11 – Photo 22 Lower Level Curb</p> <p>Damaged area of curb has been removed. New curb will be installed today.</p>	<p>Note</p>

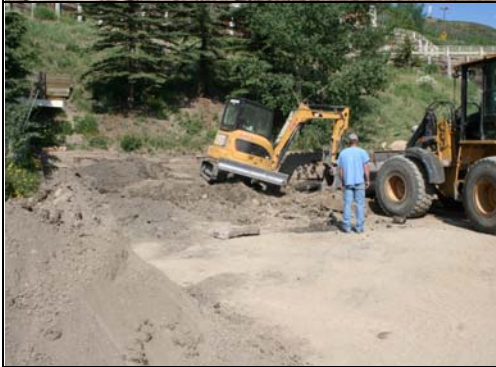
<p>6/29/11 – Photo 23 Lower Level North Parking</p> <p>Removal of additional asphalt at the parking area/ bus turnaround north of the hot tub area. Timber retaining wall was installed on top of the asphalt hindering progress.</p>	<p>Note</p>

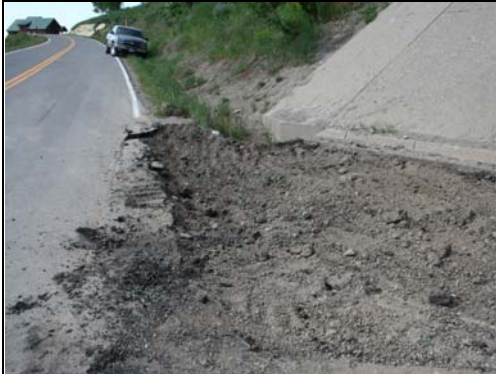
<p>6/29/11 – Photo 24 Upper Level Entrance Looking South</p> <p>Additional asphalt has been removed.</p>	<p>Note</p>

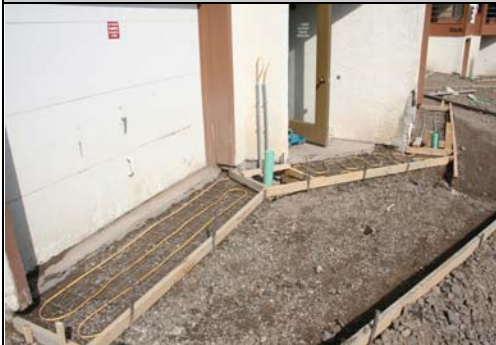
<p>6/29/11 – Photo 33 Upper Level Units 9 and 10</p> <p>Formwork and heat cable are in place.</p>	<p>Note</p>

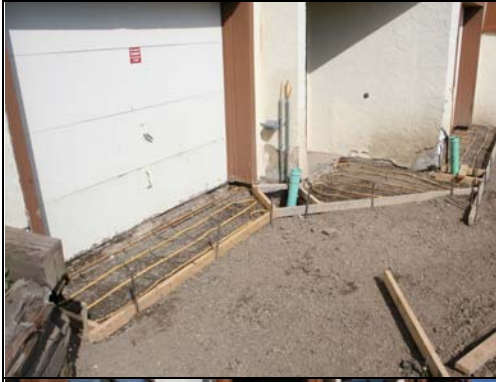
<p>6/29/11 – Photo 35 Upper Level Unit 8</p> <p>Formwork and heat cable are in place.</p>	<p>Note</p>

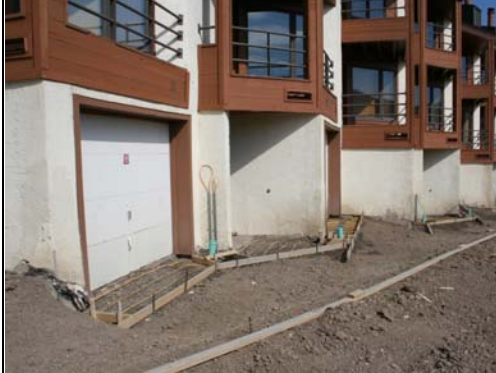
<p>6/29/11 – Photo 36 Upper Level Building B Looking North</p> <p>Formwork and heat cable are in place.</p>	<p>Note</p>

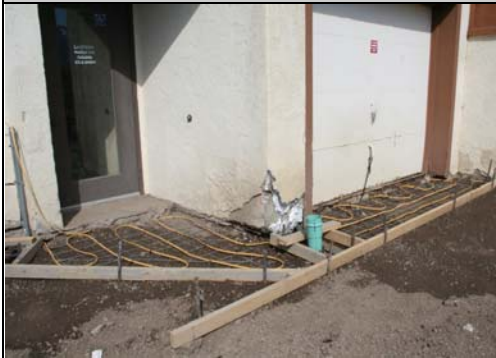
<p>6/29/11 – Photo 37 Upper Level Detail of Units 13 and 14</p> <p>Formwork and heat cable are in place.</p>	<p>Note</p>

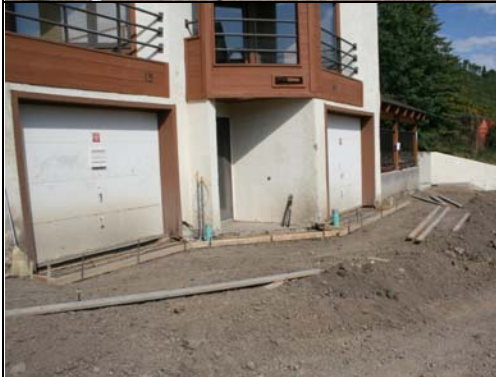
<p>6/29/11 – Photo 38 Upper Level Units 15 and 16</p> <p>Formwork and heat cable are in place.</p>	<p>Note</p>

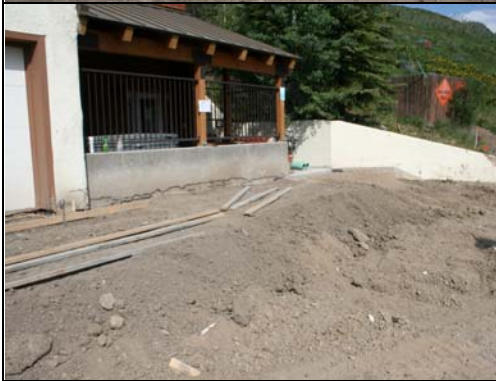
<p>6/29/11 – Photo 39 Upper Level Caretaker Unit</p> <p>Concrete formwork will be installed on 6/30.</p>	<p>Note</p>
