August 10, 2007

Re: Property Condition Assessment for Eagles Nest at Mt. Crested Butte
Project No.: 07057

We have completed our property condition assessment for the Eagles Nest at Mt. Crested Butte condominiums located in Mt. Crested Butte, Colorado. The following is a summary of our observations, comments and recommendations.

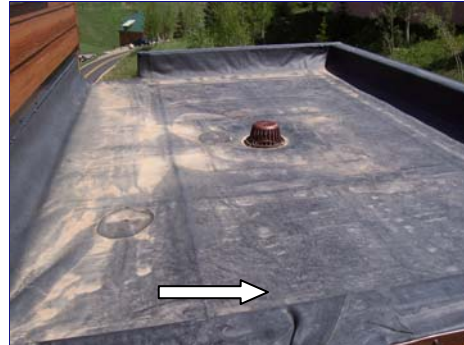
Description: The low sloped roof sections of the residential buildings have a single ply ethylene propylene diene membrane (EPDM) roof system

Comments: The membranes are mechanically adhered and utilize edge scuppers for drainage. These roofs were installed in 2003.

Recommendations: The membranes were in good condition for their age. We did note that the adjacent parapet walls did not have a parapet caps and were just wrapped with the EPDM membrane. These metal parapet wall caps are required by the manufacturer. We recommend installing the flashing if the membrane starts to prematurely deteriorate. The roofs should last another 12 to 14 more years.

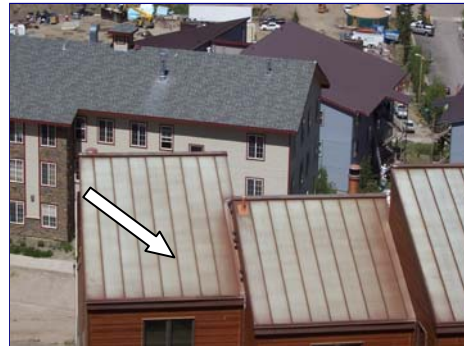
Comments: The condition of the metal panels is typical on these types of roof of this age. The metal panels are faded and in aesthetically displeasing condition. Typically, the underlayment will fail first.

We observed damage to stucco and siding from ice/snow fall from the roofs. The eaves on the buildings have no overhang relative to the vertical façade. We received report of ice damming problems during the winter months.

Recommendations: These types of roof systems typically have a useful life of 25 to 30 years before a replacement is necessary. We recommend replacing the roofs and underlayment in the next 2 to 5 years.

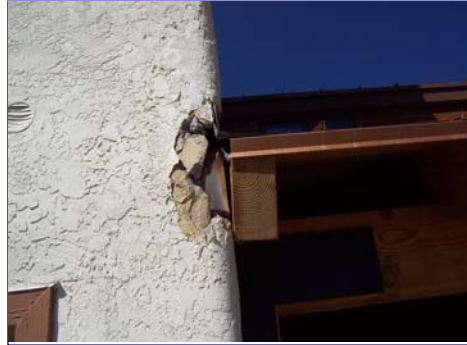
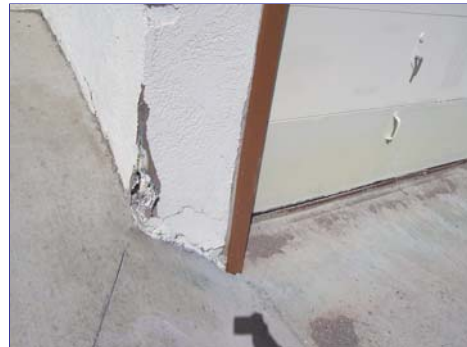
Comments: There are many areas with impact damage from what appears to be ice/snow fall and from vehicles. Some of these areas appear to have been repaired with an Exterior Insulation and Finishing System.

Recommendations: This type of stucco system can have useful lives in excess of 50 years with maintenance. The damaged areas can be patched and the stucco recoated to match. This type and color of stucco is prone to staining and impact damage, so cyclical maintenance should be anticipated.

Replacing the stucco with an alternative cladding system is also an option. A stone, or a faux stone, may work well. If choosing a stone façade we recommend full depth mortar joints. Open joints at higher elevations are prone to damage from the dramatic freeze thaw cycles.

We recommend addressing the ice/snow impact problems with a roof renovation prior to addressing the stucco damage.

We also recommend installing a vehicle barrier system at the lower stucco areas adjacent to the parking garages. There are many vehicle barrier options available, including single posts, double posts with rails, fixed, removable, collapsible, etc. It may be possible to integrate a design scheme to match the vehicle barriers and the balcony railings.

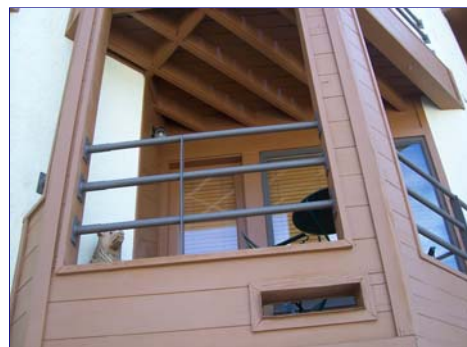
Comments: The deck boards are in low satisfactory condition and shows signs of moisture deterioration. The boards are weak and deflect when applying loads. The boards are approaching the end of their useful life.

On site maintenance personnel removed deteriorated deck boards on one balcony in order for us to observe the condition of the membrane. The membrane is brittle and deteriorated at seams along the edges. These types of membranes have a useful life of around 25 years before replacement is necessary. The membrane is approaching the end of its useful life.

The railings are in fair condition with some deterioration noted. The railings are out of current building code and should be updated during a balcony renovation.

Recommendations: We recommend removing the decking and the waterproof membranes. A plywood substrate with a heavy duty pedestrian grade urethane coating system with a skid resistant texture would work well in the Crested Butte area.

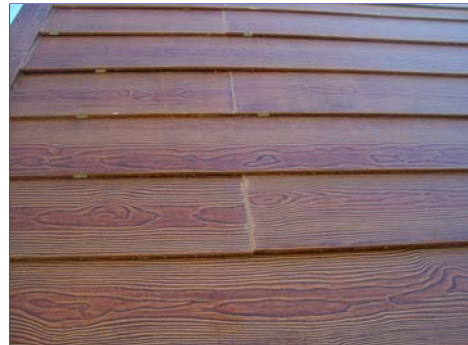
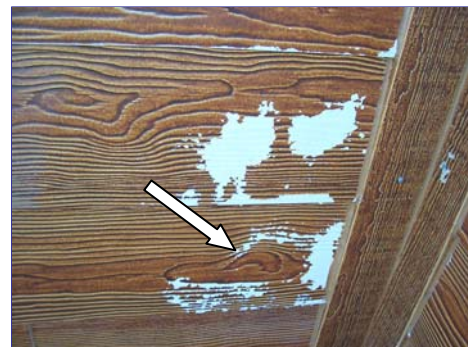
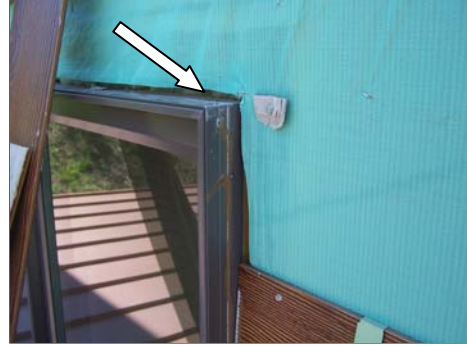
- We observed metal flashings to have been installed at roof level windows however; no metal flashings have been installed at first or second level windows or doors.

- There are no membrane flashings around window and door heads, jambs or sills.
- There are no kickout flashings at roof to wall intersections. We observed several areas at roof to wall intersections that have been damaged as a result of water intrusion due to the lack of kick out flashings.

- There are no flashings around utilities mounted to the buildings.
- There are several 1/4" to 3/8" holes throughout the lap siding. These holes are presumed to have been made as a result of attaching scaffolding during the installation of the lap siding. The holes have not been repaired and are a potential source for water intrusion.

- Several siding butt joints are greater than 1/4" in width. James Hardie recommends butt joints have moderate contact, typically somewhere between 1/16" to 1/8".

- We observed the coating on several areas of siding to be peeling and flaking from the surface. Where the coating is not peeling or flaking, several surface cracks can be seen. The coating is rapidly deteriorating and failing throughout the entire property site.

Recommendations: Membrane flashing should be installed on the jamb, sill and head of all windows and doors per AMAA Window Membrane Flashing Standard B.

Kick out flashings should be installed at all roof to wall intersections. Damaged siding should be removed and replaced prior to the installation of the kick out flashings.

Flashings and counterflashings should be installed at all window and door locations as required by the local building code and James Hardie.

As a result of the wide spread failure of the coating, we recommend that the siding be removed and replaced. We recommend that the finish coat to be applied to the newly installed siding product be painted with a 100% solid, acrylic topcoat.

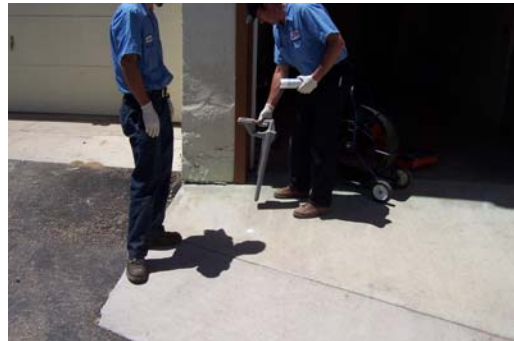
Comments: During our previous visit in 2004 we noted that the garage aprons did not have adequate slope and were in poor condition with extensive spalling and impact damage noted. Much of this damage appeared to be the result of ice/snow fall from the above roof fields.

We also received report that during periods of precipitation, several of the garage aprons drain moisture into the garages.

It appears that the aprons were simply removed and replaced, matching the elevations at the garage slabs and the asphalt drive. Many of the garage slabs have settled and the leading edges, at the asphalt, have remained at the original elevation. This has resulted in slope deficiencies at many of the aprons. We performed an elevation survey of the garage aprons and the adjacent roadway. The following is the results of that survey.

Recommendations: Remove and replace the garage aprons in 2 to 4 years. We also recommend replacing the garage slabs simultaneously in order to properly match elevations.

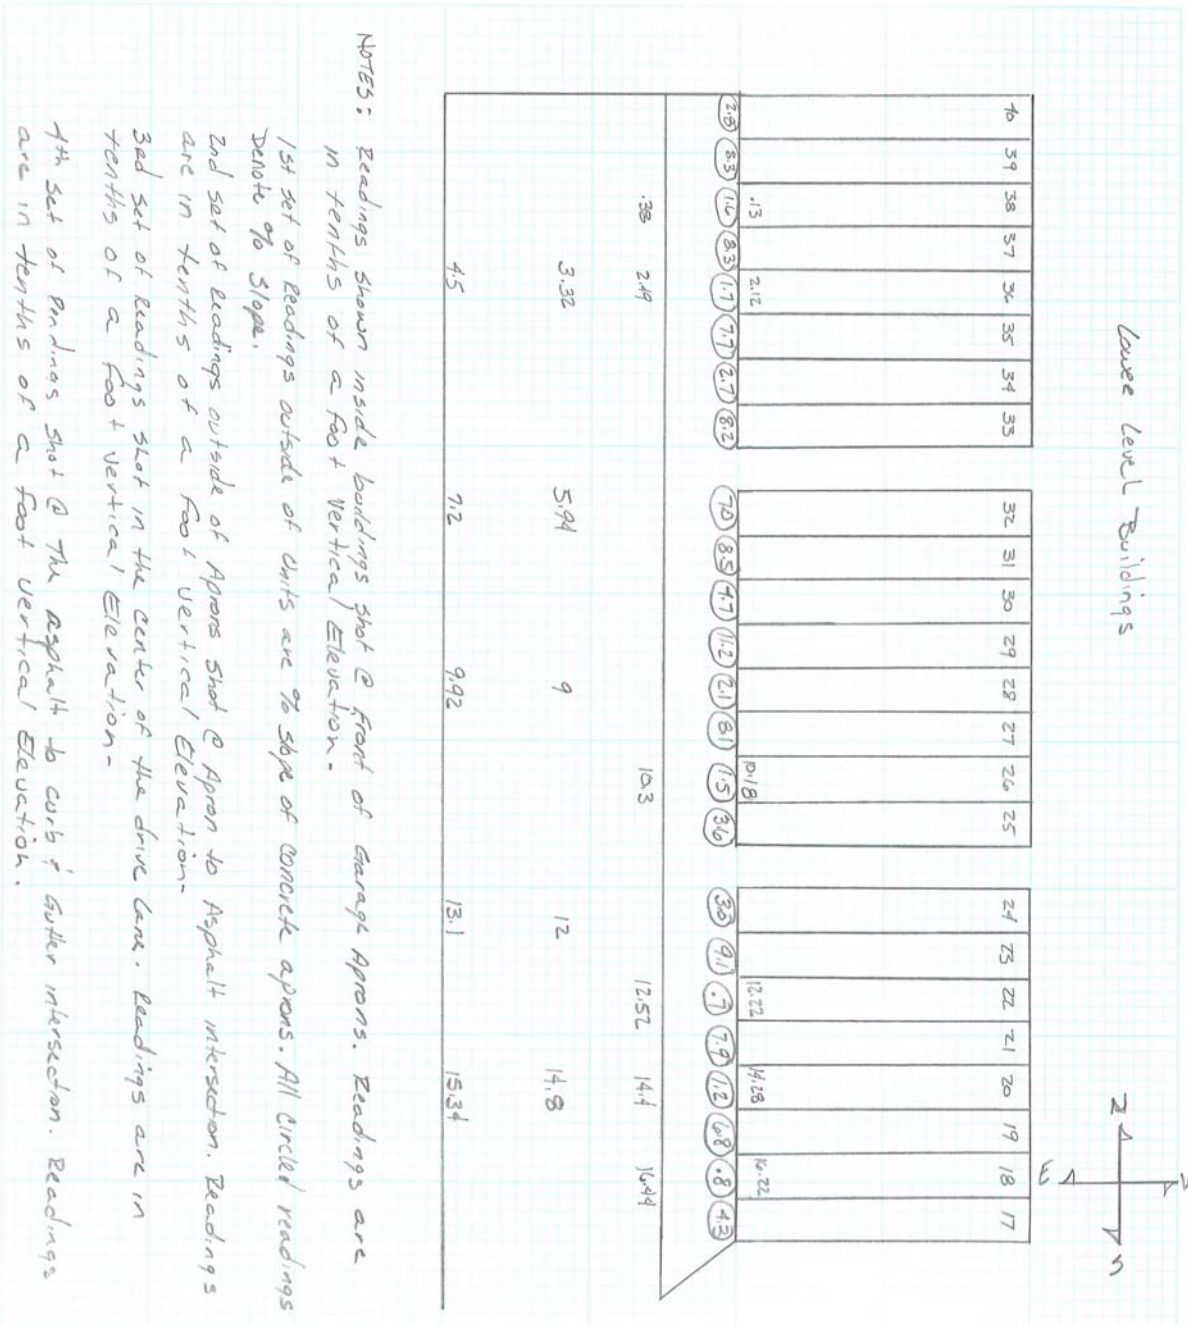
Sheet Number 2 of 2

- Please note that the elevations shown within the building footprint (at the garage entries) were taken where the garage aprons meet the garage slab.
- The numbers that are circled are the percent slope of the garage aprons taken at the lowest sloped area at that unit.
- The 2nd set of numbers, located just outside of the garage aprons, are elevation shots taken where the aprons meet the asphalt.
- The other elevations are shots taken in the middle of the asphalt drive and where the asphalt drive meets the curb and gutter.

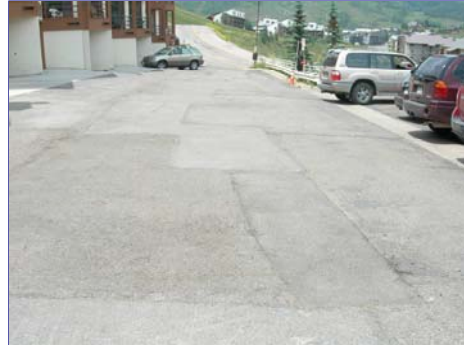
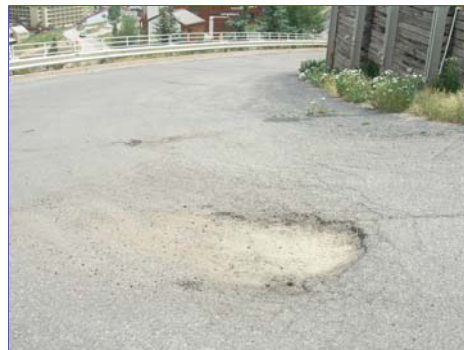
It appears the asphalt areas at the complex have had some maintenance in the past. We noted an abundance of past patches in the asphalt systems. We could determine if the asphalt has been sealcoated.

The asphalt is in low satisfactory condition with vertical deflections noted in several areas. These deflections are signs of moisture disruption of the supporting base soils. Many areas have failed resulting in "alligatoring". We also noted full depth longitudinal cracking in many areas. There is aggregate exposure on the surface. The asphalt is nearing the end of its useful life.

We noted a sizeable pothole areas on the roadway leading to the upper buildings. This is a sign of complete asphalt failure in those areas.

Recommendations: The current asphalt is showing signs of base problems. The asphalt should be removed, the sub-grade soils will need to be reconditioned, re-graded and a new asphalt system installed.

We recommend removing and replacing the damaged concrete drain pans, curbing and garage apron sections during the asphalt replacement.

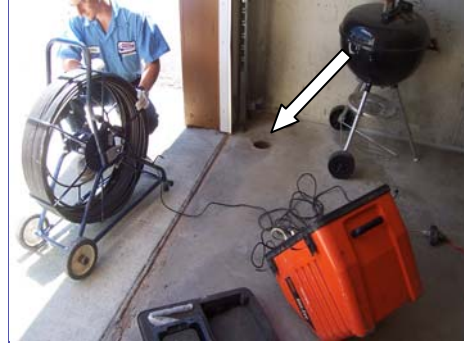
The evaluations determined that there are breeches, low spots (bellies), some pipe damage and settlement in several locations.

Recommendations: During the asphalt replacement, the lateral sanitary sewer lines servicing the individual units (groups of 2) should be removed and replaced at all locations. Replacement should include pipe replacement at the proper depth and to current code.

The lateral sewer line located in unit #30 is in the worst condition however still functional. If this line continues to collapse it may need to be replaced prior to the above mentioned recommendation.
